# AFA Guidelines for Analyzing Duo-cone Seal Failures

| THE INFORMATION HEREIN MAY NOT BE COPIED OR TRANSMITTED TO OTHERS WITHOUT THE WRITTEN PERMISSION OF CATERPILLAR | | | |
|---|---|---|---|
| AFA Guidelines for Analyzing Duo-cone Seal Failures | DATE<br>2/19/2015 | CHG<br>NO<br>00 | NUMBER<br>1301-4.04-1307 |

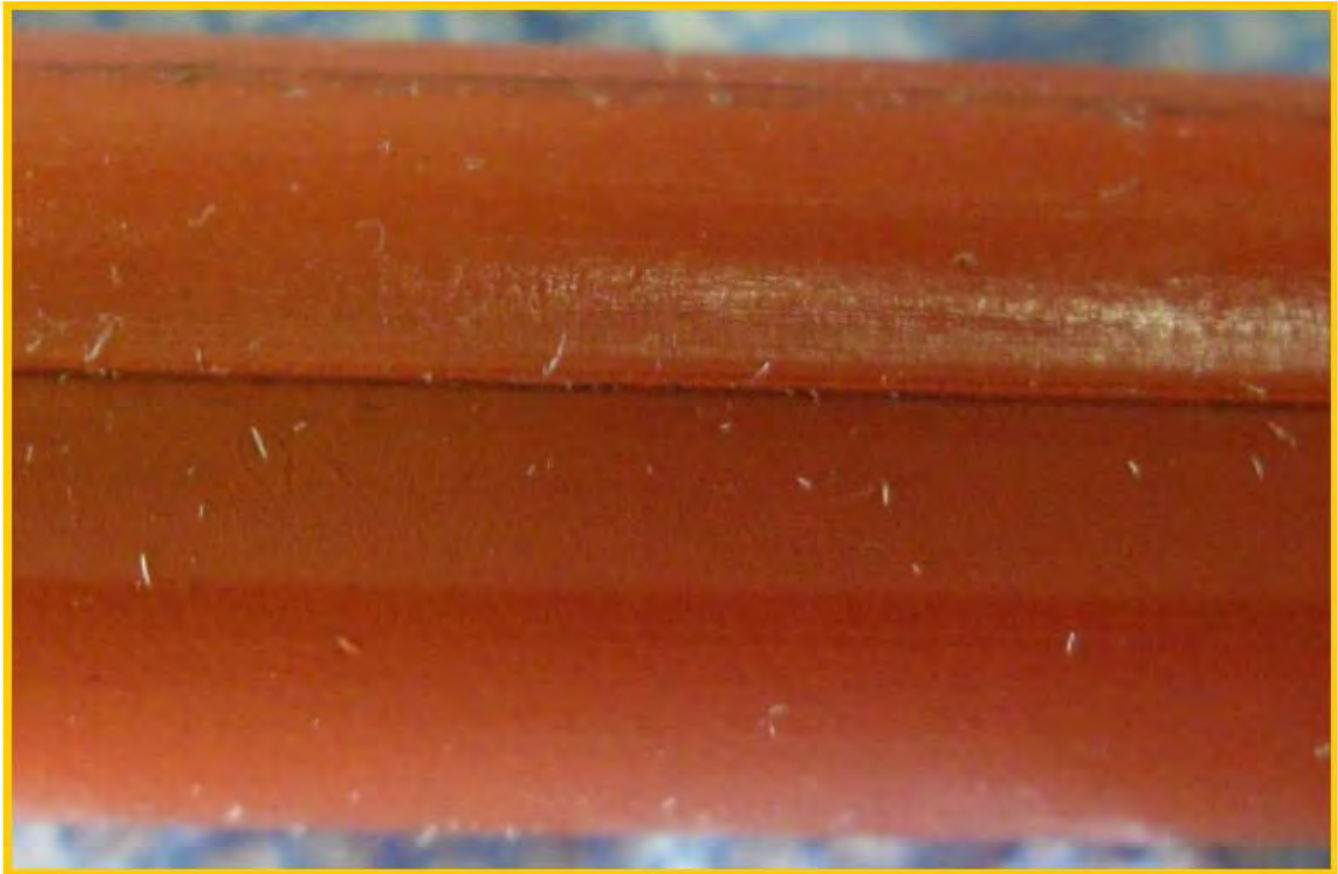
FIG: 1g

View of an OHT toric ring showing a ridge formed by contact with the duo cone retainer lip.
