# A Method for Chassis Center Tube Alignment on 793D Mining Trucks

September 2023  
4.03-230928-1

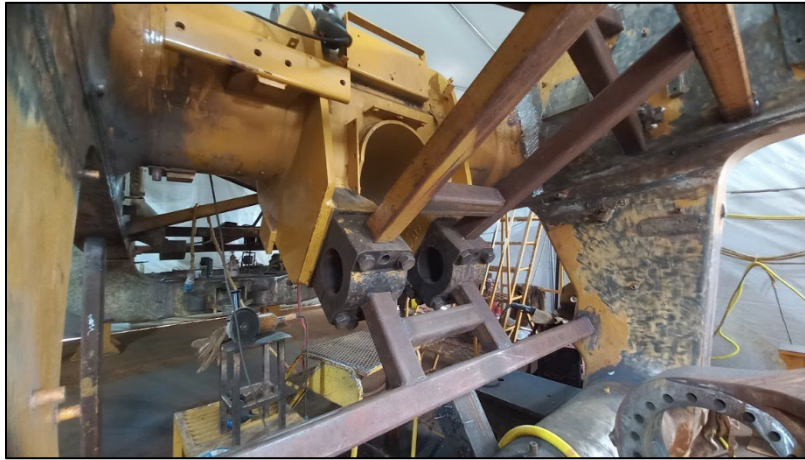
**Image 02.** Tooling Support made before the removal of the Center Tube (open image)

The Tooling Support is made with the central pin fixing bearings (**PN 8X-2944**), which must be fixed on the Center Tube by bolt **9X-6151** and then the fixing structure is made, (picture example) but another profile can be used. The Center Support must be made before removing the damaged tube and fixed to the chassis, so it is possible to obtain the installation reference for the new tube. The sequence of execution of the central pipe replacement using the tooling and the sketch with reference dimensions is presented below.

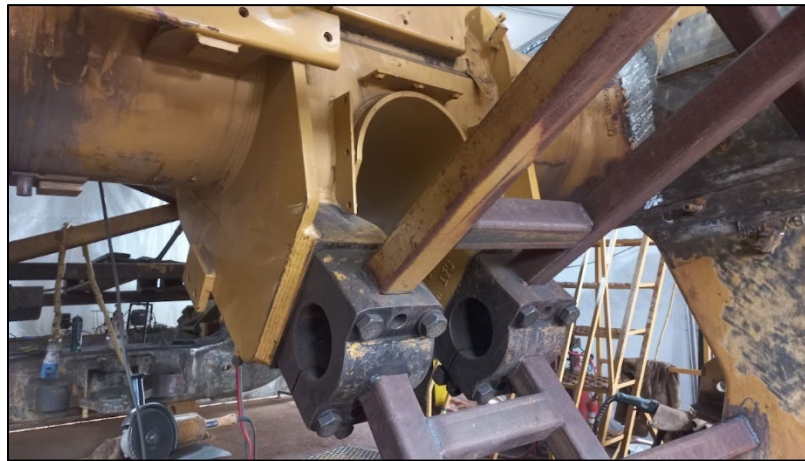
**Image 03.** Tooling Support made before the removal of the Center Tube (More focused image)

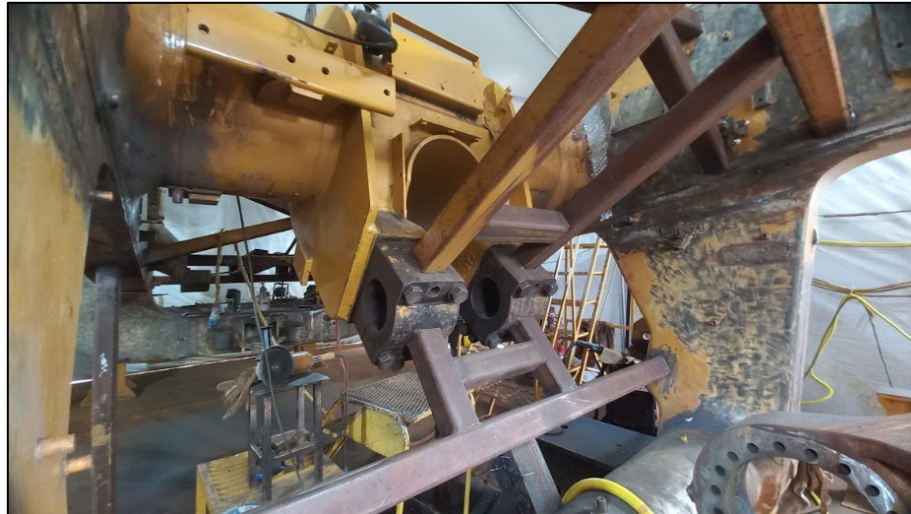
**Image 04.** Making the Tooling Support before removing the Center Tube (more focused image)

The Tooling Support is made with the Center Tube that will be removed. The bearings are fixed on the Center Tube and then a support is made so that the bearings are fixed in relation to the chassis. The image below shows the bearing and support:

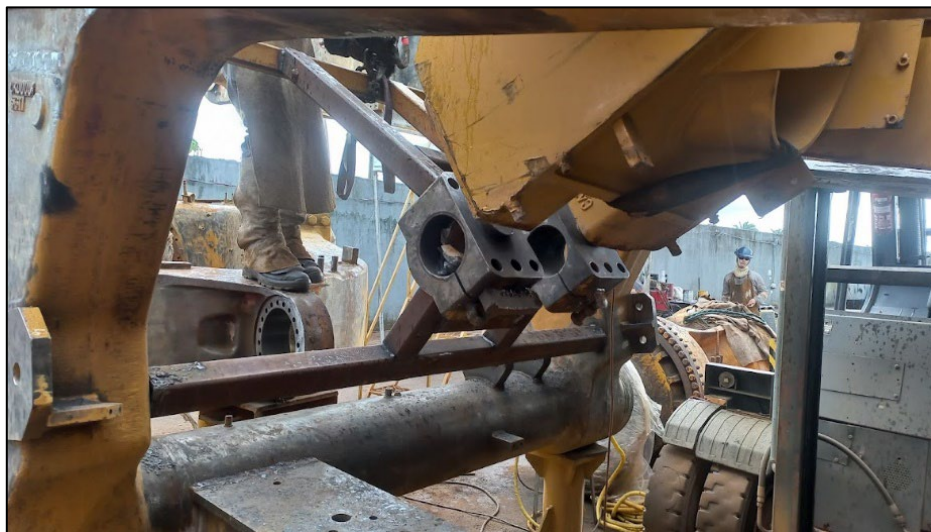
**Image 05:** Removal of the damaged Center Tube

After the tool is installed, the bearing retaining bolts are removed and the process of removing the damaged Center Tube is started. The picture below shows the removal of the Center Tube.

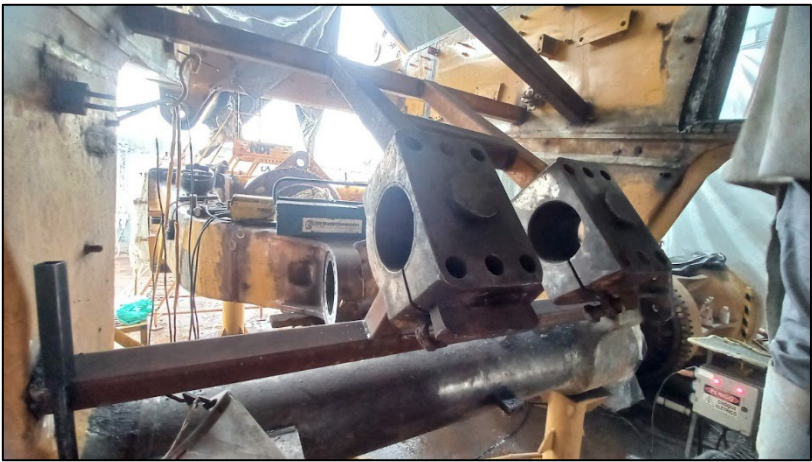
**Image 06.** Tooling positioned after removal of the Center Tube

The images below show the damaged Center Support removed and the template installed, thus maintaining the positioning reference for the new Center Tube to be installed.

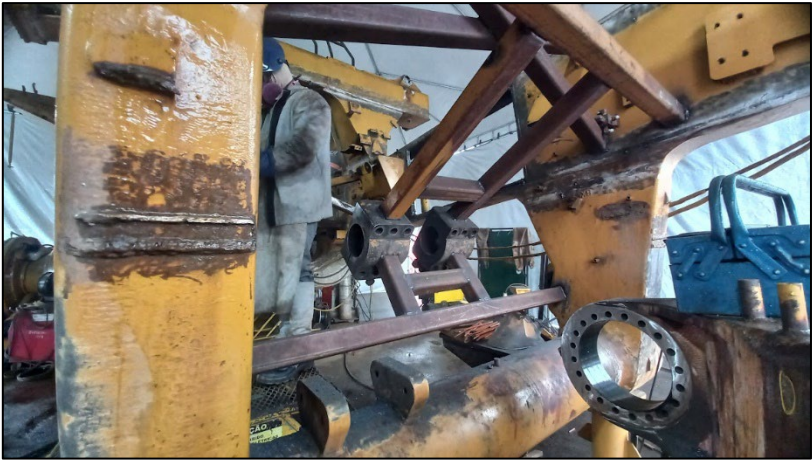
**Image 07:** Tool positioned during preparation for installation of the new Center Tube

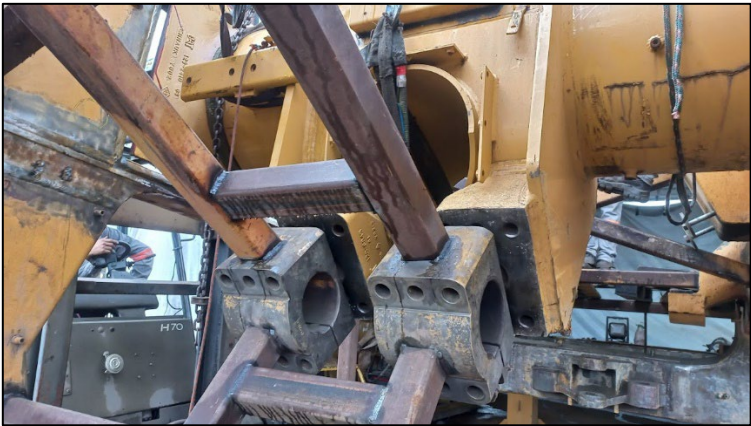
**Image 08:** Alignment of the Center Tube in the Chassis

After preparation for the new part, installation is made using the Tooling Support as reference. The images below show the installation and alignment of the new Center Support.

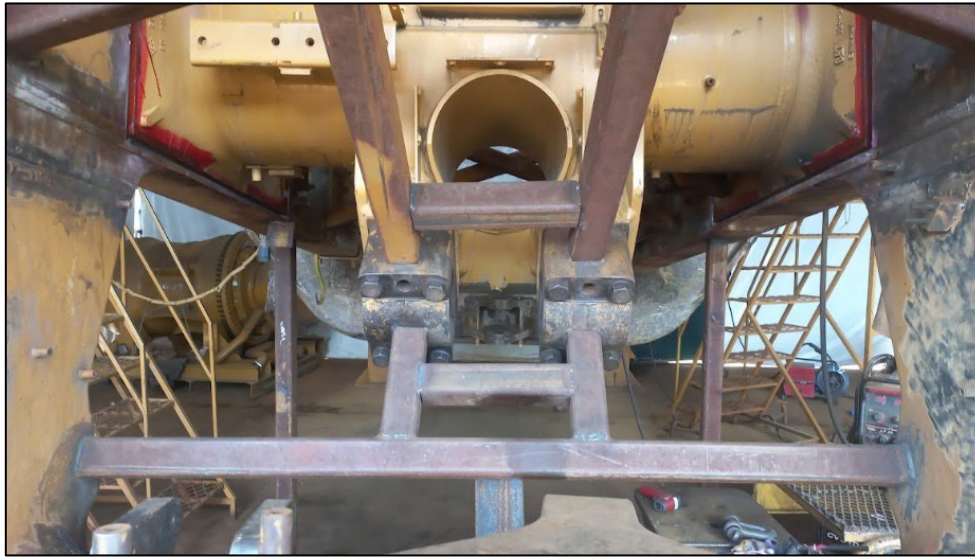
**Image 09.** New Center Tube fixed to the Chassis

After alignment and fixing the Tooling Support on the new part, the welding process of the Center Tube on the chassis is started, and after this process the removal of the tooling is performed.
