MINING DEALER BEST PRACTICE

# CAT 988H - Cooling System Temperature Measurement Optimization

August 2024  
1.05-240813-1

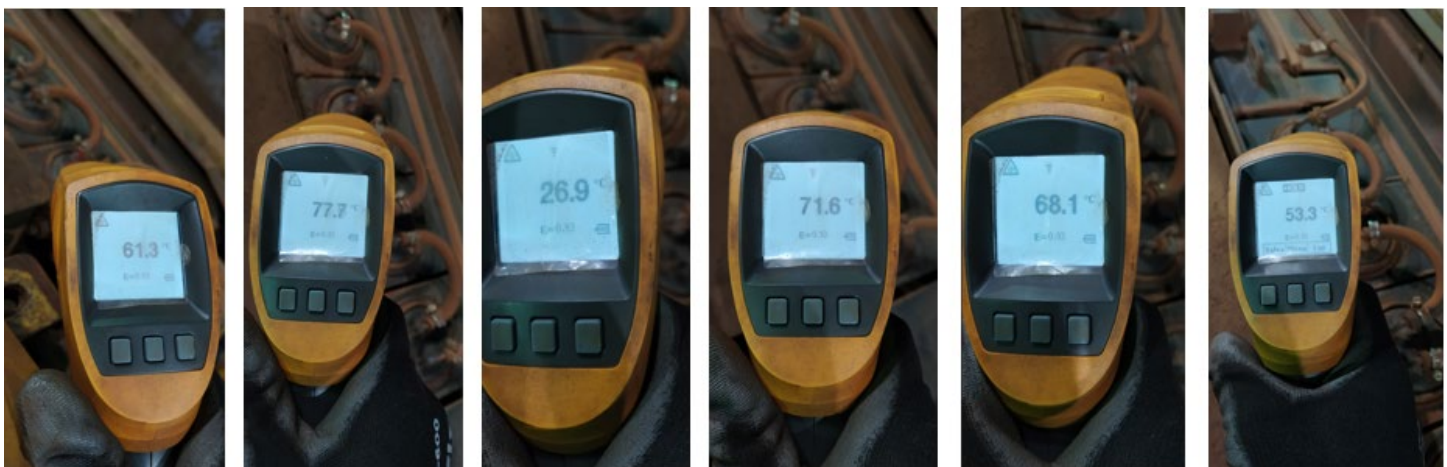
The points where the temperature should be measured are at the top of the cores near the connecting hoses between them, as shown in the images below.

Image 3 à 8: Measurements taken at the top of the cores.
