MINING DEALER BEST PRACTICE

# Disassembly Tool for Servo Piston of 320 and 324D Hydraulic Pumps

**August 2023**  
**4.01-230814-1**

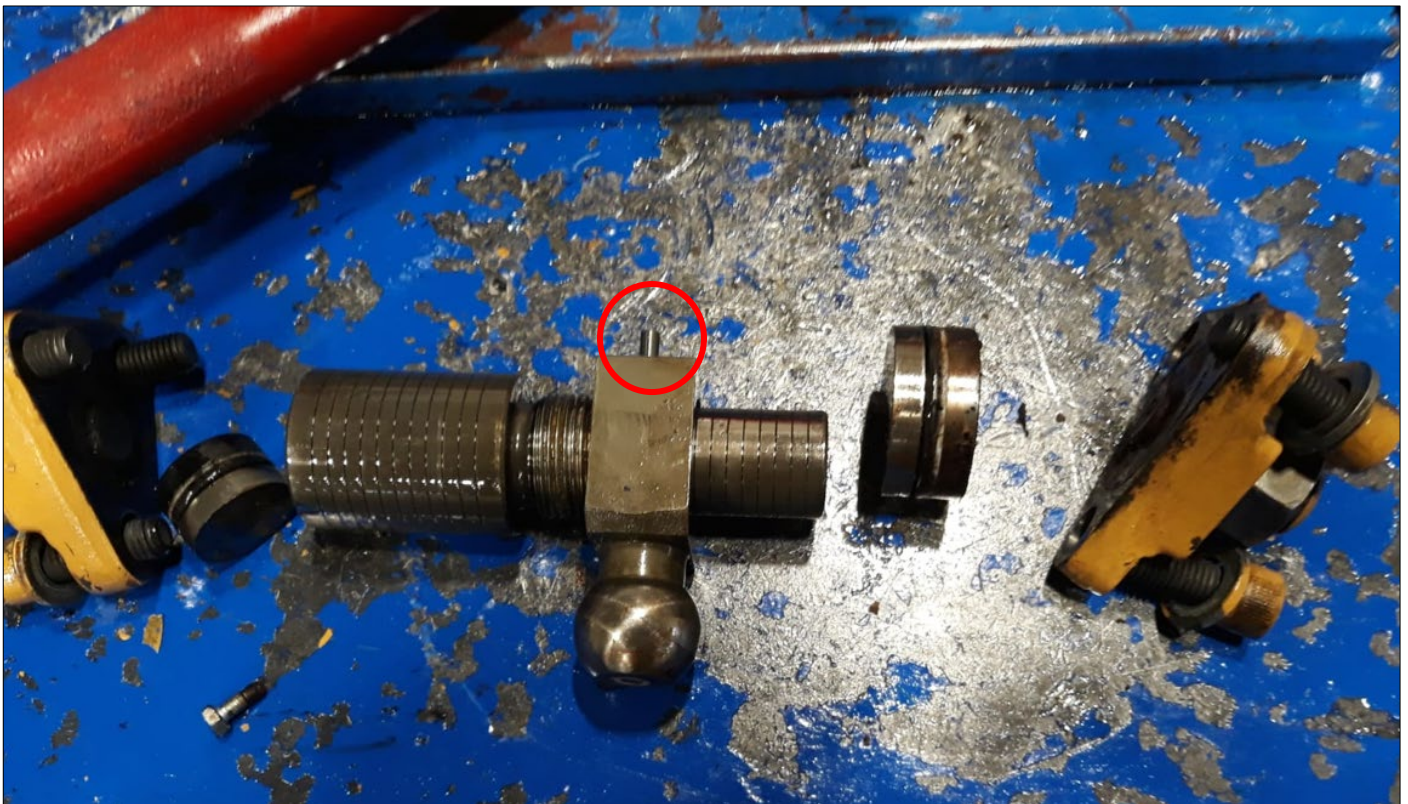
The servo piston needs to be removed for rebuild. The servo piston is not a fixed part. Therefore, it moves left and right during the removal. These movements can cause the servo piston pin to break during removal.

In addition, it was difficult to tighten according to the test procedures [SIS 2.0 \(cat.com\)](#) during the assembly phase. The breakage of the servo piston pin is a high additional cost because the broken pin does not have a single sale. If the pin breaks, the piston, and pins must be purchased and replaced.

Disassembly support pin assembly without damage the fixing pin.

A tool has been designed to prevent the pin from breaking and to facilitate the removal of the servo piston. The tool is placed around the servo piston during removal and prevents the piston from moving in either direction. The tool allows removal without breaking the pin. The piston that can be removed without damage is shown in the figure below.

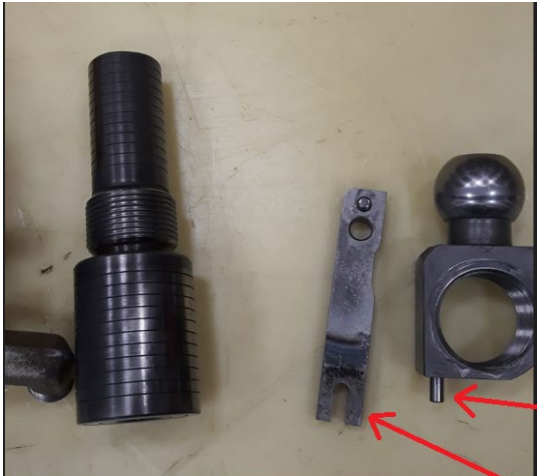
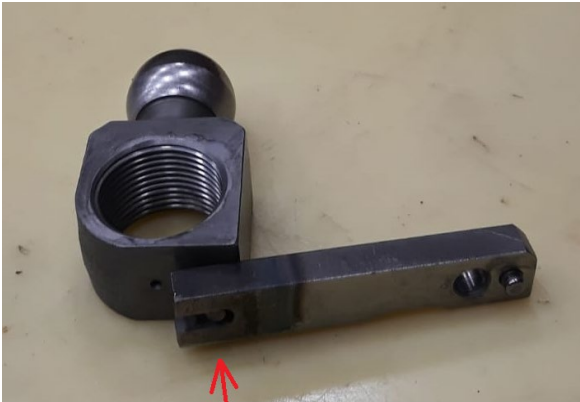
Step 1:  
The piston in the image must be fixed because it is unstable and moves to its right-left directions. The pin under the servo piston engages in the fixing slot. The pin is connected to the servo piston. When the servo piston moves, it forces the pin to move and begins to operate in the fixing split. Because the fixing split is stronger than the pin, it breaks the pin during assembly and disassembly. The tool holds the head of the servo piston in place and prevents movement during assembly/disassembly.
