MINING DEALER BEST PRACTICE

# Front Wheels Oil Drain Optimization for 777G OHT

May 2023  
1.04-230510-1

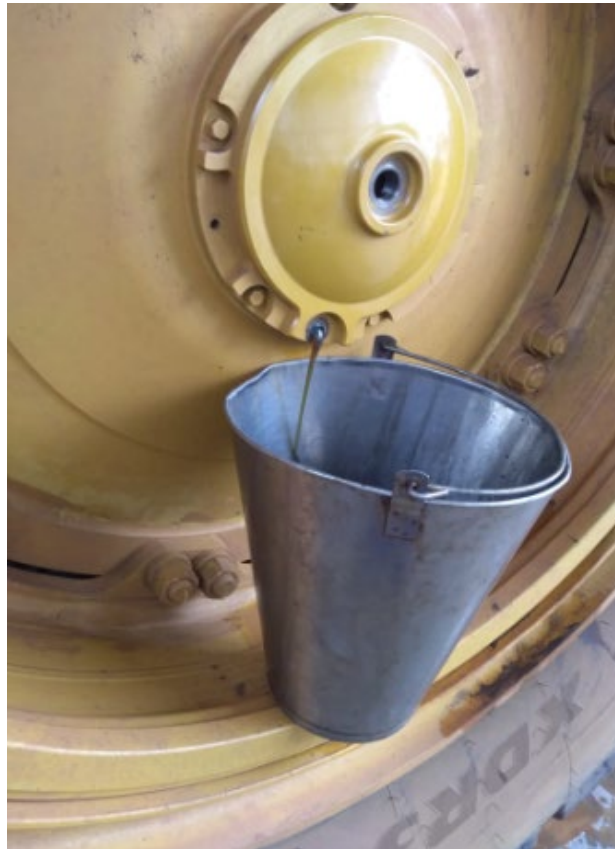
To carry out the task of draining the front wheels of the 777G fleet, field technicians used to place a bucket below the drain plug as Picture 1 illustrates. It does not stabilize on the wheel and eventually falls or moves out of position, causing oil to spill over the wheel and onto the ground. This entails, in addition to soil contamination, time loss during the preventive procedure, as the technician team needs to clean up the area affected by the oil in the equipment and on the floor.

Picture 1 - Conventional oil collection.

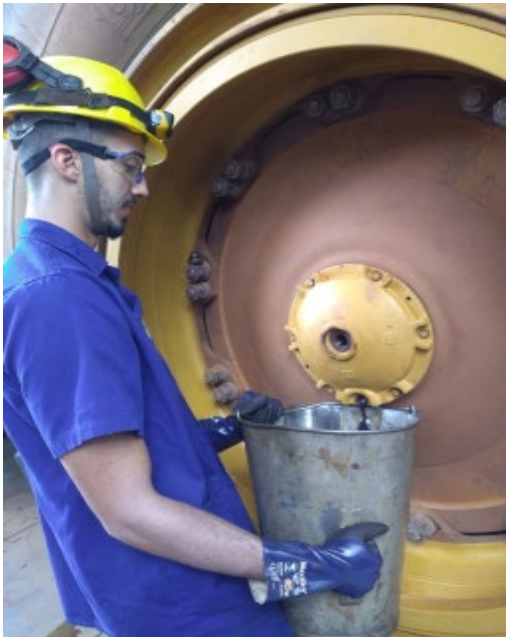
Picture 2 - The technician holding the bucket throughout the oil drain.

When the technician must hold the bucket to collect the oil, he loses about 40 minutes which he could be doing other tasks.

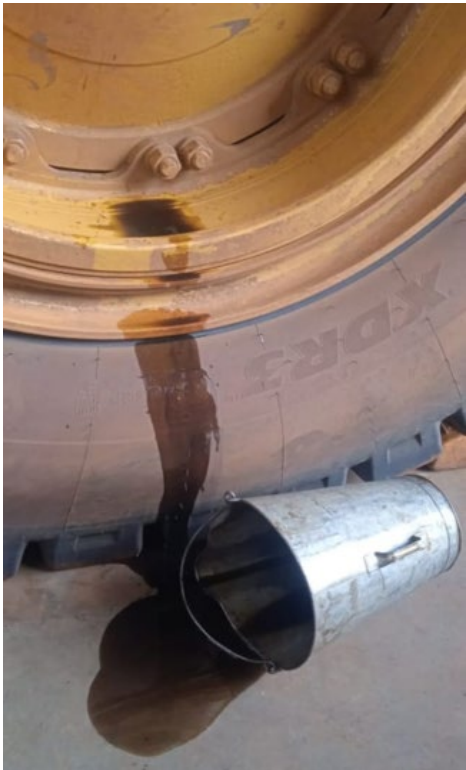
Picture 3 - Oil spillage on the wheel and on the workshop floor caused by the bucket falling during collection.
