MINING DEALER BEST PRACTICE

# Improved Assembly Process of the 793D/F XL Front Brake

**December 2022**  
**4.03-221219-1**

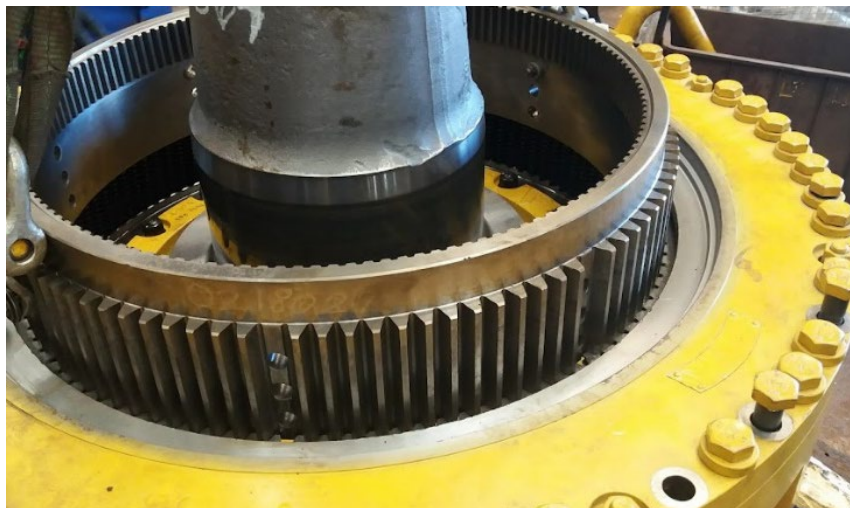
Since Hub, PN 265-3189 is not always delivered from customer site to the CRC together with the brake assembly, it often leads to misalignment.

Figure 1 - Disc spline misalignment in relation to the 265-3189 hub during the component installation.

The customization of a Hub, PN 265-3189 to be used as a tool will make it possible to correct these two problems mentioned in the previous topic.

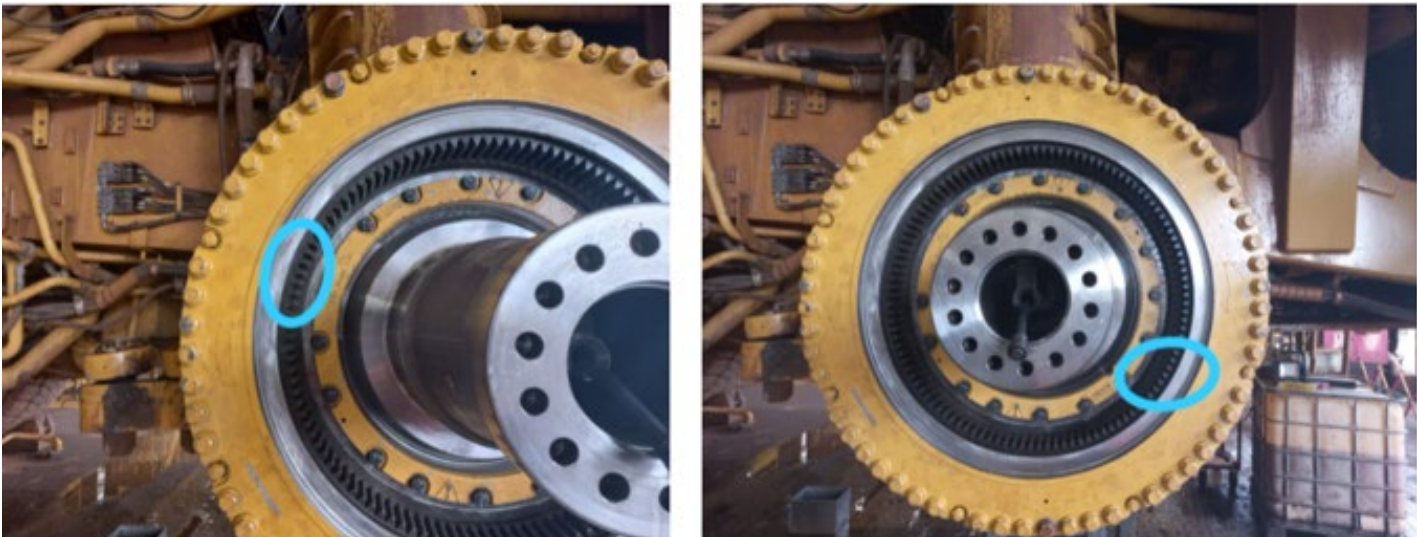
The images below show a set of brake with the splines of the discs aligned but showing the decentralization in relation to the set (housing) which makes it impossible to install the Hub during the assembly of the component in the field.

Figures 2 and 3 - Decentralization of the discs and plates in relation to the set.
