MINING DEALER BEST PRACTICE

# IMPROVED GPS ANTENNA HARNESS ROUTING IN 794AC COMMAND TRUCKS

July 2023  
1.10-230724-1

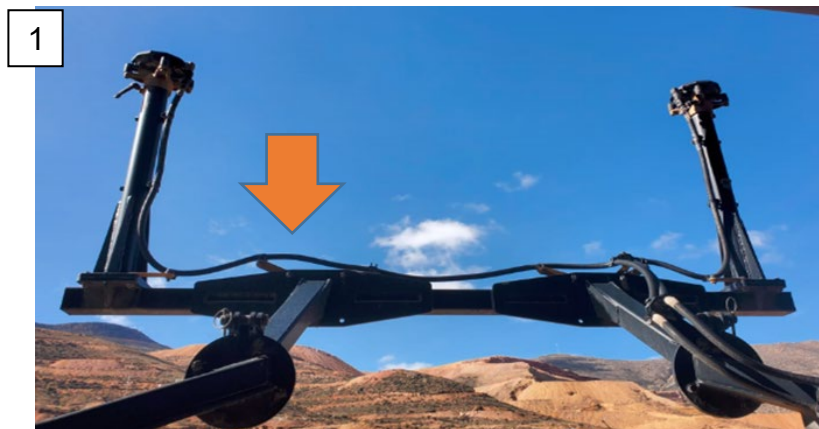
*Illustration 3: Current Design*
