# Improving Safety During Repair Management of the 994K

August 2022  
1.11-220810-1

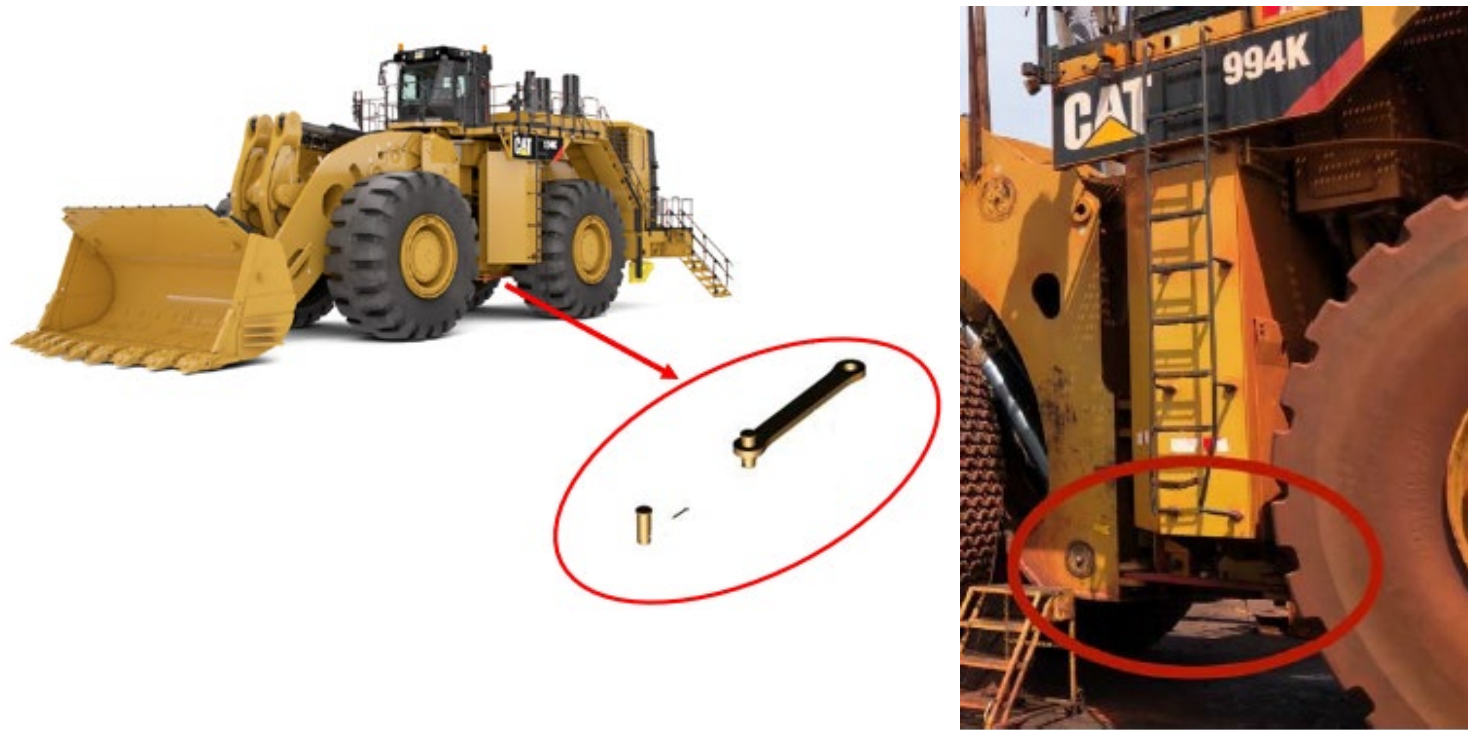
Figure 2 – 994K steering frame lock link

The 994K Wheel Loader steering frame lock link is used during maintenance to avoid crush risk and increase the security of the technicians. The steering lock link has two pins, one in each end.

To improve the mechanics' safety, a handling device was welded onto the top of each steering lock pin and on two locations of the steering lock link. These handling devices will reduce the risk of serious injury to personnel.
