MINING DEALER BEST PRACTICE

# Inversion of 793D A-Frame Pin

**June 2022**  
**1.01-220602-1**

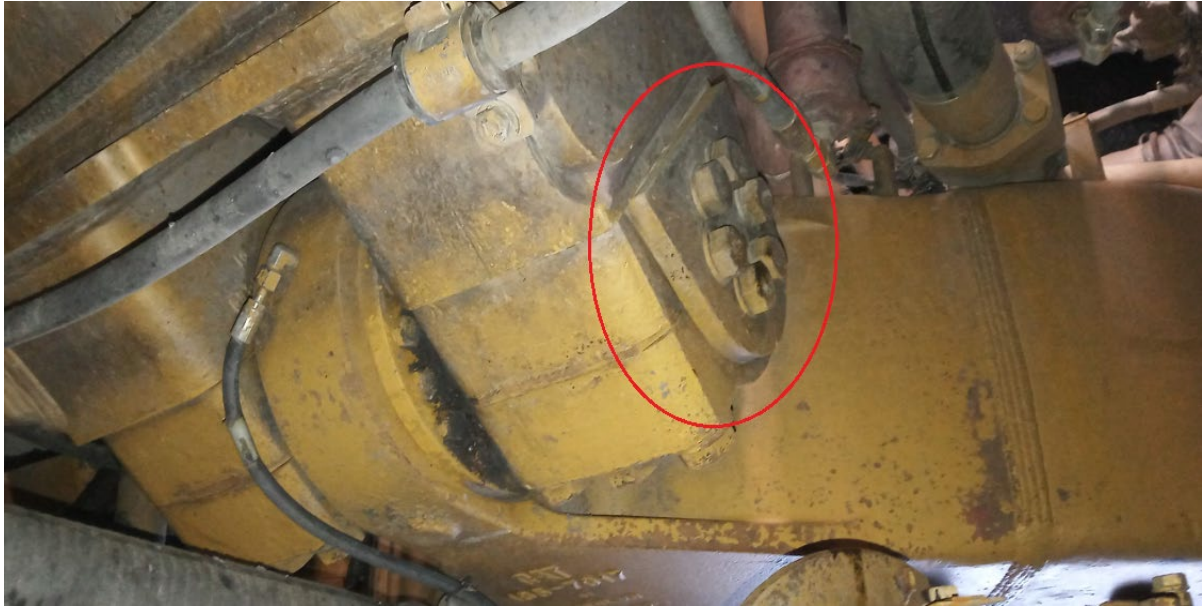
Picture 06 – A-frame pin after inversion, adjustment plate at the left side of A-frame pin with free space for pin clearance adjustment.

To avoid removing the hose to perform the pin adjustment, the customer changed the installation side of the pin. Now the adjustment plate is on the left side where there is enough space to carry out the pin clearance adjustment without the need to remove other parts.

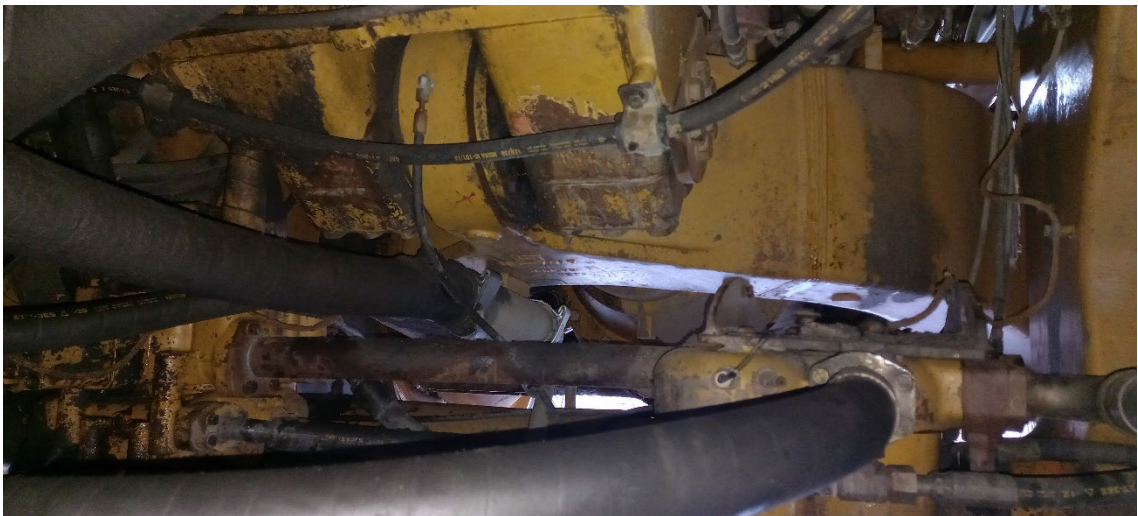
Picture 07 – Hydraulic lines to be removed to gain access to the A-frame pin.

1.1. Remove the hydraulic lines to gain access to the A-frame pin as depicted in Picture 07.

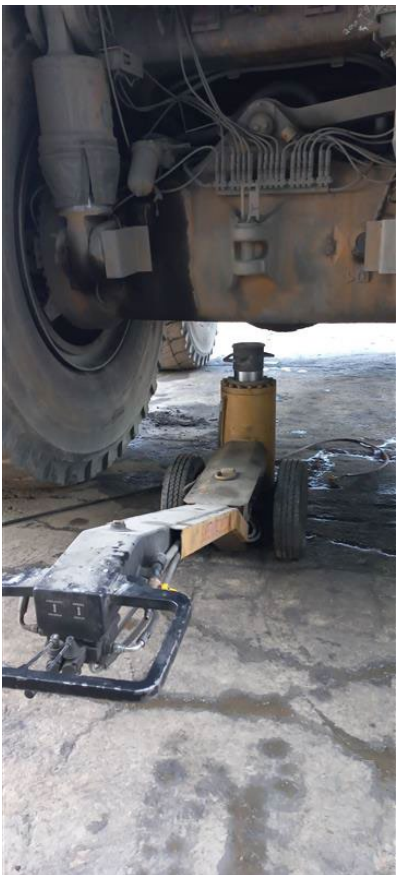
Picture 08 – Example of list stand to support the differential housing.

Before inverting the A-frame pin, secure the A-frame front end using a hydraulic stand. It is suggested to use 9U-7489 100-ton hydraulic lift stand. Example of another supplier's hydraulic lift stand is in the Picture 08. Use a suitable lifting device (not shown) to remove pin. The weight of the 8X-2936 A-frame pin is approximately 73kg.

- 1.2. Remove the hoist valve group.
- 1.3. Remove the 12 bolts that attach the retaining caps of A-frame pin.
- 1.4. After removing the 12 bolts, support the rear end of differential housing with a hydraulic lift stand and raise it until the yoke contacts the lower face of the truck frame, thus allowing to remove and invert the A-frame pin. See Picture 08.
