# Performing Condition Monitoring Management Process to Save Component Life in Lift Cylinders

**August 2022**  
**3.01-220825-1**

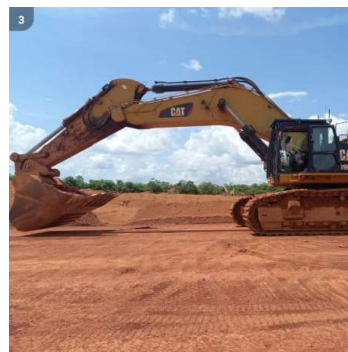
Figure 2. Position of the drop test equipment

The equipment was positioned to perform the cylinder drop test (Figure 2), and the boom lift cylinder was measured from the rod fixing pin to the cylinder liner fixing pin, and after 5 minutes with the engine off, no displacement of the cylinder rod was identified through the measurement (the cylinders kept the same measurements).

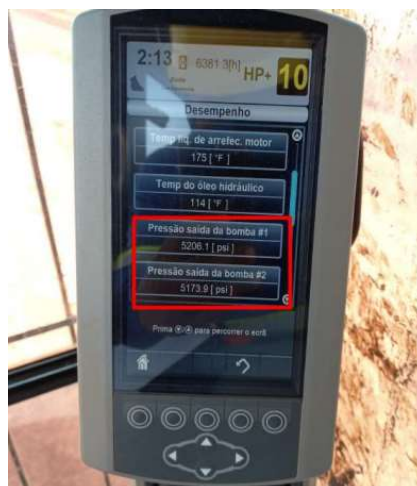
Figure 3. Pump Pressure

Before performing the cycle speed test, the pump relief pressures were checked for the boom lift function and found to be 5206 psi for the 01# pump and 5173 psi for the 02# pump (Figure 3).

*Note: The pressures were a little above the specified value, but not enough to change the test result.*

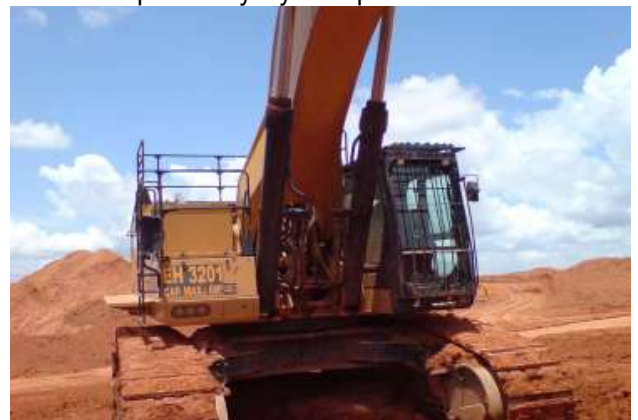
Figure 5b. EH3201 on the operation front being inspected by Hydro's predictive team

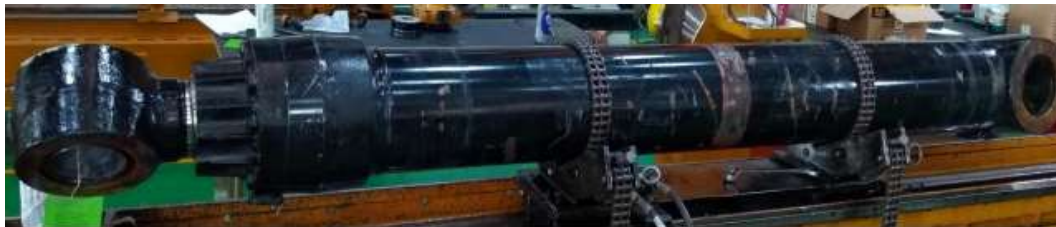
Figure 7. Cylinder at the CRC

The Remanufacturing Center (Cat-Dealer) evaluation of the cylinder allowed us to relate the field symptoms and conclude that the thermographic method can be used to define with more assurance the cylinder needing to be removed.

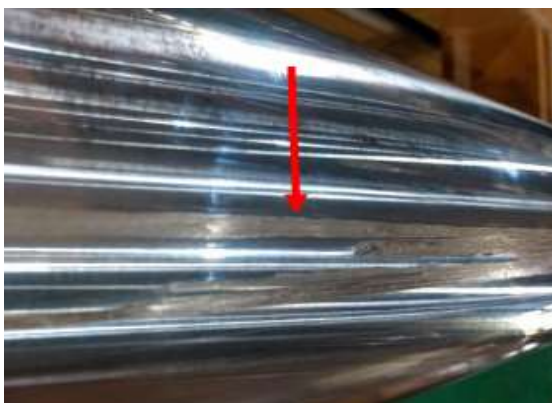
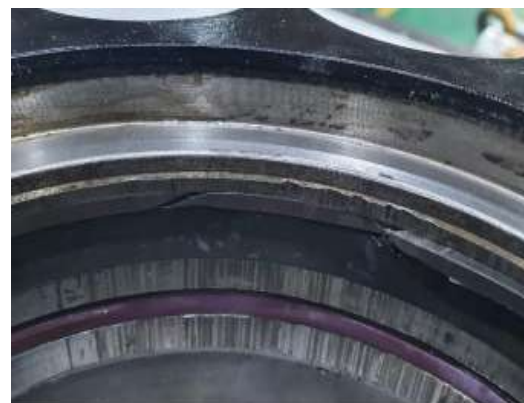
The next image shows some important details after disassembling the cylinder in the remanufacture center and evaluating internal evidence, confirming the relation between cylinder failure mode presented in the field and causes. See below that the failure mode presented in Figure 8 represents the cause of temperature increase in the field thermographic process.

Figure 8. Internal failure at cylinder

Based on this study, it was possible to see the effectiveness of using this process to indicate possible internal oil leakage by the cylinder seal assembly. The Remanufacturing Center confirmed that removing the cylinder based on the thermography along with the other tests was shown to be the proper decision to save money.
