MINING DEALER BEST PRACTICE

# Salvage C175 Engine Block Coolant Passage Using Metal Spray

December 2023  
4.02-231220-1

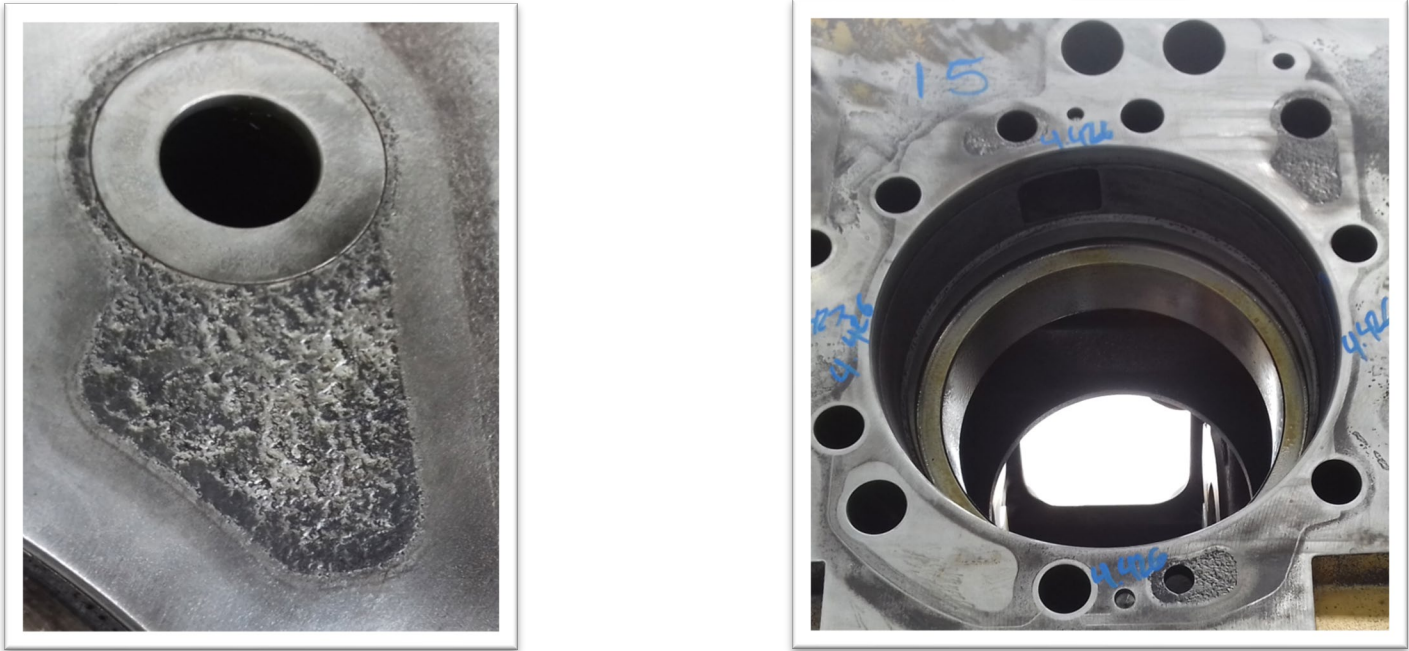
Significant cost savings can be achieved by salvaging the coolant passages on the top deck surface of the C175 engine cylinder block using metal spray technology.

Figure 1. Coolant passage’s surface affected by pitting

Coolant passage salvage consists of machining the damaged surface using an end mill to eliminate the pitting, grit blasting the surface to create a bond interface, metal spraying the surface, and machining the top deck to create a uniform surface.

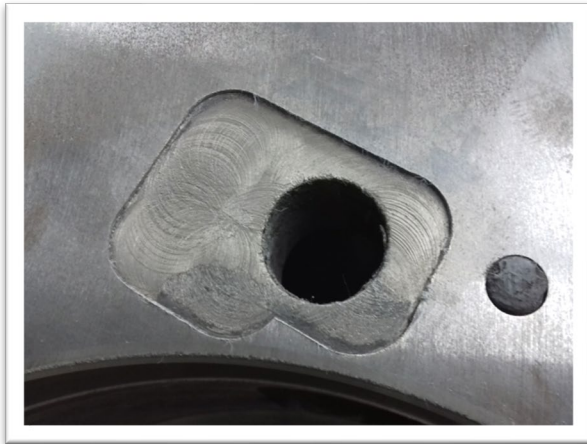
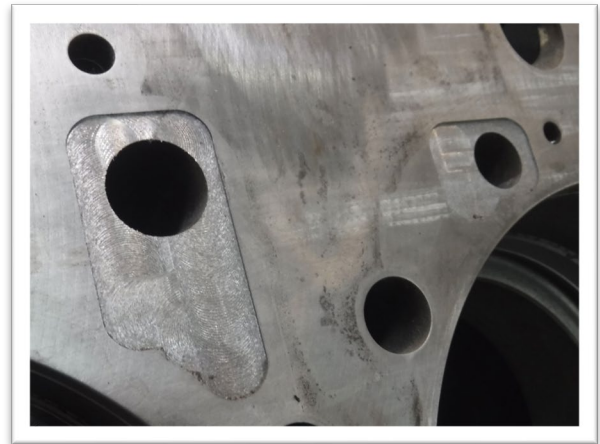
Figure 1 Machined pocket on coolant passage surface.

3.1. Rough cut: Eliminate the pitting on the coolant passages surface using an end mill to machine a pocket that contains the damage. Most of the time a 0.040" deep pocket is enough for removing pitting.

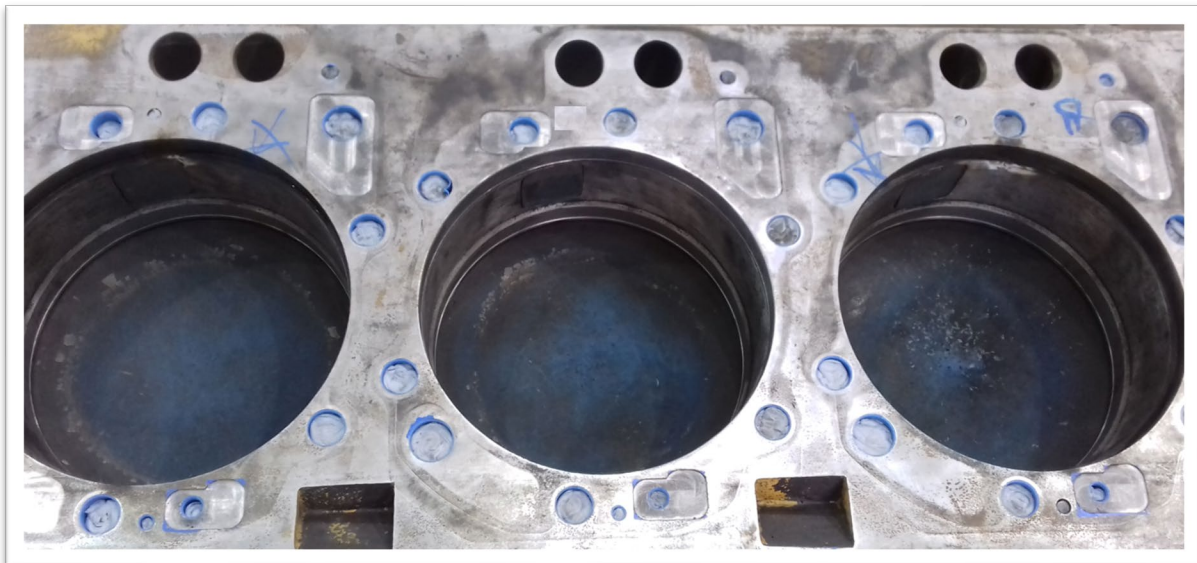
Figure 2. Top deck bore and thread protected

3.2. Top deck bore and thread protection: Use anti-bond materials to cover and protect all the threads and bores which are near to the area to be sprayed on the top deck.

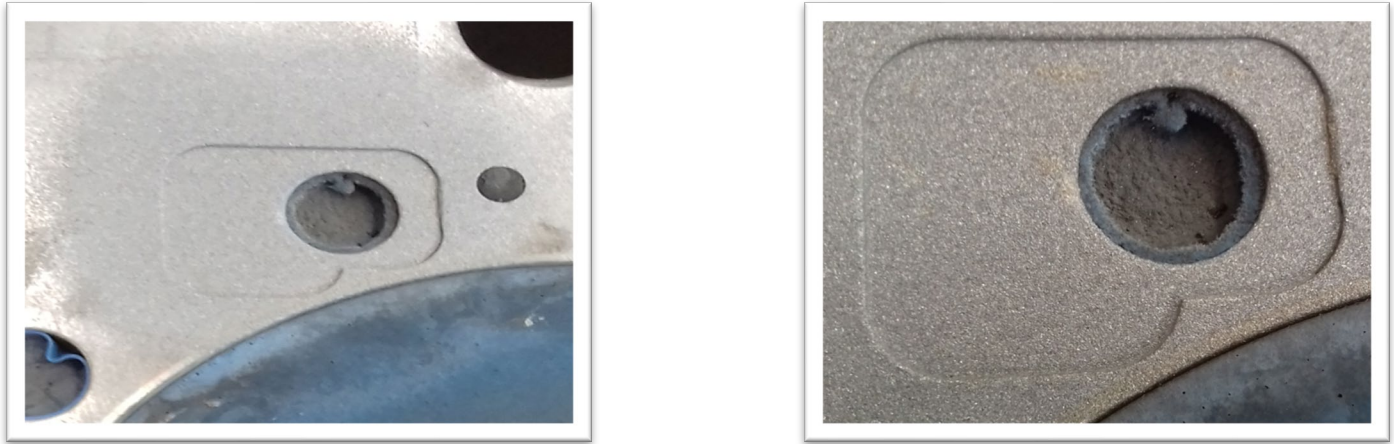
Figure 3. Grit blasted surface

3.3. Grit blasting: Follow the instructions in SEBF2120 “Thermal Spray Procedures for Engine Cylinder Block Top Surface”. Propel a stream of aluminum oxide against the block surface under high pressure to prepare the work piece for metal spray.
