# Salvage C175 Engine Cylinder Block Upper and Lower Liner Bores Using Metal Spray

| THE INFORMATION HEREIN MAY NOT BE COPIED OR TRANSMITTED TO OTHERS WITHOUT THE WRITTEN PERMISSION OF CATERPILLAR | | | |
|---|---|---|---|
| Salvage C175 Engine Block Cylinder Block Upper and Lower Liner Bores using Metal Spray | DATE<br>4/18/2024 | CHG<br>NO<br>00 | NUMBER<br>4.02-240418-1 |

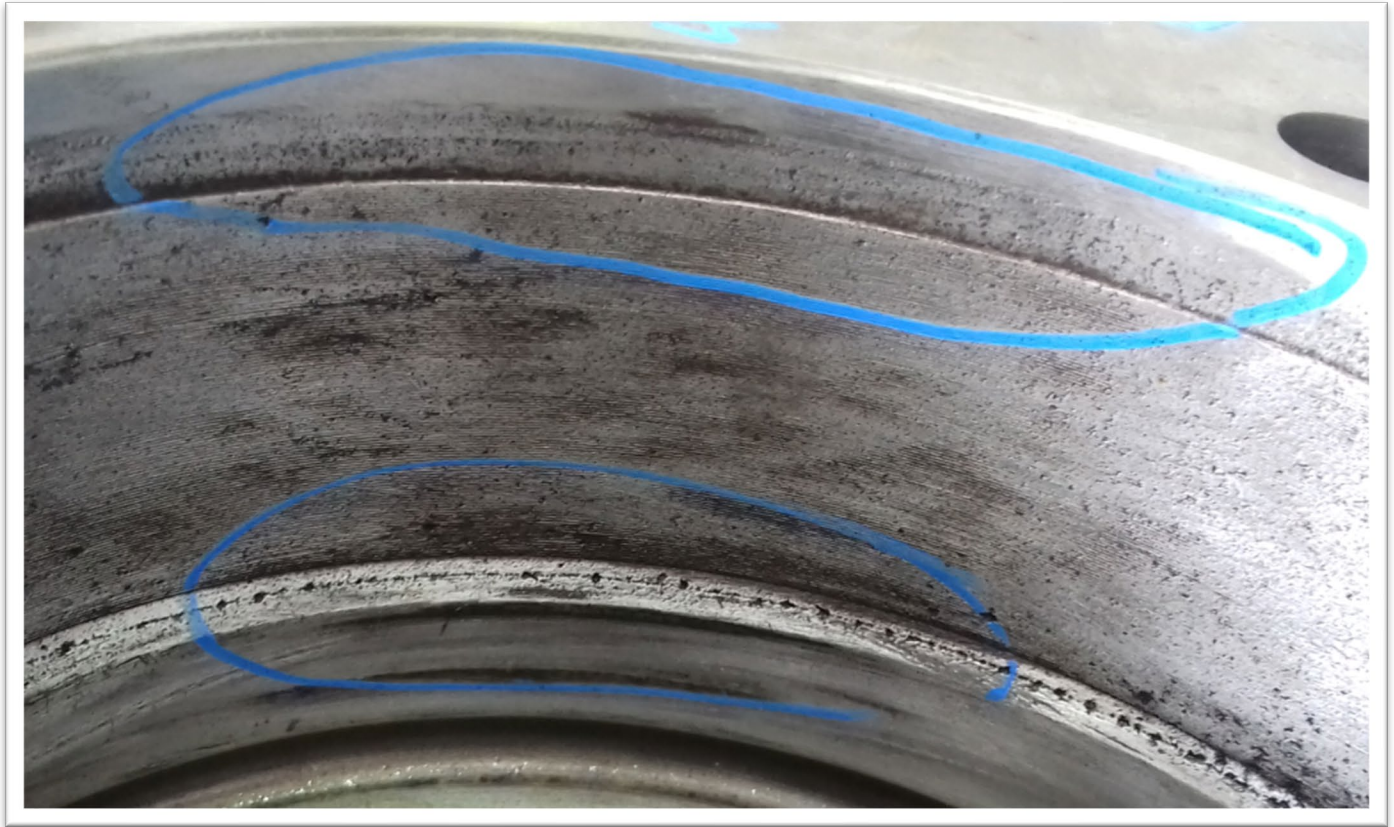
Figure 1. Pitting on upper- and lower-cylinder block liner bores

This process has been developed as a superior salvage procedure. This procedure eliminates the need to install a machined sleeve when pitting exists on the upper- and lower-cylinder block liner bores in C175 engines.

Upper- and lower-cylinder block liner bores salvage procedure consists of: Machining the cylinder block liner bores to remove the pitting, grit blasting the surface to create the bond interface, metal spraying the surface, and machining the inside diameter of the bore.

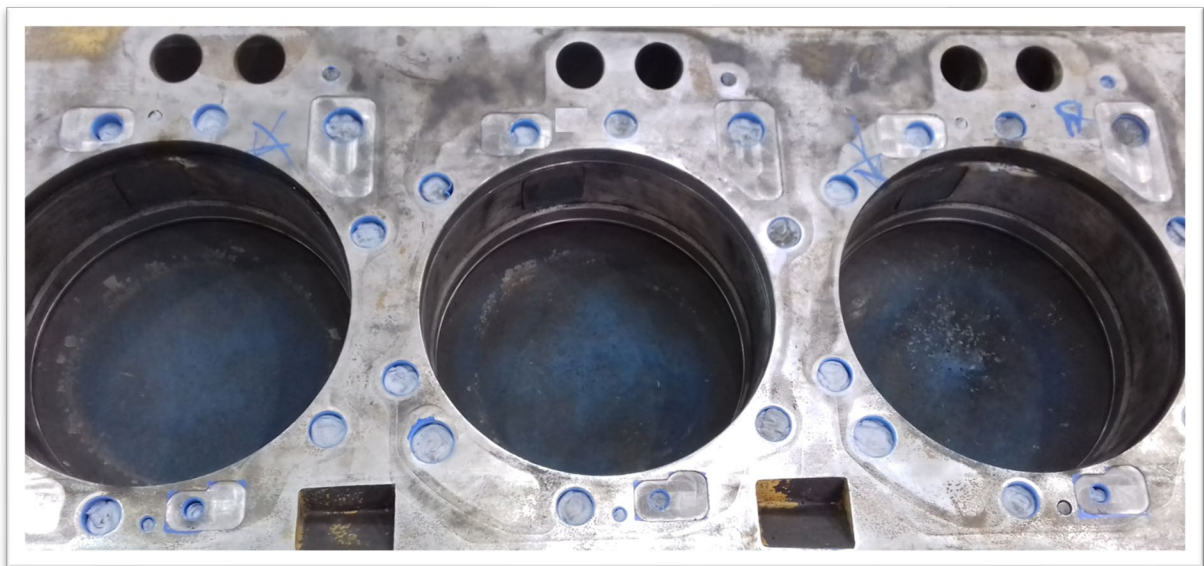
Figure 3. Top deck bore and thread protected

3.2. Top deck bore and thread protection: Use anti-bond materials to cover and protect all the threads and bores which are near to the area to be sprayed.

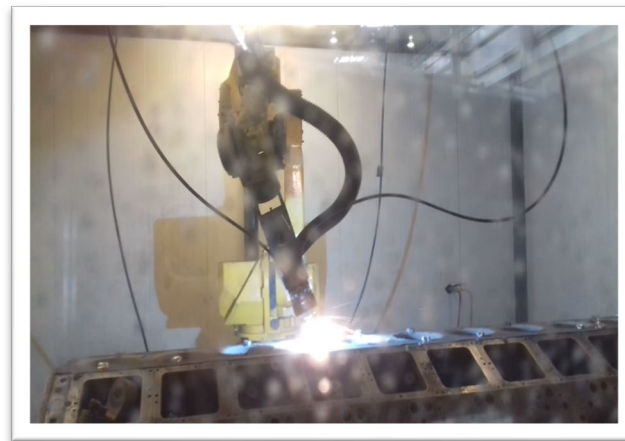
Figure 5. Spraying upper- and lower-cylinder block liner bores

3.4. Metal spraying the surface: Using an industrial robot and metal spray equipment it is possible to control velocity, distance and position of the spray with a high degree of accuracy improving the strength of the bond and finish of the coating. For the spraying parameters use the specifications found in SEBF2120 “Thermal Spray Procedures for Engine Cylinder Block Top Surface”.
