MINING DEALER BEST PRACTICE

# Swing Motor Sensors Position Change on HMS 6060AC

**February 2023**  
**1.04-230202-1**

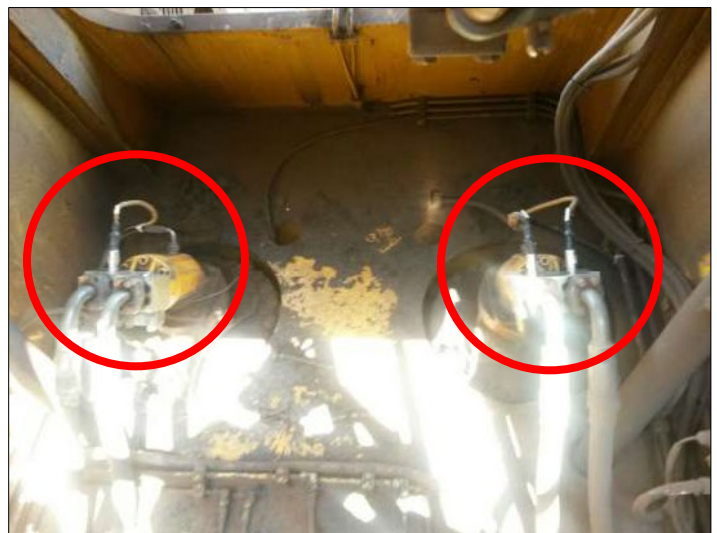
**Picture 6:** Front swing motors after installation, with sensors installed on the manifolds.

1. Stop and shutdown the machine. Lock the safety device preventing the machine from switching on, apply a warning sign.
2. Remove the sensors installed on the rear swing motors and install the plugs and seals (items #1 and #2 of parts list) at same location.
3. At front swing motors, install the manifolds (items #3 and #8 of parts list) one on each motor and install all the flanges and adapters (items #4 to #7 of parts list).
4. Install the pressure and temperature sensors at the manifolds installed on the front swing motors;
5. Develop 3 electrical harness using the wire and conduit (items #11 and #12 of parts list). The connectors of these harness are Deutsch type (items #9 and #10 of parts list). Each harness has 4 meters and a female connector in terminal and male connector in other;
6. Connect these harnesses at original harness and at the sensors.
