MINING DEALER BEST PRACTICE

# Upgrade Pulley Carrier MD6420-16

**August 2023**  
**1.01-230802-1**

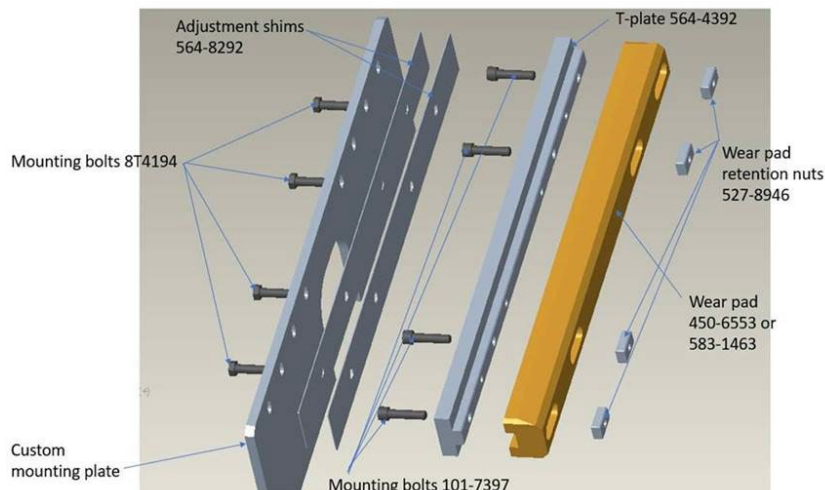
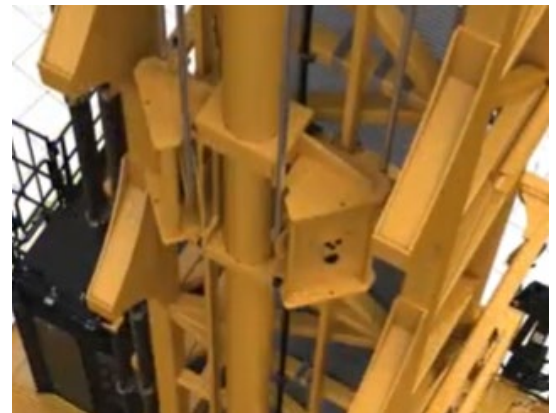
The MD6420-16 drilling rigs in operation at the Conceição Mine use the PN467-7871 roller to guide the pulley carrier. These rollers have been constantly breaking during operation and falling from the mast reaching equipment components.

The Roller pulley carrier guides presented the first failure after approximately 6000 hours of operation and after this failure, consecutive failures have begun in this component. In some cases, the roller failure has resulted in damage to beam I which has the function of along with rollers keep the pulley carrier aligned.

The Project consists of the replacement of the roller guides of the pulley carrier currently installed in the equipment by a set of sliding guides that uses polyurethane guides.
