# **Welcomes you all - YIPL 15<sup>TH</sup> Semi final Kaizen Competition**

**Plant Name –YIPL GJS**

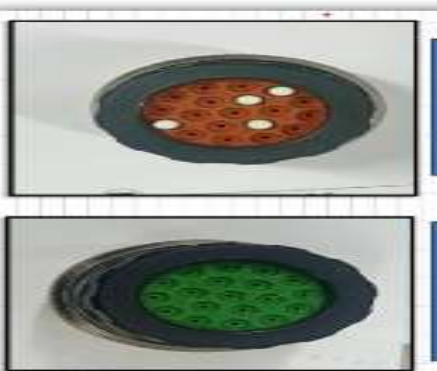
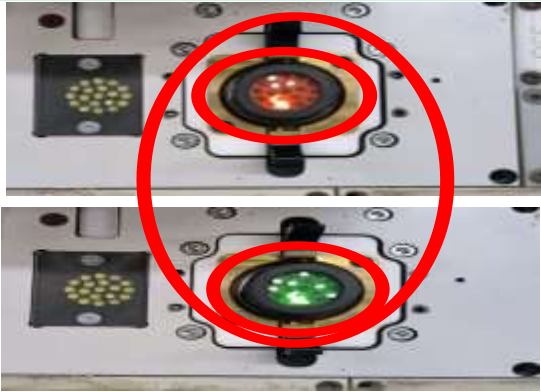
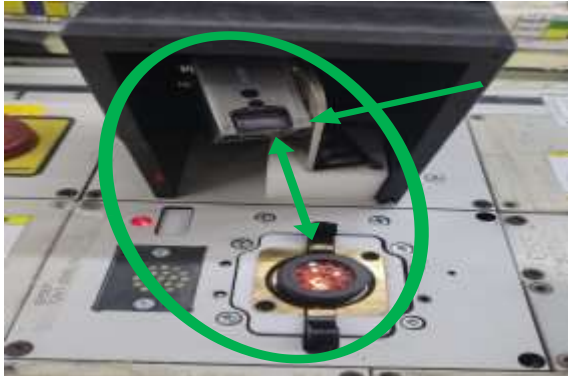
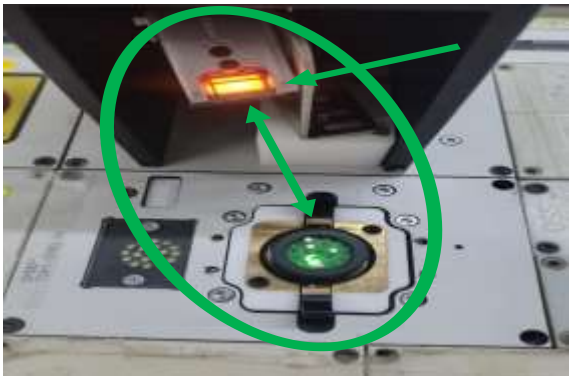
| <div>Limber EVLV sub assy-01 HV BATTERY LV CONNECTOR have 2 type of connector one in red and second in green color.</div> <div></div> | | | | <div></div> <div>Sensor Detected this is not corect connector inserted so wrong connector not paased .</div> <div>Sensor detected this is ok connector inserted and then it is paasing for the next operation.</div> | | | | |
| We have facing the problem of wrong connector attached in the harness on the limber evlv line of and it is ditected on the functional checker becuase no any poka-yoke available for detecting the wrong connector it is totaly depend on operator skill. If operator do this mistake defet will generate and hold the harness for the rework . | | | | After we have found this problem, we have Installed the Color detection sensor for the error proofing so now Sensor detect the wrong connector (Only in 2 color-green & red connector )and stop the process of wire insertion navigation system.<br>So now we are prevent the defects produce and save INR 900 connector price for connector rejection. | | | | |

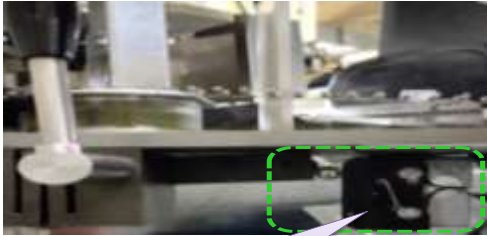
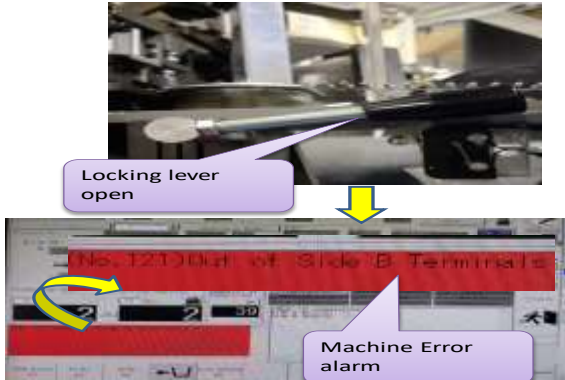
| KAIZEN SHEET | | | | | | | | | YAZAKI |
|---|---|---|---|---|---|---|---|---|---|
| <div>In AC 90 machine, there is no any provision available to detect Applicator lock open</div> | | | | <div><br/>Provided Limit Switch at Applicator locking lever</div> <div><br/>Locking lever open<br/>Machine Error alarm</div> | | | | | |
| <p>As you can see in the image, in the earlier situation, there was no any Poka yoke system available in AC 90 machine to avoid applicator unlock due to the design of the machine.</p> <p>So due to unavailability of Poka yoke for Applicator lock, operator forgets to applicator lock some times &amp; below problem comes after that:</p> <ul style="list-style-type: none"><li>1) Applicator dies gets fully damaged and increased maintenance cost</li><li>2) Conductor height (C/H)changed in running</li><li>3) Conductor and insulation High- low issue</li><li>4) Beark down in form of CFM error</li><li>5) Applicator can fully damaged</li><li>6) It can create safety issue</li></ul> <p><b>This issue happened six times in past three months and total repair cost was 16450 rs.</b></p> | | | | <p>Provided Limit switch at Applicator locking lever and interlocked with out of terminal sensor. Now if the operator does not lock the applicator, Poka Yoke will not allow the machine to run and will give out of terminal alarm.</p> | | <p>After implementing this Poka Yoke technique the machine got completely interlocked and the problem of applicator unlocking was solved. And given issues solved</p> <ul style="list-style-type: none"><li>1) Unnecessary dies damage issues solved</li><li>2) Quality defects which was occurring because of Applicator unlock solved like; C/H issue</li><li>3) Conductor and insulation High- low issue solved</li><li>4) CFM error because of Unlock solved</li><li>5) Applicator damaged chance eliminated</li><li>6) Safety issue because of Applicator unlock solved.</li></ul> <p><b>After implementation of this Kaizen, Applicator unlocked chance eliminated and we have saved repaire cost which can occurred in future.</b></p> <p><b>Investment cost : 680 Rs per machine.</b></p> | | | |

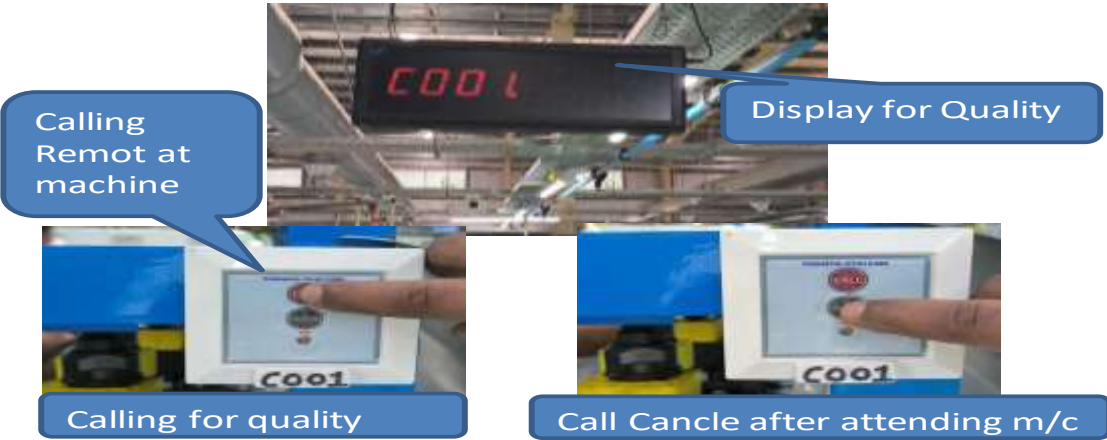
| Plant name | | KAIZEN SHEET | | | | | | | YAZAKI | | |
|---|---|---|---|---|---|---|---|---|---|--|--|
| <p>Quality Calling system not available</p> | | | | | | | | | | | |
| <b>Problem Description:</b><br>In before condition there was no facility for quality calling. So in every job setup or any kind of quality support, operator goes to quality area to call the quality inspector. So for calling & attending the quality person to machine we found huge hidden losses like;<br># Operator time loss<br># MUDA of operator movement<br># Machine output loss<br># Required 5 nos.quality inspector to maintain the line<br># Loss in operator moral | | | | | <b>Solution Description:</b><br>As you can see in image we have implemented wire less calling system for quality support calling. Display of this setup we have provided in Quality area and calling switch provided at machine. Now only required of press call switch from switch box for quality support & with help of display and bell sound quality person attending the machine. After implementation of this setup we have got better result;<br># Operator movement reduced for quality serching<br>#Operator time saved<br># Machine output increased<br># Only 4 nos. quality inspector maintaining Maikotei area<br># Machine Operator & quality inspector also feeling happy because their unnecessary movement reduced.<br>Cost investment for this calling system: 30000 inr. | | | | | | |

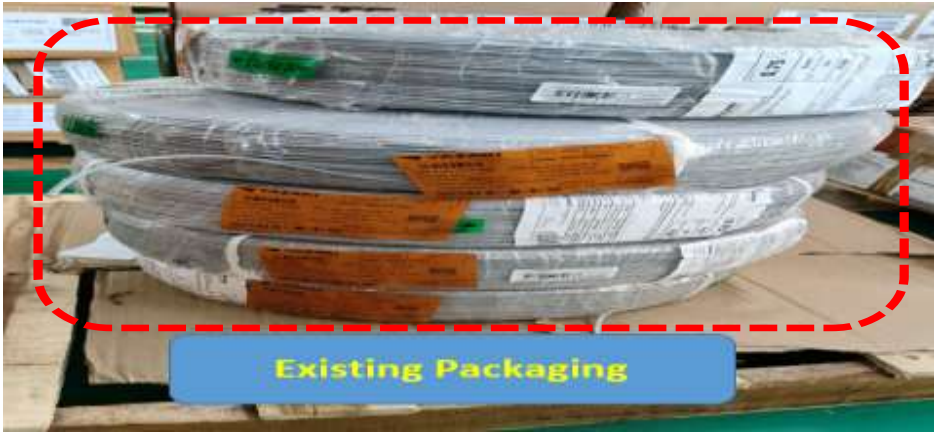
<table><tr><td>Tare 1- Empty Plastic Container</td><td>Flange Hole ID</td><td>Cable rewinding as per above qty</td><td>Initial Polythene wrapping</td></tr><tr><td></td><td></td><td rowspan="2"><b>Packing standard revised without cost impact</b></td><td rowspan="2"></td></tr></table>

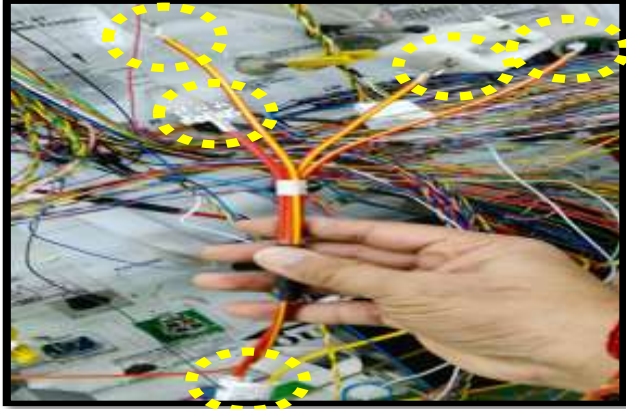
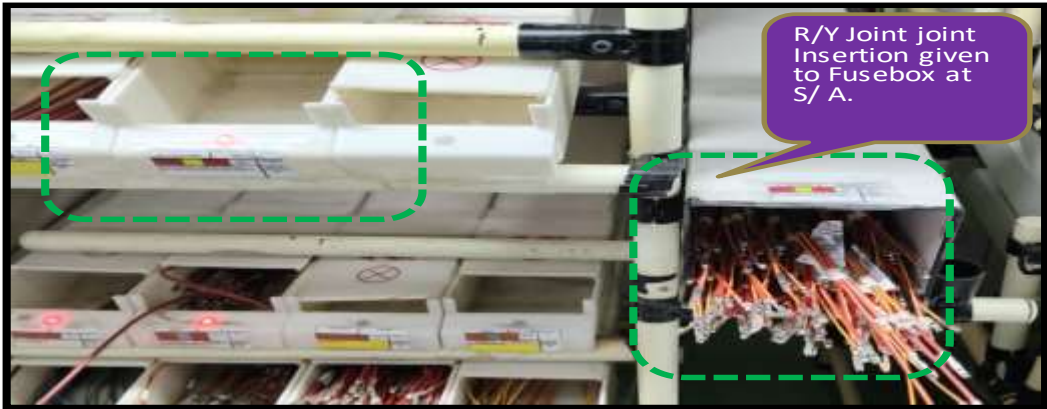
| Plant name | | KAIZEN SHEET | | | | | | |
|---|---|---|---|---|---|---|---|---|
| <div>R/Y Joint insertion give to jig boards due to operator not follow the PCPP and 3 lag terminal found damage.</div> | | | | | | | | |
| <p>1. R/Y joint 5 insertion given to jig boards due to TPO and terminal damage issues increased in offline process.</p> <p>2.during fusebox insertion Operators were taking a lot of time to locate the correct cavity and they wewr inserting the wires into the wrong cavity.</p> <p>3. 3 leg terminal stuck each other part and getting damage, due to rework increased.</p> <p>4. During jig board insertion operator confused and insert wire in wrong cavity.</p> <p>CKT Details :<br/>Line Name : Nova Front.<br/>Sub ASSY: 1D<br/>Comp No : C173,C624 ,C625 ,C531 ,C532, C891<br/>Joint Colour : R/Y.</p> | | | | <p>1. We have added all joint jig boards fusebox insertion to the sub assbly with navigation system.due to this the TPO and terminal damage issues have been resolve.</p> <p>2. The time required for operators to search for the fusebox insertion cavity has been reduced.</p> <p>3. R/Y Joint wire insertion added in fuse box sub assembly last insertion to avoided entangle during process.</p> <p>4. Wire color updated fusebox drawing provided on jig board.</p> <p>5. Navigation program updated and verified.</p> | | | | |

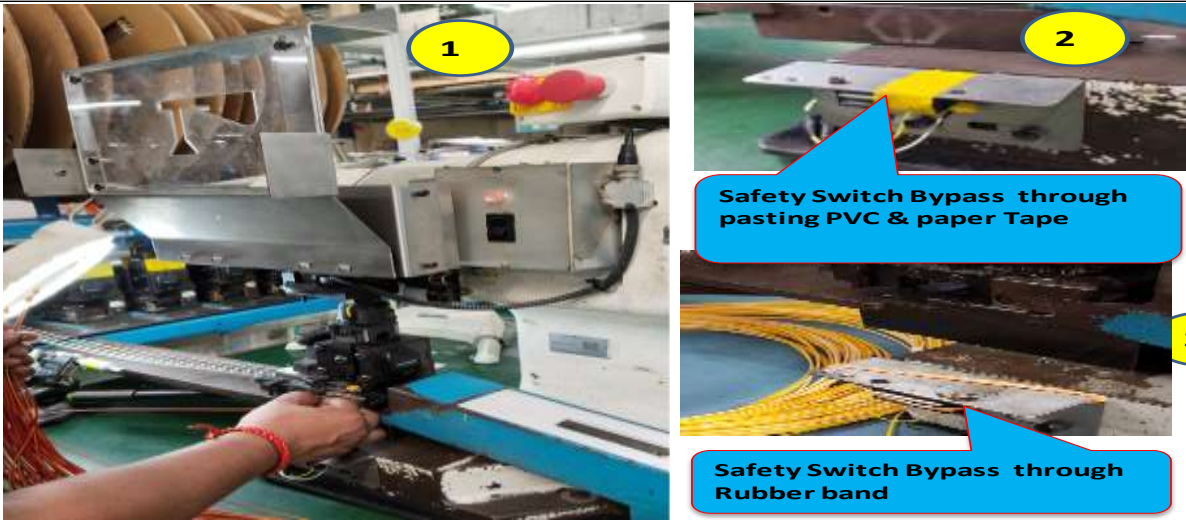
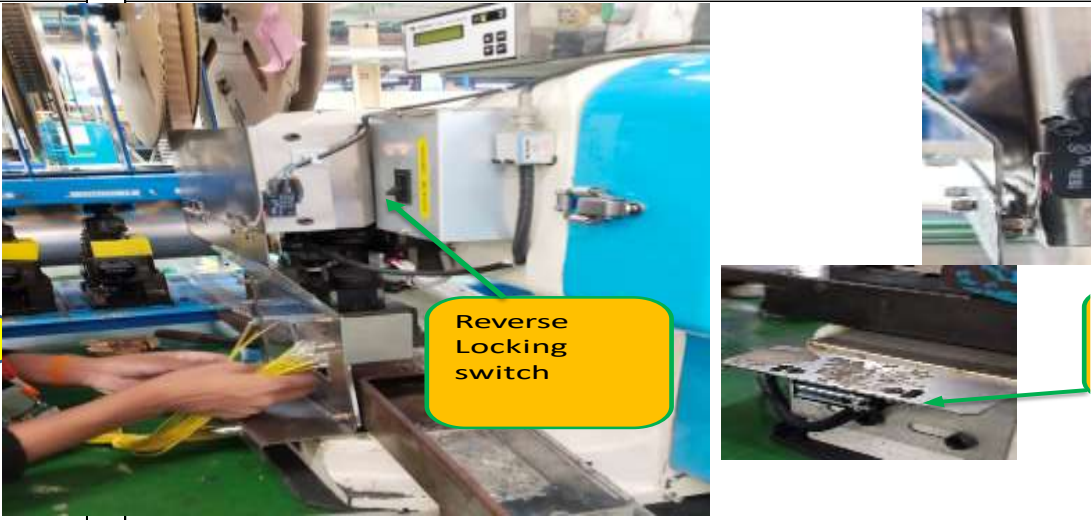
| Problem Description: | Solution: | Result: |
|---|---|---|
| In Before Condition operators are crimping wire without use of protective safety cover. As you can see in picture number 2 and 3, the operator bypassed the safety switch by sticking tape or using a rubber band for the bypass. This is a major safety concern on the crimping machine, and can cause an accident on the machine | As you can see in image 4, we have installed the reverse locking switch on the machine. The machine is now fully interlocked. | # The machine is fully interlocked.<br># The operator cannot bypass the reverse interlocking.<br># The machine will not run after a rubber to the safety switch. |
