SHAMS POWER COMPANY

CERTIFICATE OF INSPECTION

ITEM : LP- Heater -1

DATE OF INSPECTION : March, 2020

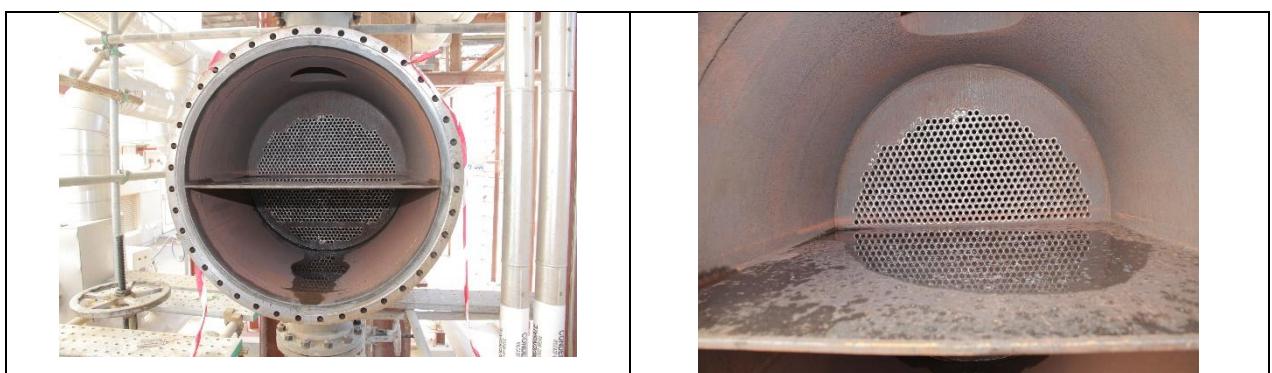
- 5.2.1 All tubes as could see internal surfaces found satisfactory condition without evidence of corrosion, apart from a considerable amounts of deposits which have cleaned by high pressure hydro jetting.
- 5.2.2 Three tubes were plugged as it was taken as a sample for metallurgical investigation on years 2014, 2015 & 2016.
- 5.2.3 All tube to tube sheet welds found in satisfactory condition.

Tubes (3 plugged) , welds and internal surfaces of (channel & pass partition)

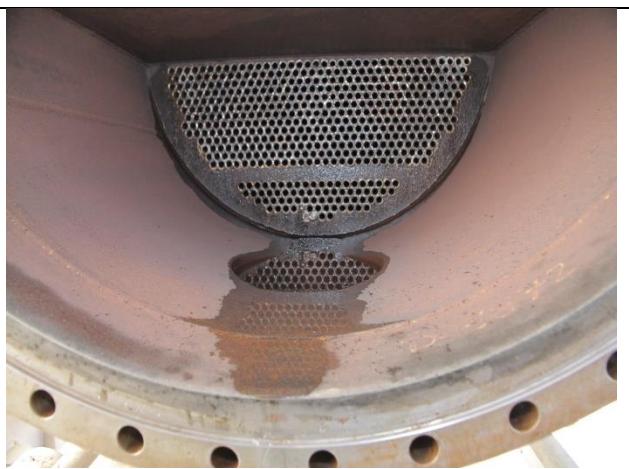
Due to presence of inter-granular corrosion, tube thickness cannot be accurately measured using eddy current technique and IRIS suitable probe for this diameter of tube not available in the market, borescope was utilized as visual inspection aid tool inside some tubes and outside from shell side, result was satisfactory (see attached videos and photos).

Tubes outside surfaces and baffles condition inside shell

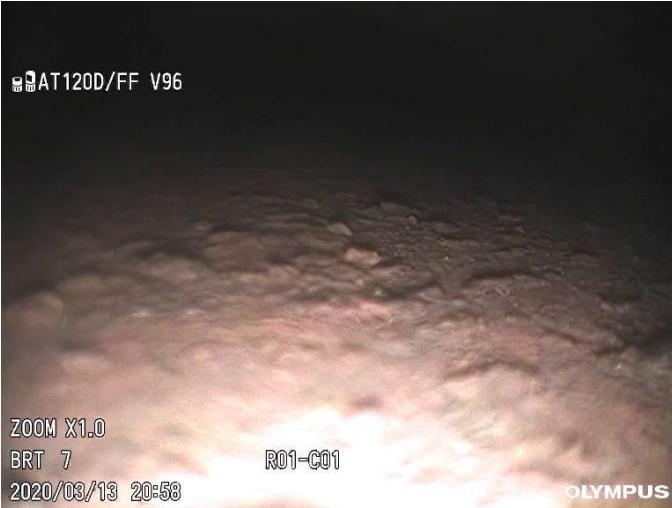
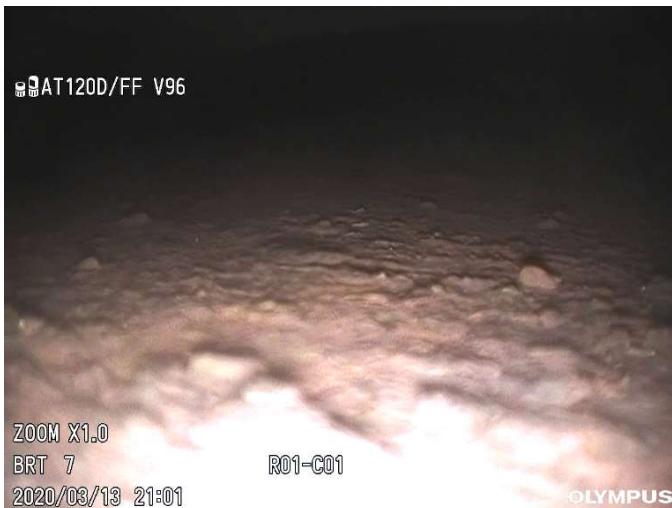
SHELL-0°	SHELL-90°

<p>AT120D/FF V96 ZOOM X1.0 BRT 7 2020/03/13 21:01 R01-C01 OLYMPUS</p>
Observation: Minor scales observed in visual inspection	Observation: Minor scales observed in visual inspection

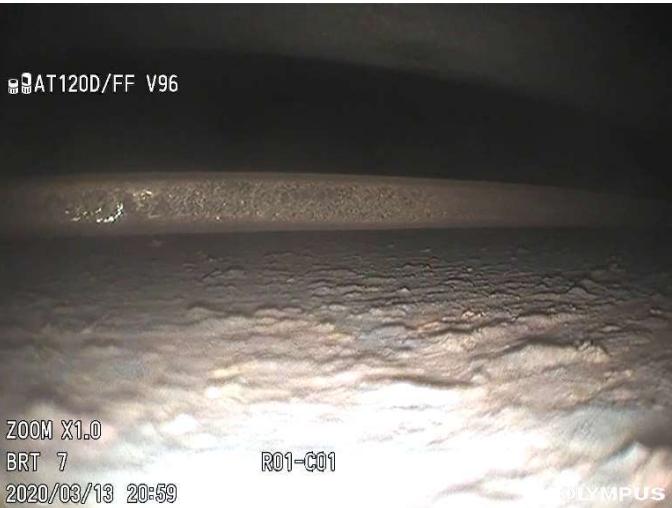
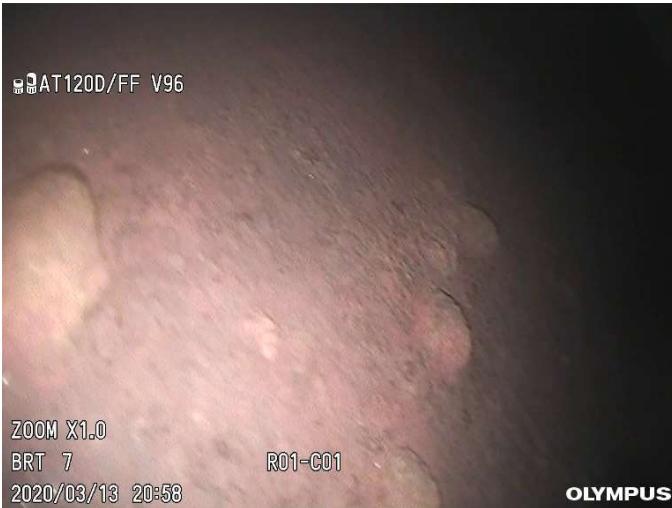
SHELL-180°	SHELL-270°

<p>AT120D/FF V96 ZOOM X1.0 BRT 7 2020/03/13 20:58 R01-C01 OLYMPUS</p>
Observation: Minor scales observed in visual inspection	Observation: Minor scales observed in visual inspection
