SHAMS POWER COMPANY
ENGINEERING DIVISION
INSPECTION & CORROSION SECTION

CERTIFICATE OF INSPECTION

ITEM : HP- Heater -1

DATE OF INSPECTION : March, 2020

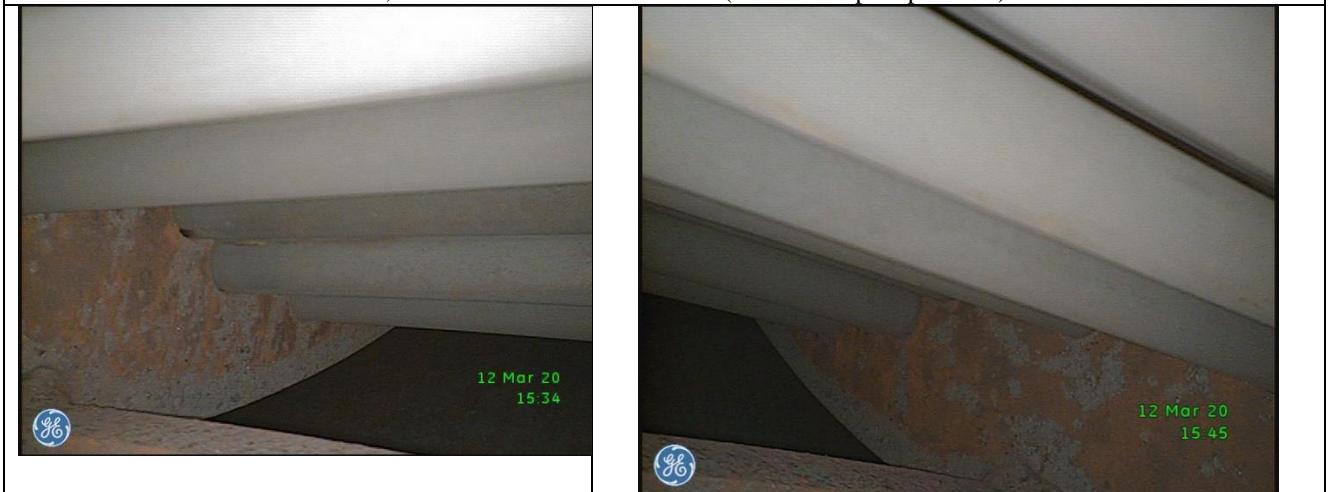
Tubes outside surfaces and baffles condition inside shell

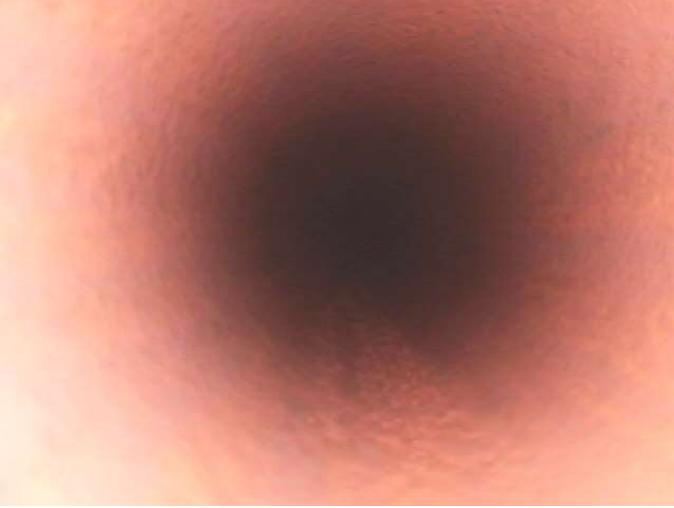
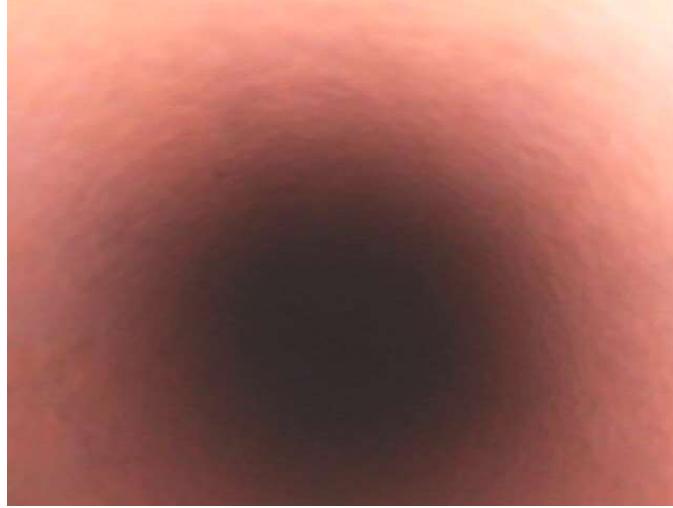
ROW-12 TUBE-38	ROW-37 TUBE-5

Observation: No Anomalies found in visual inspection	Observation: No Anomalies found in visual inspection

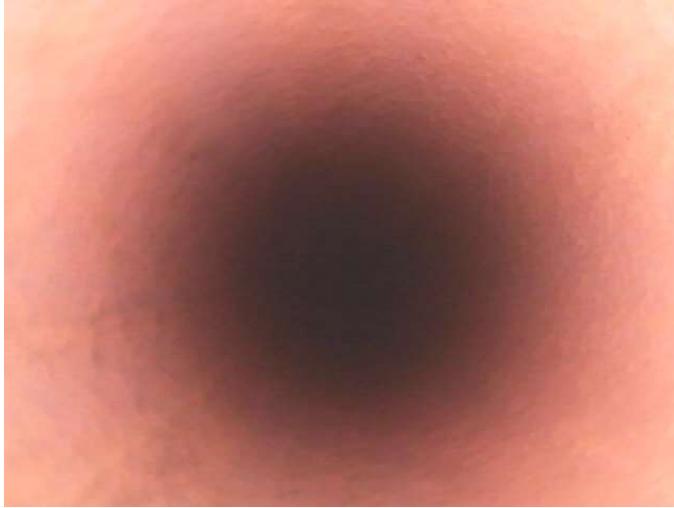
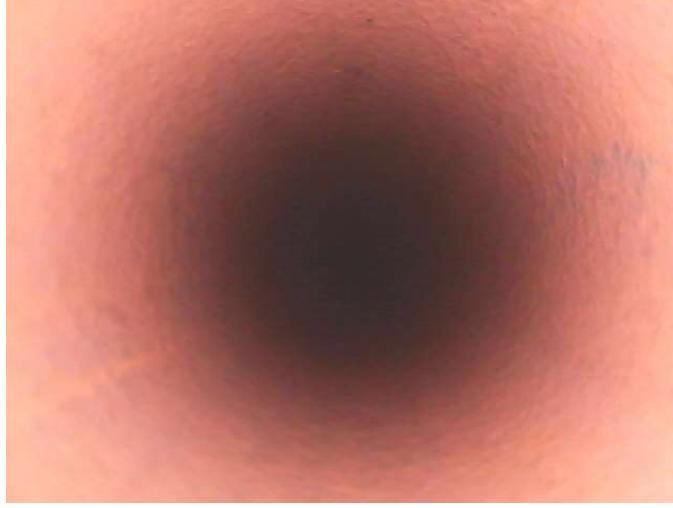
ROW-4 TUBE-16	ROW-5 TUBE-1

Observation: No Anomalies found in visual inspection	Observation: No Anomalies found in visual inspection

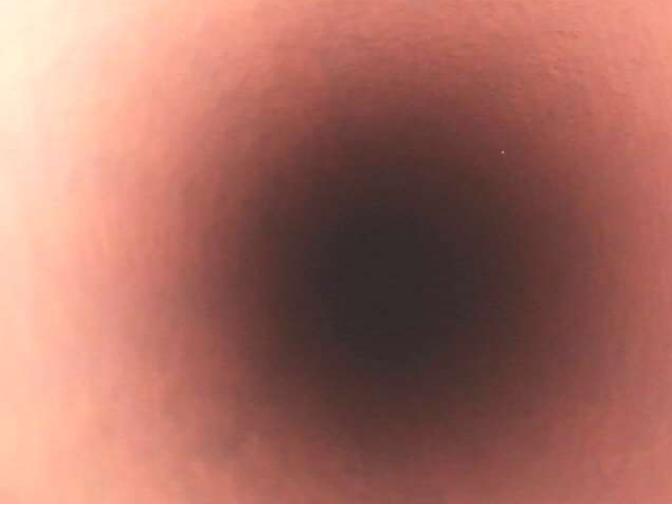
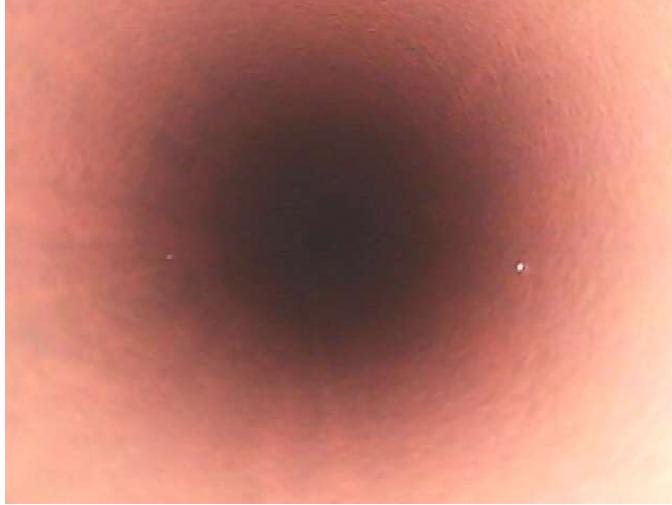
ROW-10 TUBE-9	ROW-12 TUBE-4

Observation: No Anomalies found in visual inspection	Observation: No Anomalies found in visual inspection

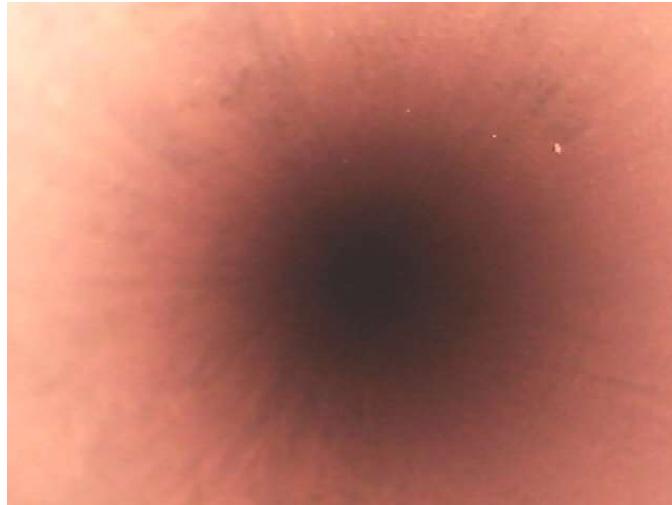
ROW-12 TUBE-26	ROW-12 TUBE-28

Observation: No Anomalies found in visual inspection	Observation: No Anomalies found in visual inspection
