SHAMS POWER COMPANY
ENGINEERING DIVISION
INSPECTION & CORROSION SECTION
SHAMS 1

CERTIFICATE OF INSPECTION

ITEM : **Booster heater-2**

TYPE OF INSPECTION : **Major**

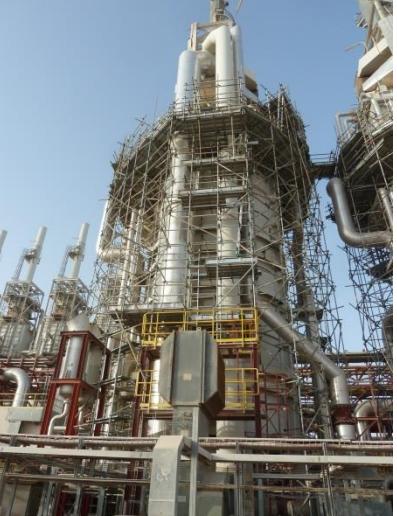
| General view of booster heater -2 | Air preaheter |

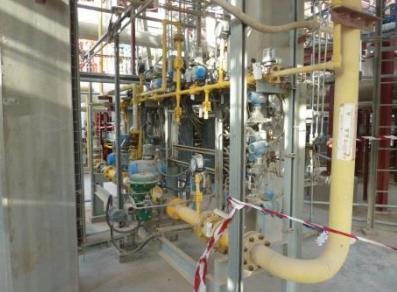
| Burner connected piping | Earting lug |

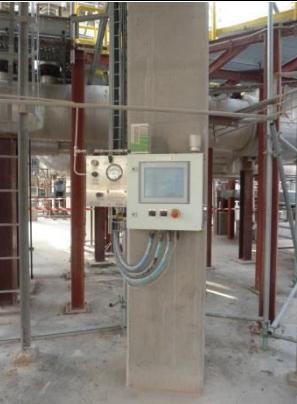
| Concrete support | Ladder, stairways and handrail |

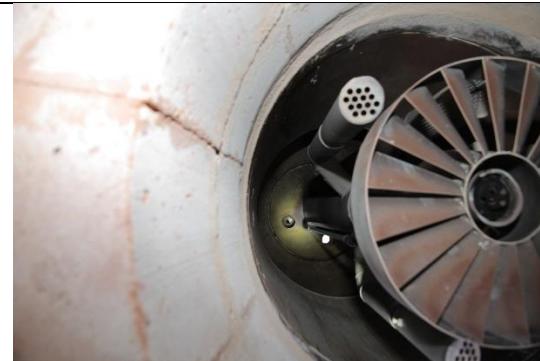
Burner blades

- 6.1 All deposited material on burner opening should be cleaned.
- 6.2 Peep holes should be clean and maintain to open smoothly to allow operators clearly check flame condition.
- 6.3 Heater to be inspected after 4 years as per SHAMS Code of Practice.

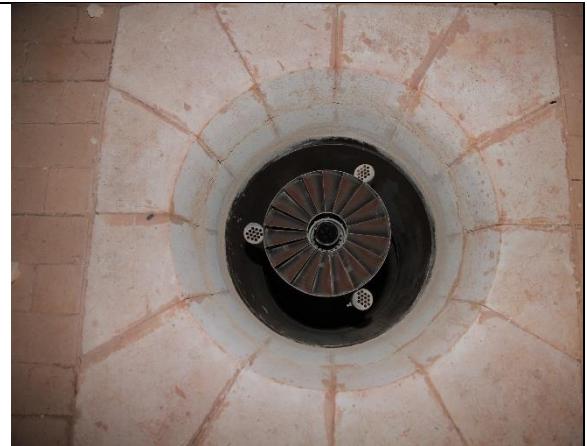
Bricks around burner

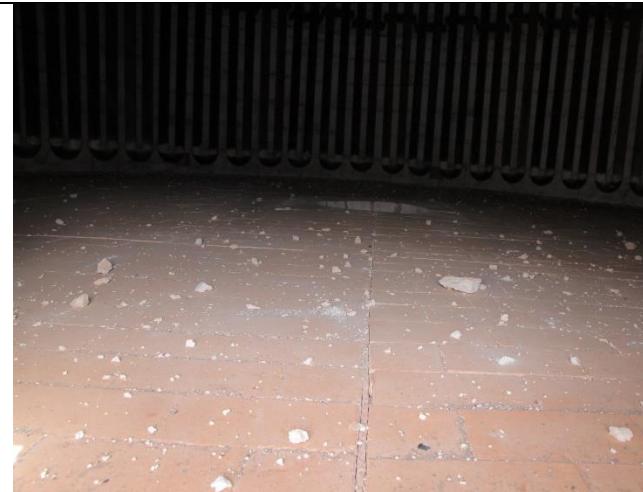
- 5.2.1. All external surfaces of all radiation and convection tubes found in satisfactory conditions without evidence of creep, bowing, sagging and overheating.
- 5.2.2 All piping supports and hungers found satisfactory conditions without evidence of damage or broken.
- 5.2.3 All insulation (fibers and anchors) found in satisfactory conditions in radiation and convection zones.
- 5.2.5 All floor bricks found in satisfactory condition apart from minor separation between floor bricks. All separations were filled by refractory cement.
- 5.2.6 Burners found in satisfactory condition without evidence of back fire.
- 5.2.7 Refractory around burners found in satisfactory condition without evidence of cracking or spalling.
- 5.2.8 Fallen down small parts of refractory material found scattered on floor.

Fallen down refractory

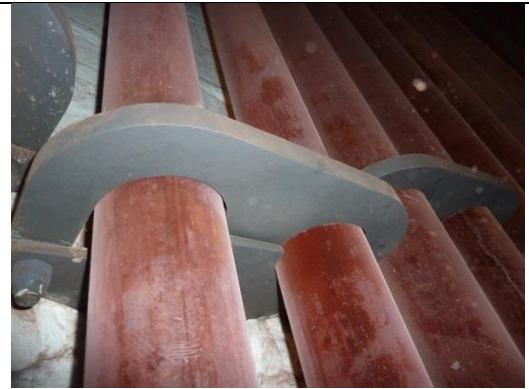
Close up view of tube and tube support at radiation zone

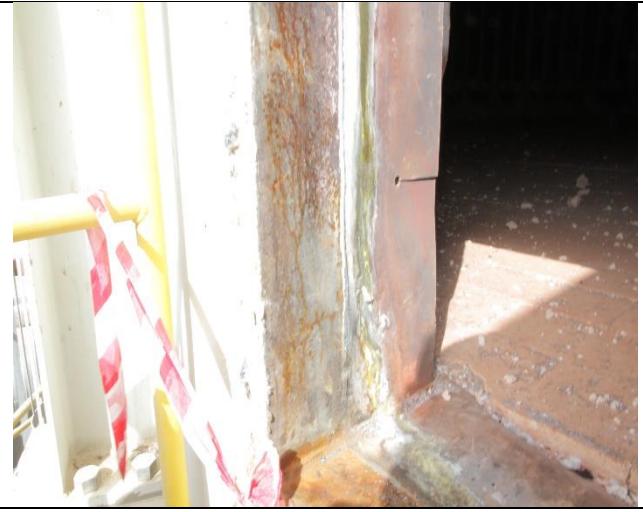
Many way cover

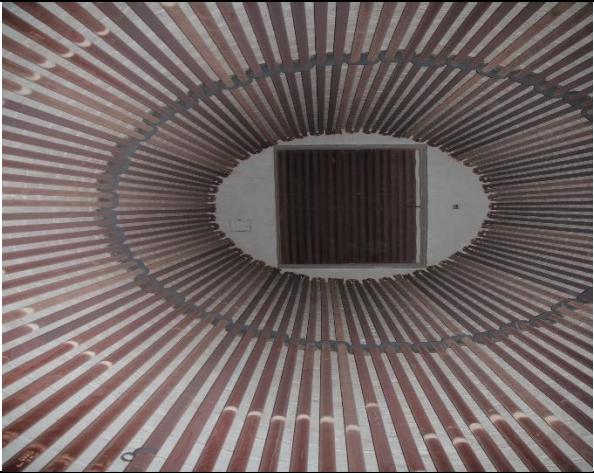
General view of tubes at radiation and convection zones

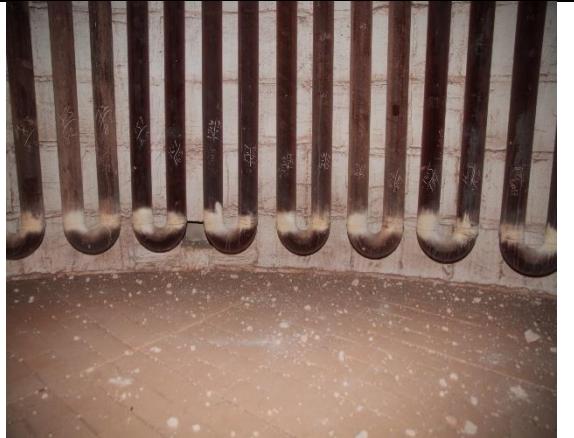
General view of tubes at radiation zone

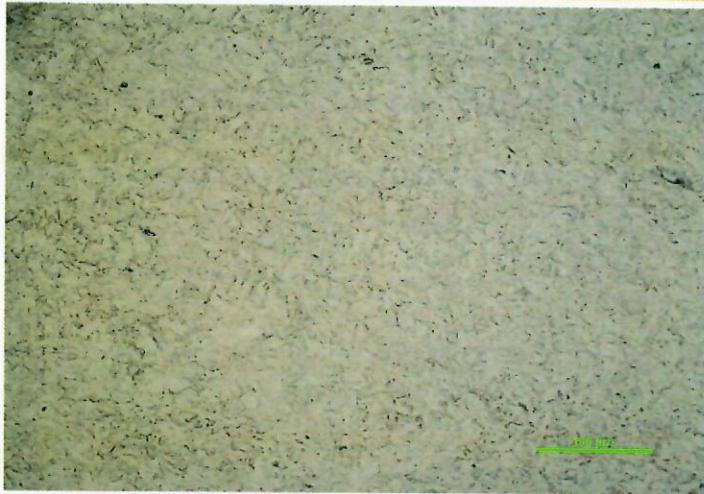
Location: Base Metal ; Etchant: Fry's Reagent; Magnification: 200x

Microstructure revealed tempered martensite and some carbides at the examined location.

No significant metallurgical anomalies were observed.

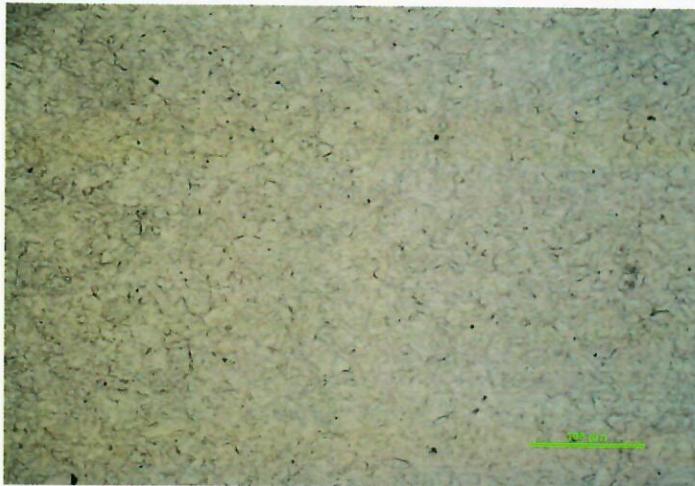
Location: Base Metal ; Etchant: Fry's Reagent; Magnification: 200x

Microstructure revealed tempered martensite and some carbides at the examined location.

No significant metallurgical anomalies were observed.

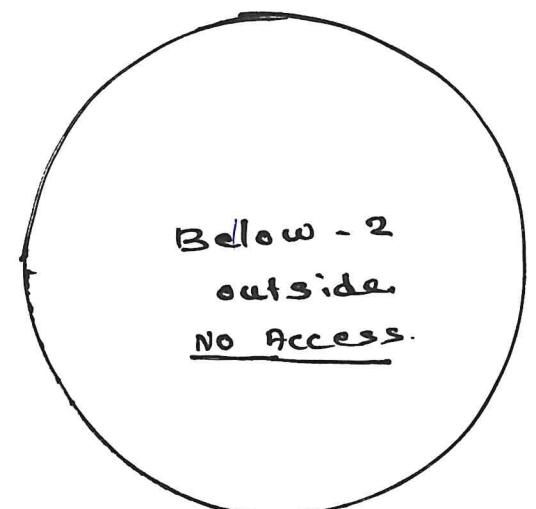
Turbine Bellow - DPT Done (Highlighted Areas) - 10/03/20

① - DPT Done,
