SHAMS POWER COMPANY
ENGINEERING DIVISION
INSPECTION & CORROSION SECTION
SHAMS 1

CERTIFICATE OF INSPECTION

ITEM : **Booster heater-1**

TYPE OF INSPECTION : **Major**

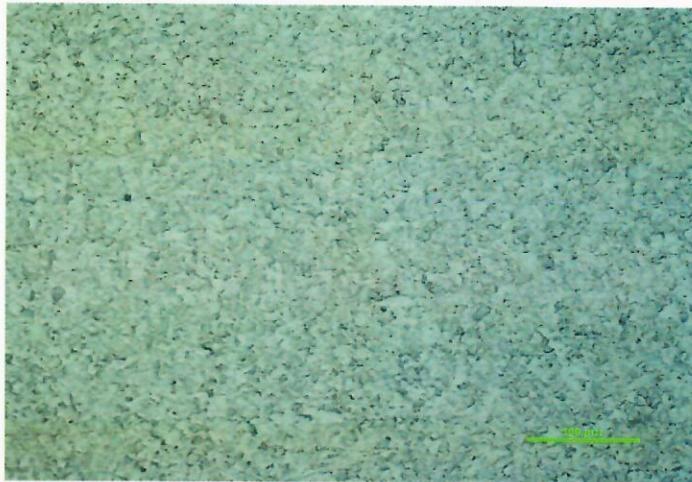
Location: Base Metal ; Etchant: Fry's Reagent; Magnification: 200x

Project:	Maintenance Shutdown
Vessel:	BOOSTER HEATER NO. 1
Size:	N/A
Material:	ASTM A333 Gr. P91
Locations:	12 o'clock; Outlet Tube No. 1- TOP
Spot No.:	1

Microstructure revealed equiaxed ferrite with some tempered martensite and carbides in sharp contrast to the fully tempered martensite structure of the virgin material.

No other metallurgical anomalies were observed.

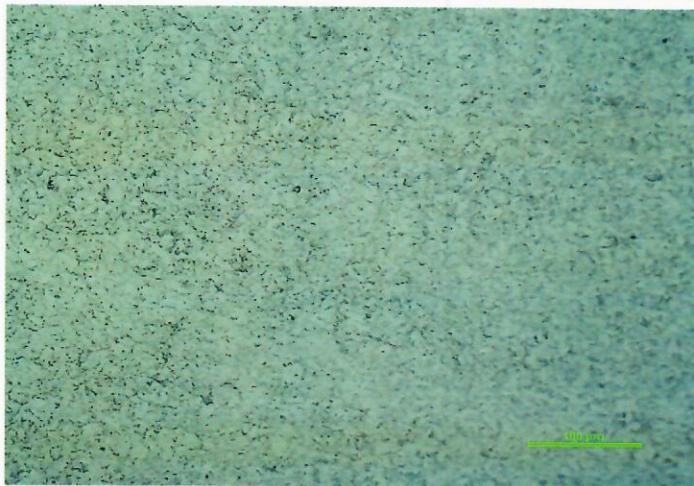
Location: Base Metal ; Etchant: Fry's Reagent; Magnification: 200x

Project:	Maintenance Shutdown
Vessel:	BOOSTER HEATER NO. 1
Size:	N/A
Material:	ASTM A335 Gr. P91
Locations:	6 o'clock; Outlet Tube No. 56- MID
Spot No.:	3

Microstructure revealed equiaxed ferrite with some tempered martensite and carbides in sharp contrast to the fully tempered martensite structure of the virgin material.

No other metallurgical anomalies were observed.

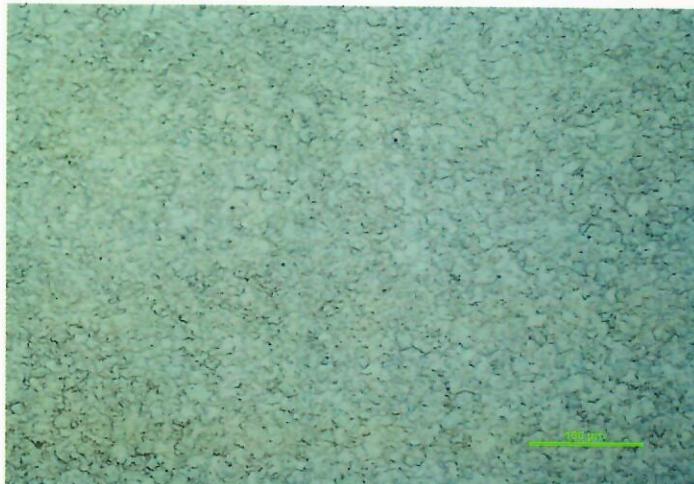
Location: Base Metal ; Etchant: Fry's Reagent; Magnification: 200x

Project:	Maintenance Shutdown
Vessel:	BOOSTER HEATER NO. 1
Size:	N/A
Material:	ASTM A335 Gr. P91
Locations:	12 o'clock; Outlet Tube No. 1- MID
Spot No.:	5

Microstructure revealed equiaxed ferrite and carbides in sharp contrast to the fully tempered martensite structure of the virgin material. No other metallurgical anomalies were observed.

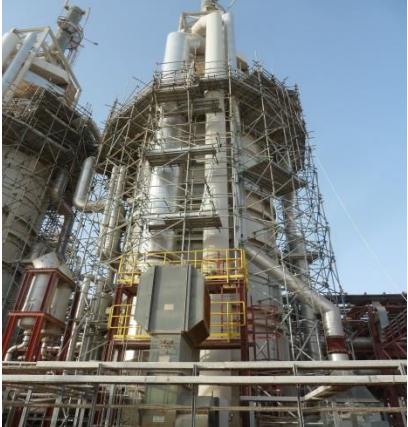
General view of booster heater -1	Burner connected piping

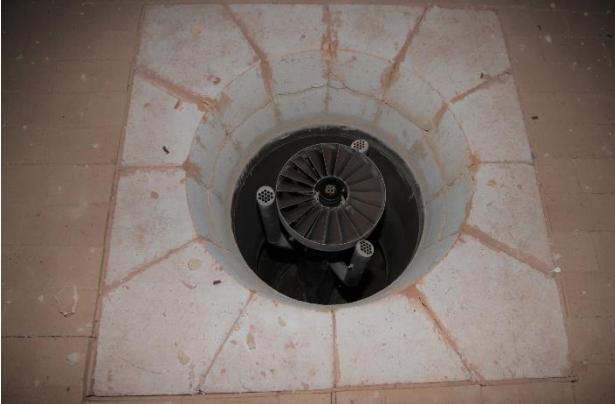
Refractory around burner

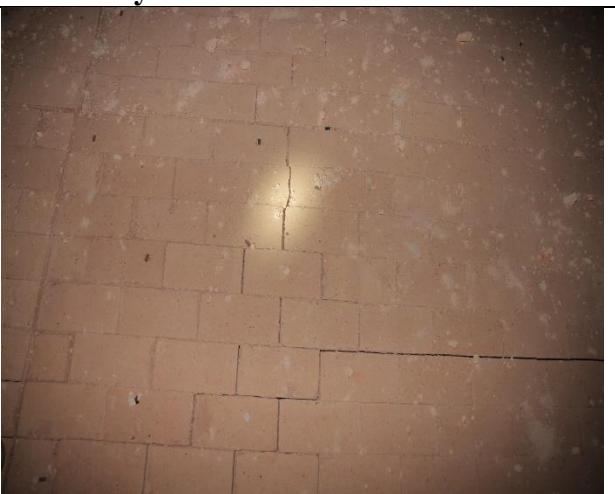
Burner blades

- 6.1 All deposited material on burner opening should be cleaned.
- 6.2 Peep holes should be clean and maintain to open smoothly to allow operators clearly check flame condition.
- 6.3 Heater to be inspected after 4 years as per SHAMS Code of Practice.

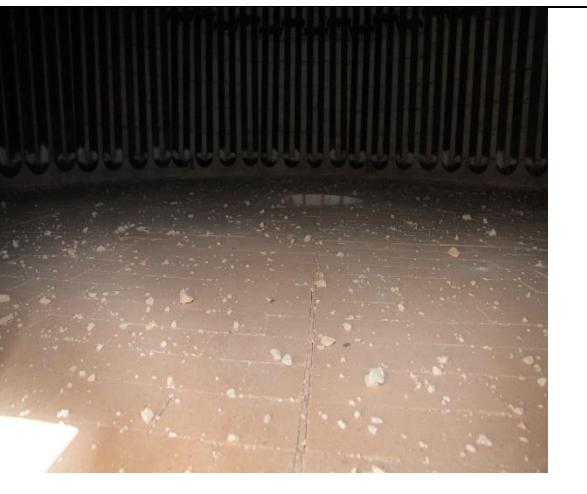
- 5.2.1. All external surfaces of all radiation and convection tubes found in satisfactory conditions without evidence of creep, bowing, sagging and overheating.
- 5.2.2 All piping supports and hungers found satisfactory conditions without evidence of damage or broken.
- 5.2.3 All insulation (fibers and anchors) found in satisfactory conditions in radiation and convection zones.
- 5.2.5 All floor bricks found in satisfactory condition apart from minor separation between floor bricks.
- 5.2.6 Burners found in satisfactory condition without evidence of back fire apart from minor deposit on burner opening most probably due to burned fallen refractory materials.
- 5.2.7 Refractory around burners found in satisfactory condition without evidence of cracking or spalling.
- 5.2.8 Fallen down small parts of refractory material found scattered on floor.
(See below attached photos)

Floor bricks

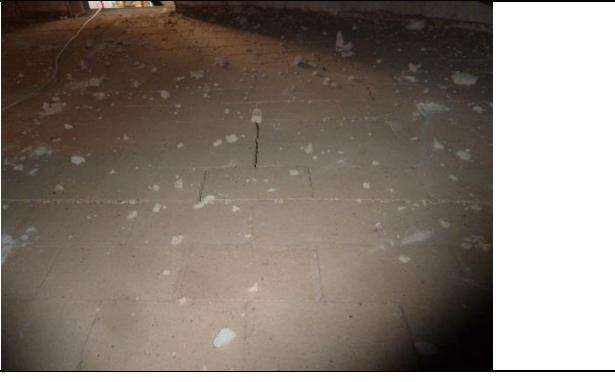
Fallen down refractory materials

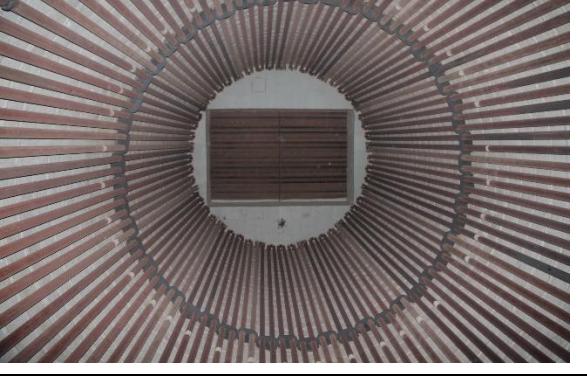
Many way	General view of radiation and convection zone tubes

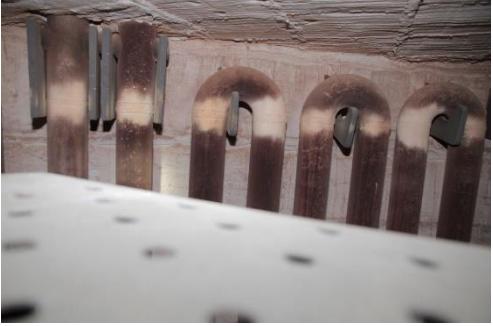
Close up to top supports of radiation zone	Close up view of radiation tubes.

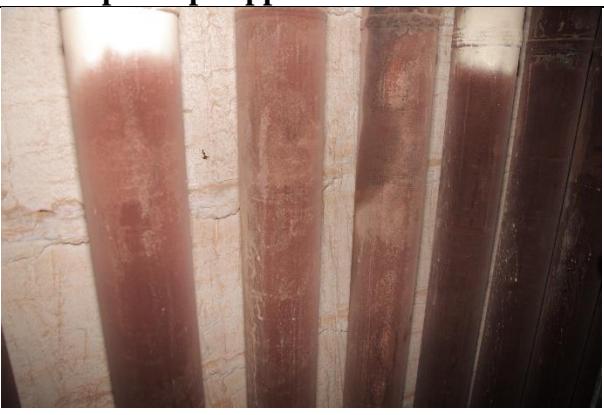
Close up view of wall insulation at radiation zone	Close up view of pipe support at radiation zone

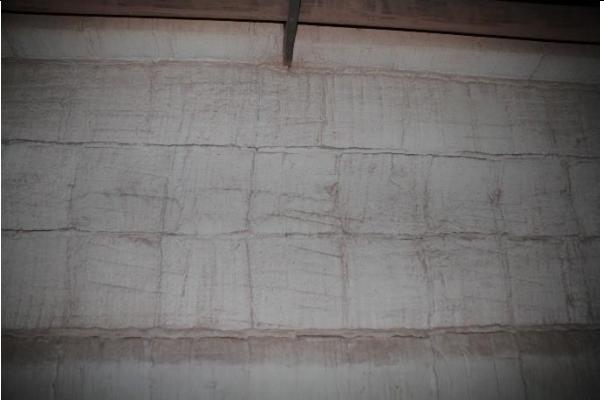
Insulation in top side of radiation zone	Bottom elbows of radiation zone
