**SHAMS POWER COMPANY**

**SHAMS 1**

**CERTIFICATE OF INSPECTION**

**ITEM : Main steam header**

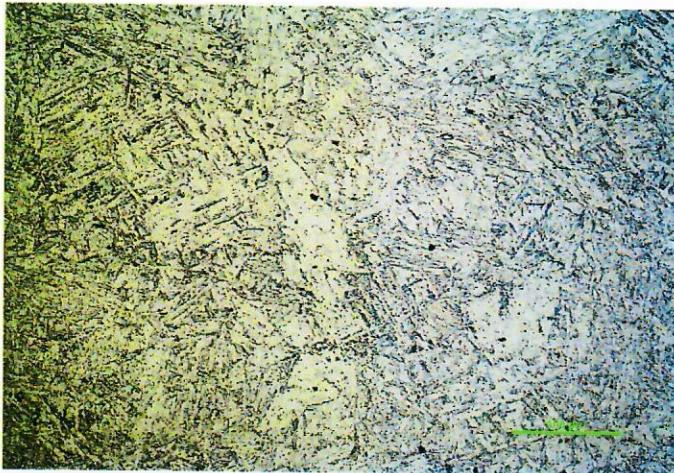
Location: Base Metal ; Etchant: Fry's Reagent; Magnification: 200x

Microstructure revealed ferrite pools and carbides in the tempered martensitic matrix at the examined location.  
No other significant metallurgical anomalies observed.

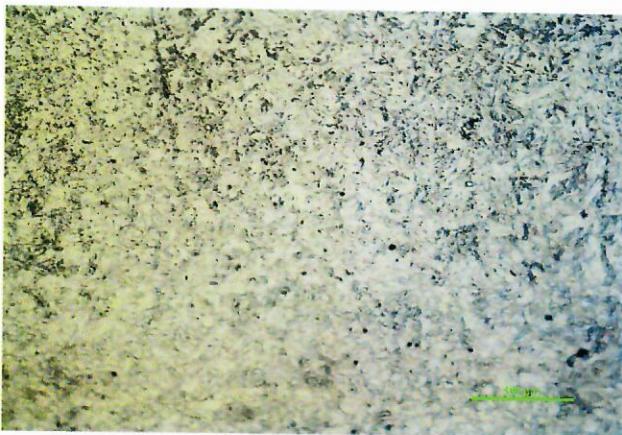
Location: Heat Affected Zone ; Etchant: Fry's Reagent; Magnification: 200x

Microstructure revealed ferrite, carbides and some tempered martensite at the examined location.

No other significant metallurgical anomalies observed.

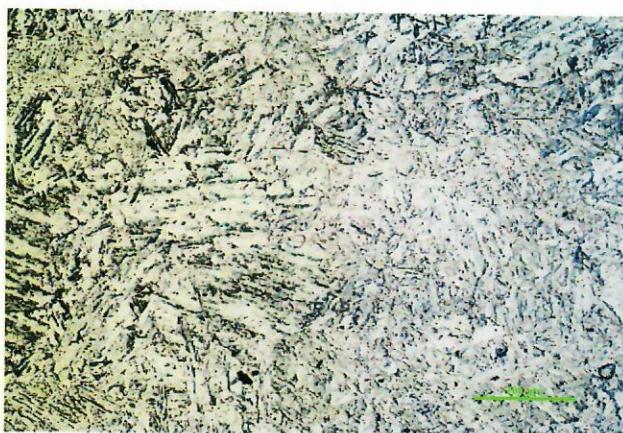
Location: Weld Metal ; Etchant: Fry's Reagent; Magnification: 200x

Microstructure revealed ferrite pools and carbides in tempered martensitic matrix at the examined location.

No other significant metallurgical anomalies observed.
