ELEVATOR WORLD

July 2009

The Impact of Worn Sheave Grooves on Rope Life Expectancy

by Kevin Heling, Rick Perry and Martin Rhiner

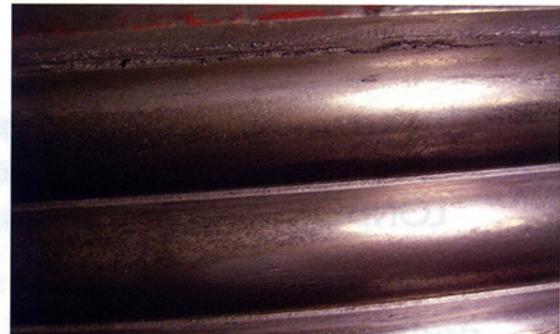
Figure 5: This close-up of one of the worn grooves shows evidence of light pitting due to years of service. In this case, small metal parts or shavings (filings) have become removed from the groove itself. The presence of filings within an installation is some cause for concern and could be an indication that the hoist ropes need replacement and that sheave re-grooving is required. A pitted surface, if left unaddressed, can greatly affect the rope surface and lead to dramatically shortened rope life expectancy.

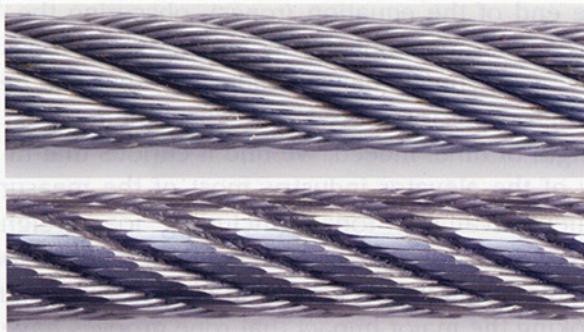
Figure 7: The excessive crown wear shown in the bottom sample of an 11/16-in., 8 X 19, RRL rope (taken from a double-wrap drive sheave) is easily visible in this close-up. Notice the polishing or abrasion of the individual outer wires themselves.

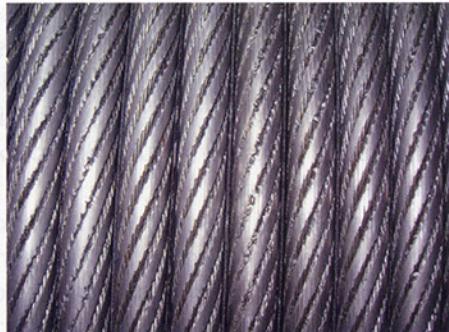
An examination of six hoist ropes in a bank of six high-rise elevators showed alarming evidence of advanced, severe rope crown wear after only 18 months of service (1.2-1.4 million elevator starts). The old ropes were removed and rope diameter measurements carefully taken from the area where maximum crown wear was most evident. As you can see from our readings in Table 2, the initial 11/16-in. (17.5-mm) rope has been gouged and worn significantly.

Figure 8: A complete set of ropes showing dramatic, heavy crown wear
