# MATJHABENG LOCAL MUNICIPALITY

FLOODING REPORT  
TUMELO MAKOFANE

## **MATJHABENG LOCAL MUNICIPALITY'S INFRASTRUCTURE AND RELATED WATER INCIDENCES**

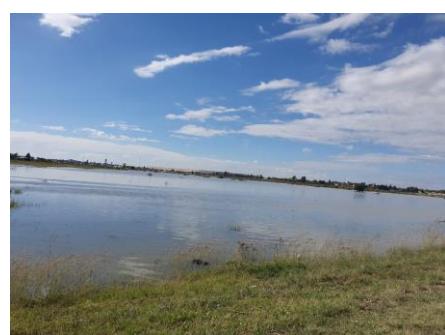
The R732 road was not affected but it was certainly built without consideration of the impact of the flood line which became evident during the floods that it was unable to assist in alleviating the flood damages by channelling water away from the central catch pits.

As a result the small channels could not handle the amount of water which stagnated for a while at the central catch but which ultimately found a way during Monday of moving towards Bronville South at the location of the stadium and ultimately the Bronville Primary School, the pump station at Bronville South as well as scrap metal business and other businesses adjacent to the school. Some houses were also affected by the running water which, through winds, found new direction to flood even homes along the south of Bronville.

*Picture 1: View from side of R732-Before robots  
After robots*

As part of technical improvement to the R732, we need to create more and sizeable channels that will carry increased amount of water at a time to alleviate potential deluge as it happened in the area of the site as depicted in pictures (pictures 1 and 2) below as follows:

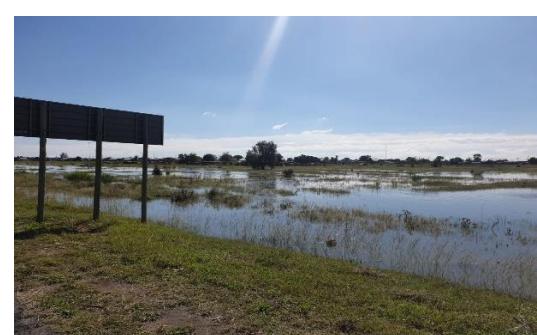
*Picture 2: View from side of R732-*

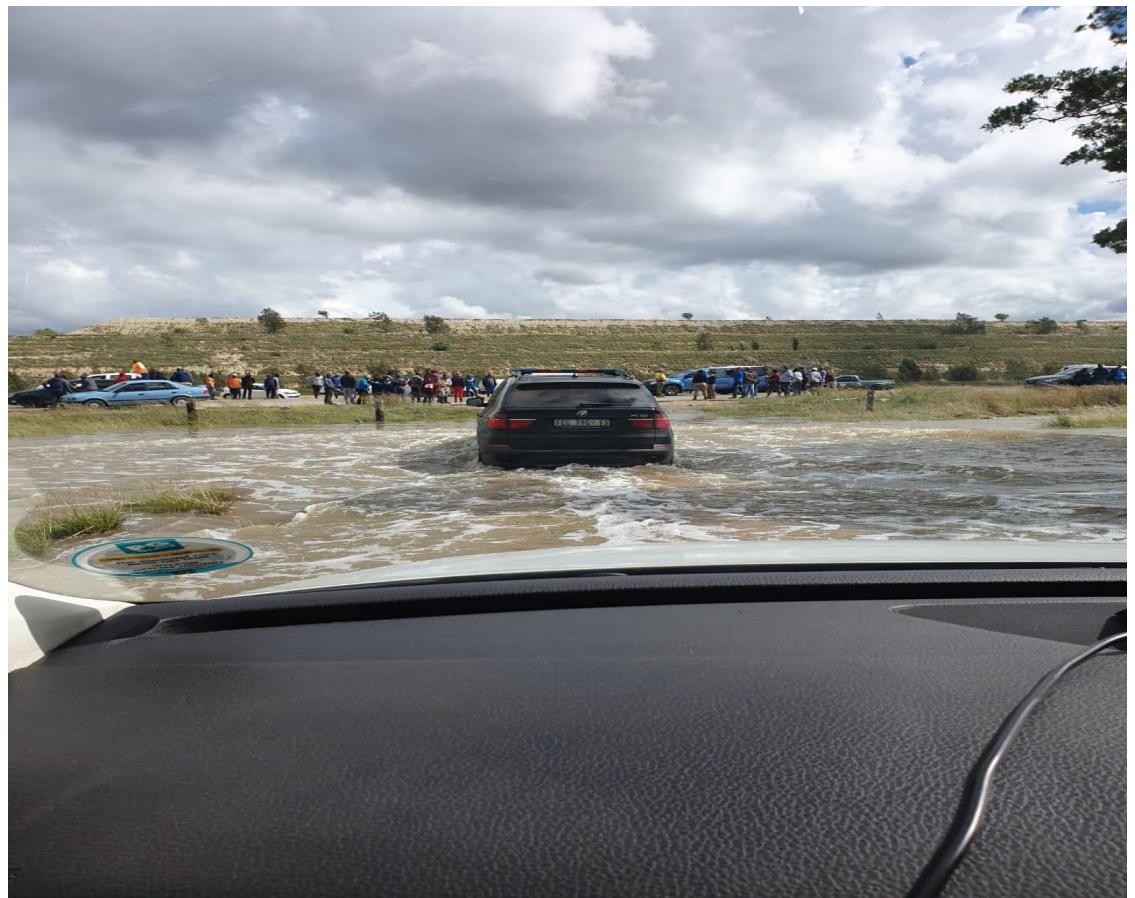
*Picture 3- Drive towards R732 from the connector road to Bronville during actual flooding on Tuesday, the 23<sup>rd</sup> April 2019*

As a result, the fencing to the Bronville Stadium will need replacing as the damage could bring unforeseen danger to sports people and any other people who are likely to use the stadium in the future. Costs related to the damage in the stadium could not be immediately established at the time but would require rebuilding the entire pavilion at the South side of the stadium.

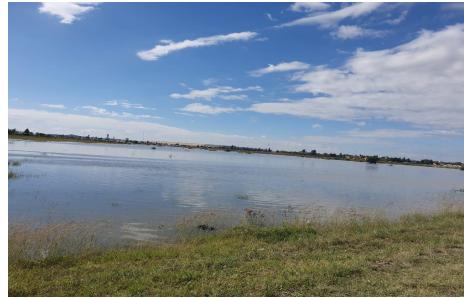
The road that connects Bronville with the R732 has also been structurally damaged although no formal assessment has been done. This section of the road was virtually submerged in water as the pictures below would show:

*Picture 4: Bronville entrance*

The pictures above show entrance from the newly established traffic control entrance to Bronville. They also depict uneven level of the road entrance to Bronville which must receive major upgrading to take into account the level of the internal flood line. The distance from the entrance to the 4-way stop next to the taxi rank 1,2km. This section of the road requires major financial injections to be aligned to the R732 in anticipation of future flood occurrences.

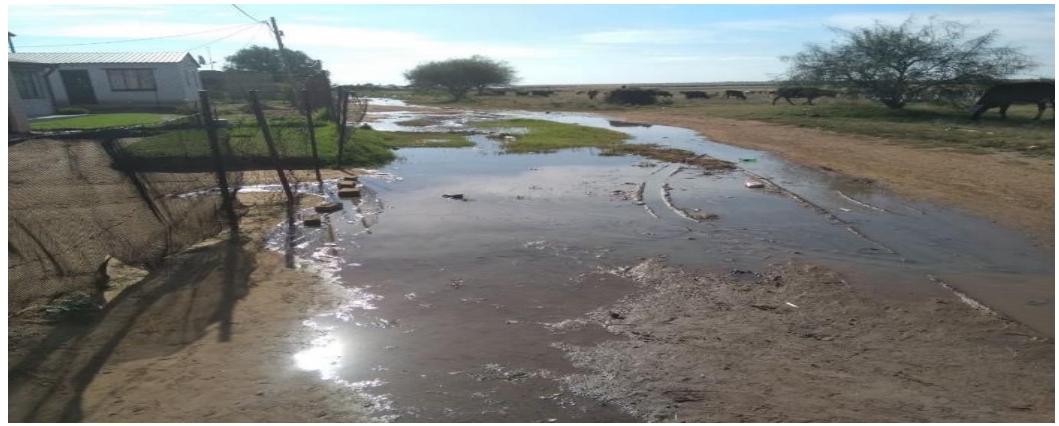
Other internal roads have also been affected by the floods and in some places, no access is guaranteed after the rains and pictures taken in some areas pose a worrisome health and safety environment as terrains have become difficult to traverse like in pictures below:

*Picture 6: Depicting a before scenario*

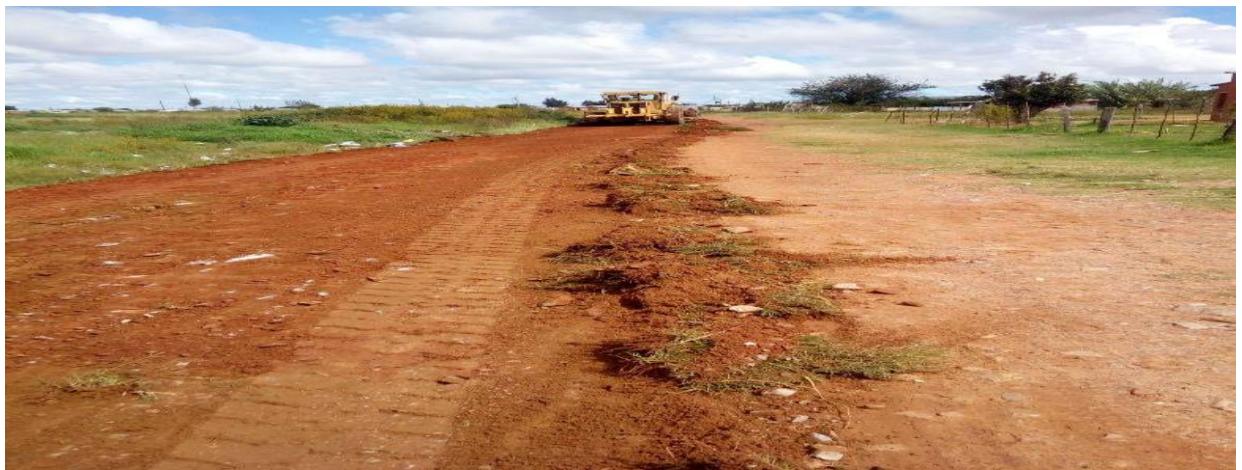
*Picture 7: Depicting a “during” scenario*

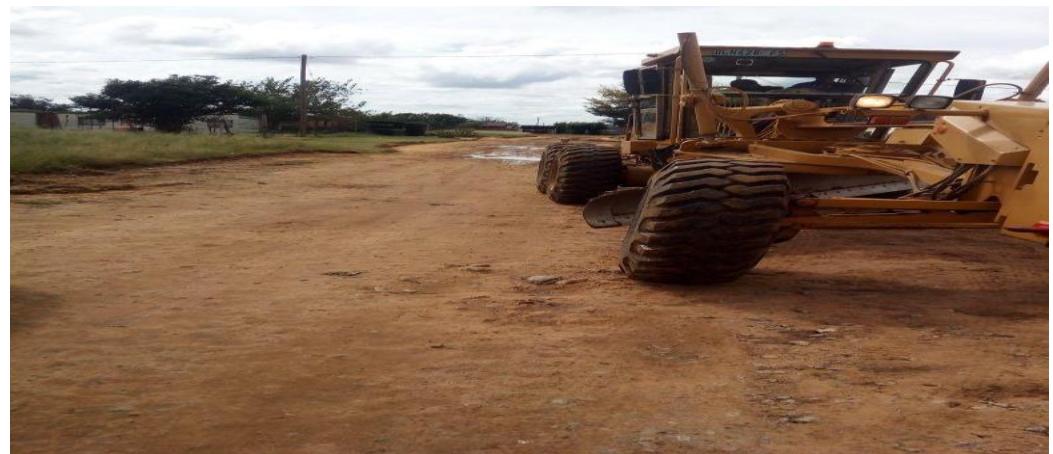
*Picture 8: Depicting an “after” scenario*

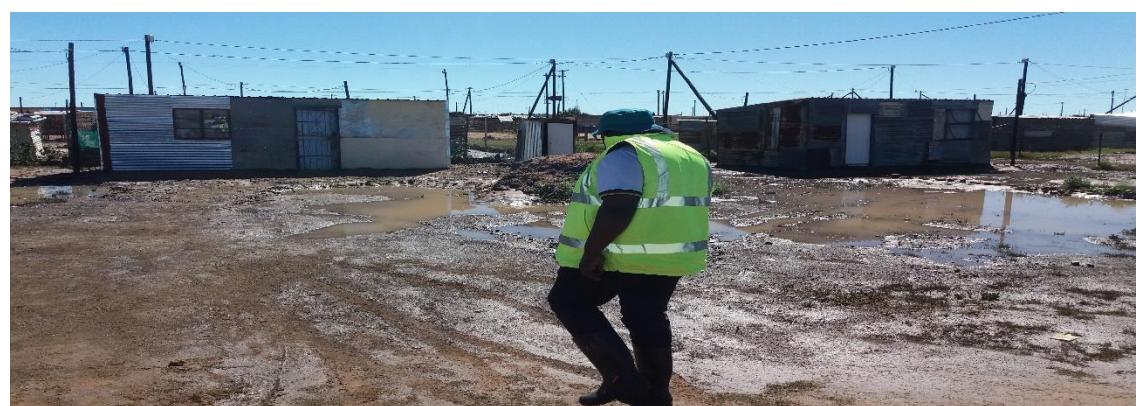
*Picture 9: the “current: scenario*

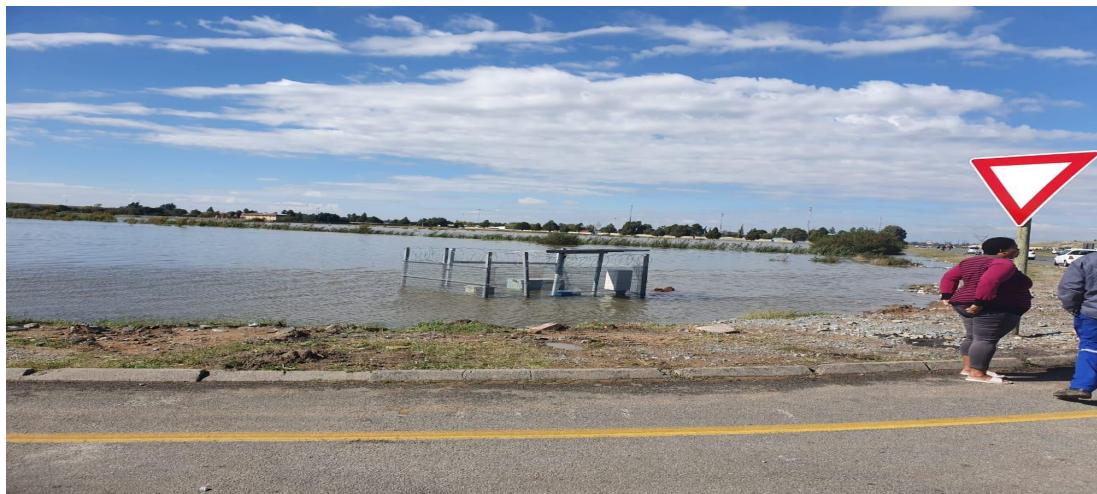
Bronville and surrounding areas have been badly affected by the floods and in the process, there was a black out for six consecutive days which was abnormal in terms of electricity regulations. Complaints lodged indicate that people lost food as a result of the black out. We expect more people to lodge complaints regarding the financial loss as a result. There was also an accident as a result of the non-functioning of the traffic lights in the entrance to Bronville.

The extent of the damage could not be determined as the accident happened in the wee hours of Thursday when no one was present at the accident scene. One set of robots was destroyed increasing damage costs which must then be incurred by the Municipality.

Consequentially, there were a number of robberies reported in the areas affected by black out. Electrical cables and pump station equipment were stolen by thieves. A 15 meter cable was stolen at 12<sup>th</sup> Street in the Industrial Area of Mannys (Welkom) during the morning of the 26<sup>th</sup> April 2019 when advanced work was achieved with intention to ultimately switch Bronville on during same Friday morning. In one area, a cable fault was discovered and a replacement of same took place same morning. These are additional costs to the Municipality under forced and

unforeseen circumstances due to floods. Our electrical network providing energy to Bronville is reticulated underground and that has always been the challenge. The recommended route is to redirect reticulation to go above the ground to ensure that any interference is visible and prompt action is taken during electricity down time. The source and distance calculated should start from Urania pump station.
