Key Findings on Household Registration for Housing Reconstruction Survey in 14 Districts

Central Bureau of Statistics

3 Key Findings of the Survey (First and Second Phase) in 14 districts

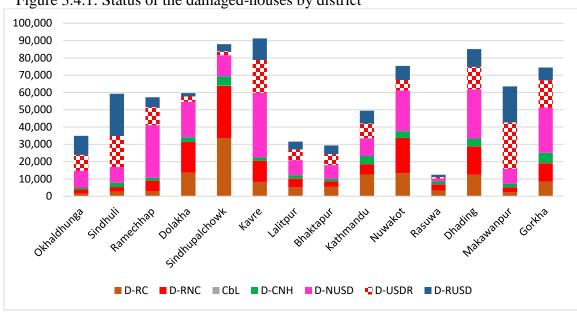
Figure 3.4.1: Status of the damaged-houses by district

Three-fourth of the damaged houses in Sindhupalchok are under the category of "Rubble not Yet Cleared" or "Rubble Cleared" which shows the extent of damage by the earthquake in this particular district. Likewise, Sindhupalchok has the highest proportion, 34 percent, of damaged houses with "Rubble not yet cleared" status. The number of damaged houses with the highest proportion of "Rubble cleared" is also in Sindhupalchowk with 38 percent of damaged houses. However, the proportion of the damaged houses in Rasuwa with "Rubble cleared" and "Rubble not cleared" is only 26 percent and 27.7 percent respectively.

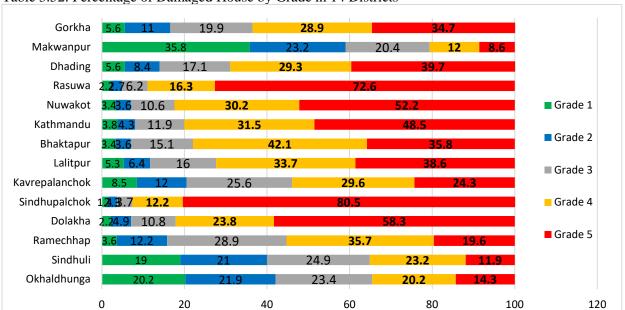
Table 3.52: Percentage of Damaged House by Grade in 14 Districts

Among the 14 districts, Sindhupalchok and Rasuwa was found hardest hit by the earthquake with 93 percent and 89 percent of the surveyed houses with Grade 4 or 5. Likewise, Nuwakot and Dolakha was also seriously affected by the earthquake with more than 82 percent of the houses damaged to grade 4 or 5. Makawanpur was least hit by the earthquake with only 21 percent of houses damaged to grade 4 or 5 whereas over one-third of the houses were damaged to the grade 4 or 5 in Okhaldhunga and Sindhuli.

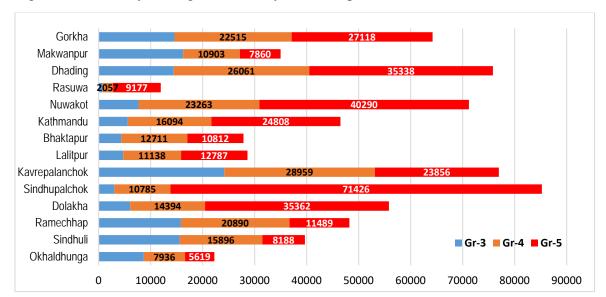
Figure 3.6: Severely Damaged Houses by the Earthquake in 14 Districts

Among the 14 districts, Sindhupalchok has the largest number (85228) and highest proportion (96 percent) of severely damaged houses followed by Kavrepalanchok (76959), Dhading (75819), Nuwakot (71202), Gorkha (64216) and Dolakha (55828). In terms of lowest number of severely damaged houses, Rasuwa comes in the first place with 11934 houses severely damaged. However, in terms of the proportion of SDH wihin the district, more than 94 percent of the total surveyed houses were severely damaged in Rasuwa. Okhaldhunga has the second lowest number of SDH (22230) followed by Bhaktapur (22230), Lalitpur (28617), Makawanpur (34997), Sindhuli (39659), Kathmandu (46504) and Ramechhap (48200).

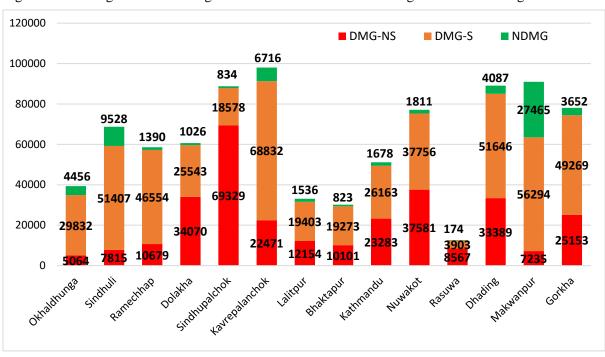
Figure 3.7: Damaged Houses Categorized with the Position "Standing" or "Not Standing"

The survey found that more than one-third (35 percent) of the surveyed houses in 14 districts are completely collapsed or "not-standing" whereas more than half (57.6 percent) of the surveyed

houses are damaged but in the "Standing" position and only 7.4 percent is not damaged by the earthquake.

The top five districts with the highest number of completely collapsed or "Not-Standing" houses are (i) Sindhupalchok (69,329) (ii) Nuwakot(37,581) (ii) Dolakha (34,070) (iv) Dhading (33,389)and (v) Gorkha (25,153) where almost two-third (65 percent) of the totally collapsed houses in 14 districts found. Okhaldhunga (5,064) has the lowest number of "completely collapsed" houses among the 14 districts.

Likewise, the five districts with the highest number of "Standing" damaged houses are (i) Kavre (68,832) (ii) Makawanpur (56,294) (iii) Dhading (51,646) (iv) Sindhuli (51,407) and (iv) Gorkha (49,269) that accounts more than half (55 percent) of the "Standing" damaged houses in 14 districts. The lowest number of "Standing" damaged houses were found in Rasuwa (3,903).

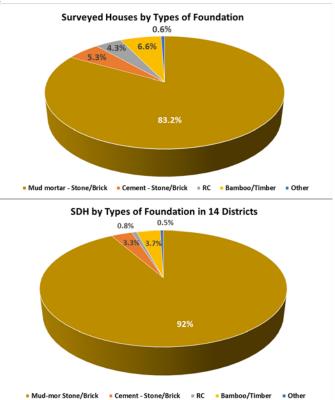
The figure in the right shows the proportion of houses surveyed and SDHs by types of foundation. It is very apparent in the figure that the proportion of SDH built on the foundation of "Mud mortar"

-Stone/Bricks" exceeds the proportion of surveyed houses built on foundation of same category. proportion of SDHs built on the foundation of other categories is lesser than the surveyed households with the same categories of foundation which could be due to the varied impact of earthquake on the houses built on the types of foundation. Table 2 below shows the severely damaged houses by types of foundation of the houses. About 87 percent (6,32,914) of the total houses with foundation built of "Mud-Mortar with Stones/Bricks" were severely damaged which accounts to about 92 percent of the total SDHs in the 14 districts. The number of severely damaged houses with the foundation

built of "Cement – Stone/Bricks" and "Reinforced Concrete (RC)" found to be 3.3 and 0.8 percent of total SDHs which seems nominal compared to the proportion of the SDH with other categories of foundation.

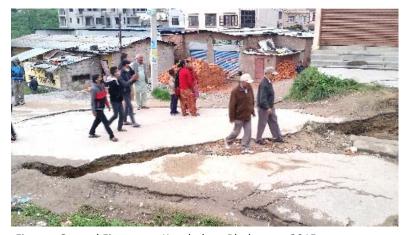
Figure : Ground Fissures at Kaushaltar, Bhaktapur, 2015
