# Key Findings of Household Registration for Housing Reconstruction Survey in 17 Districts

# **Central Bureau of Statistics**

# 4 Key Findings of the Survey (Third Phase) in 17 districts

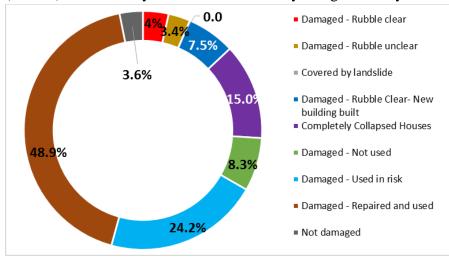
The survey has found that almost half (48.9%) of the total surveyed houses in 17 districts have been repaired and are using the repaired shelter by the households. However, about one-fourth (24.2 %) of the surveyed houses are currently using at risk by the households without the houses

whereas 8.3 percent of the surveyed houses abandoned (damaged and not used) by the house-Likewise, owners. percent of the surveyed houses were completely collapsed. About half of the completely collapsed (7.5% of the total surveyed) houses has already been rebuilt. The

number of completely collapsed houses with the rubble being removed and yet to remove constitutes four and 3.4 percent respectively. The reconstructed houses in 17 districts constitutes 7.5 percent of the surveyed houses. (See Annex Table 2).

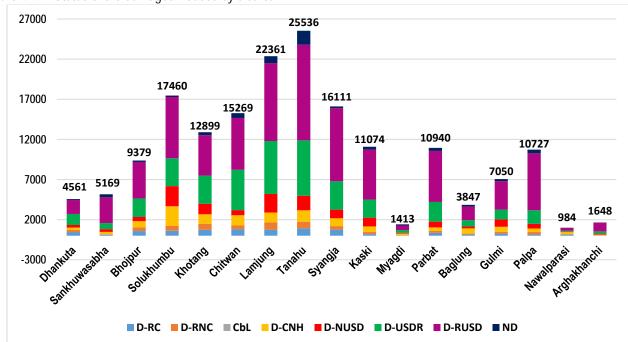
Figure 4.4.1: Status of the damaged-houses by district

The completely collapsed houses with "Rubble not yet cleared" numbered 6009 which accounts to 3.4% of the total surveyed houses in 17 districts. The highest number of such houses are found in **Lamjung** (883) followed by Tanahu (823) and Khotang (731). The lowest number of damaged houses under this category are found in Arghakhachi (34) followed by Myagdi (37) and Nawalparasi (50). However, the rubble from 7051 completely damaged houses has been cleared from the site in 17 districts. The highest number of rubble-cleared from completely collapsed houses has been found in **Tanahu** (908) followed by Chitwan (815) and Lamjung (763).

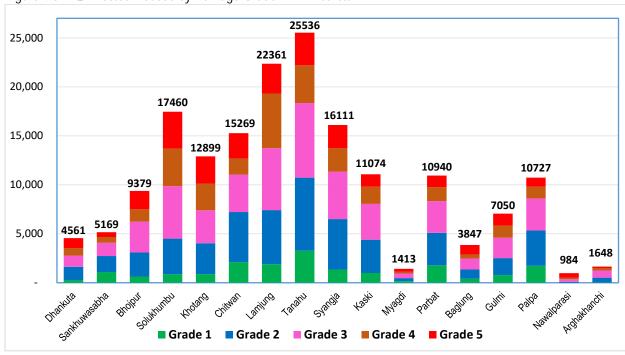
Figure 4.5: EQ Affected Houses by Damage Grade in 17 Districts

With the above categorization for the severity of damage caused by the EQ, the survey found that about one-third (32.3 percent) of the surveyed houses were damaged to the grade level 4 or 5 whereas more than one-third (38.4 percent) of the surveyed houses were found with damage grade of 1 and 2 (See Annex Table 1).

Among the 17 districts, Lamjung and Solukhumbu was found hardest hit by the earthquake with highest number of houses damaged to the grade of 4 or 5. Lamjung and Solukhumbu have 8629 and 7588 houses which accounts to 38.6 percent and 43.5 percent of the total surveyed houses respectively that were damaged to the grade of 4 or 5.

Myagdi and Arghakhachi has only 390 and 472 houses that were damaged to the grade level of 4 or 5 which is the lowest number among the 17 districts. (See Annex Table 1).

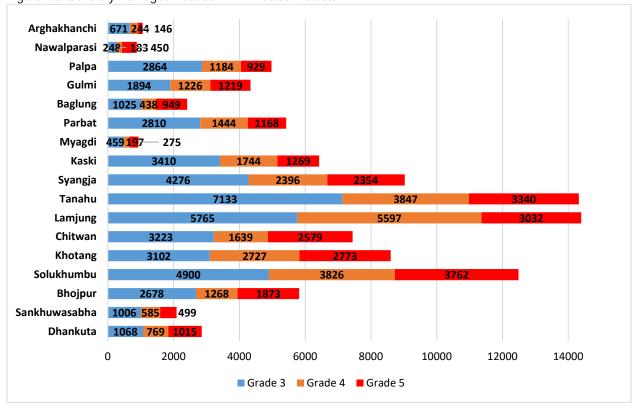
Figure 4.6: Severely Damaged Houses in 17 Affected Districts

Among the 17 districts, Tanahu has the largest number (7133) of SDHs with damage grade 3 and "major repair" as technical solution followed by Lamjung and Solukhumbu with 5765 and 4900 number of SDH houses with damage grade 3.

In terms of largest number of SDH with damage grade 5, Solukhumbu district comes at the top with 3762 houses followed by Tanahu and Lamjung with 3340 and 3032 houses respectively

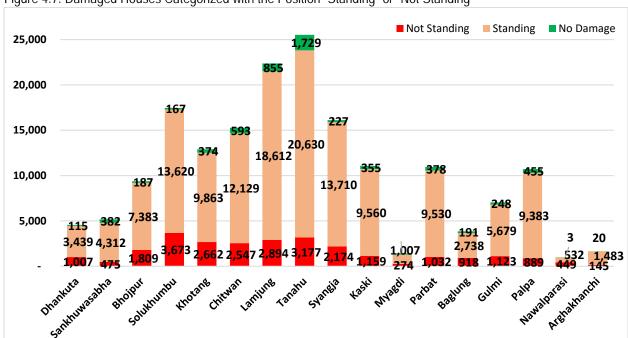
Figure 4.7: Damaged Houses Categorized with the Position "Standing" or "Not Standing"

The survey found that two-third (81.4%) of the surveyed houses in 17 districts are damaged but "standing" whereas completely collapsed or "Not Standing" houses constitutes only 15 percent of the surveyed houses. There are only 3.6 percent of the surveyed houses that are found "Not damaged" by the earthquakes. (Table 4.7).

Likewise, the three districts with the highest number of "Standing" damaged houses are (i) Tanahu (20,630) (ii) Lamjung (18,612) and (iii) Syangja (13,710).

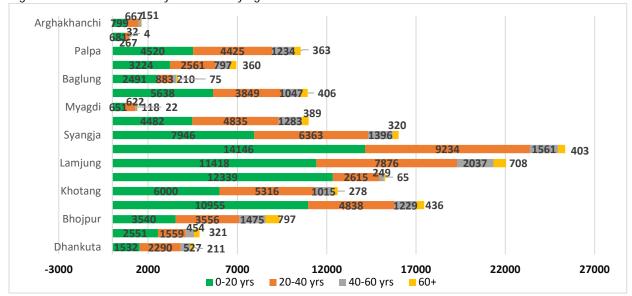
Figure 4.8: Number of Surveyed Houses by age in 17 districts

Among the 17 surveyed districts, Chitwan has more than three-fourth (80.8 percent) of houses that were built less than 20 years older followed by Nawalparasi and Baglung where the proportion is 69.2 and 68.1 percent respectively. Chitwan and Nawalparasi districts have relatively higher proportion of houses that constitutes 66 percent and 54 percent of the surveyed houses that are built more than 20 years ago. (See Annex Table 4). Likewise Tanahu and Lamjung districts which have largest number of surveyed houses constitutes 43 percent and 50 percent of the surveyed

houses that were less than 20 years of age. About half of the surveyed houses that were severely damaged in Tanahu and Lamjung by the earthquake were older than 20 years of age.

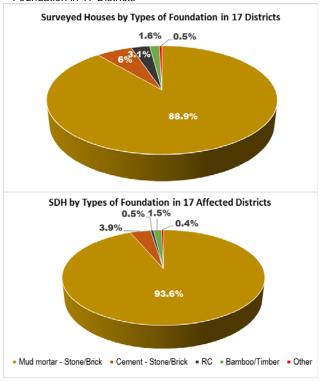
Figure 4.9.1: Surveyed Houses and SDHs by Types of Foundation in 17 Districts

Most of the surveyed houses in 17 districts were built on the foundation of "Mud-mortar with Stone/Brick". The houses built on the foundation of "Mud-mortar with Stone/Brick" seems more vulnerable to sustain the seismic effect as about 62 percent of SDHs were built on the foundation of "Mud-mortar with Stone/Brick" in 17 districts. Likewise, 38.4 percent of the surveyed houses that were built on the foundation of "Cement –Stone/Brick" were severely damaged. Slightly more than half of the saverely houses built on the foundation of "Bamboo/Timber" were also severely damaged. The houses that were built on the foundation of "Reinforced Concrete" seems sustained during the earthquake as about 90 percent of the surveyed houses that were built on the foundation of "Reinforced Concrete" were found with minor or no damages at all.

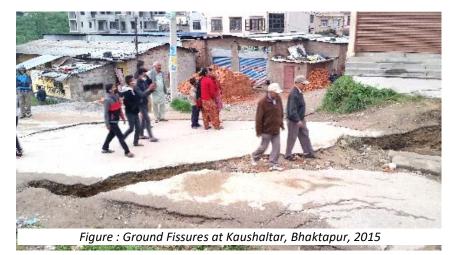
The vast majority of the surveyed houses (almost 93%) in 17 districts did not reported occurrence of any kind of geo-technical hazards. However, 8.2 percent of the surveyed houses reported that there were occurrences of geo-technical hazards in or nearby houses (Table 3.14). Around half of those houses reported the occurrence of "Landslide" after the earthquake. Tanahu, Lamjung and Solukhumbu constitutes the highest number of surveyed houses that reported "Landslide" in or nearby the surveyed houses.
