1. Summary

This report provides results from testing conducted by the Bioengineering Department on the Anschutz Medical Campus in Aurora Colorado. Test procedures were adapted from the American National Standards Institute (ANSI) standard Z87.1-2003 [1] and guidelines compiled for the Journal of Occupational and Environmental Hygiene [2]. This test does not assess mechanical impacts.

1.2. Summary of Reconfiguration

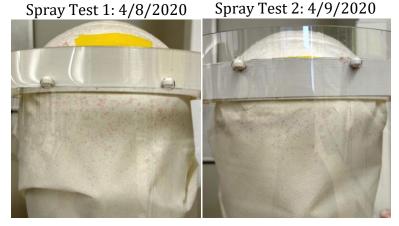
Halo flipping was previously used to reduce liquid penetration in the visor-less Prusa v2 system (Figure 2). With the addition of both visor models, no liquid penetration was observed

Figure 2: Previous spray tests with visor-less Prusa V2 model.
