## PV Solar System

### Report

Customer : RATCH GROUP PCL.  
Place : EGAT (Sai Noi Office) /T.0011  
Equipment/Device/System : DC Panel Box No.3 / 11SNPB-WDC01

Report by : Energy Conversion and Management Co.,Ltd.  
Date : 9-Dec-2024

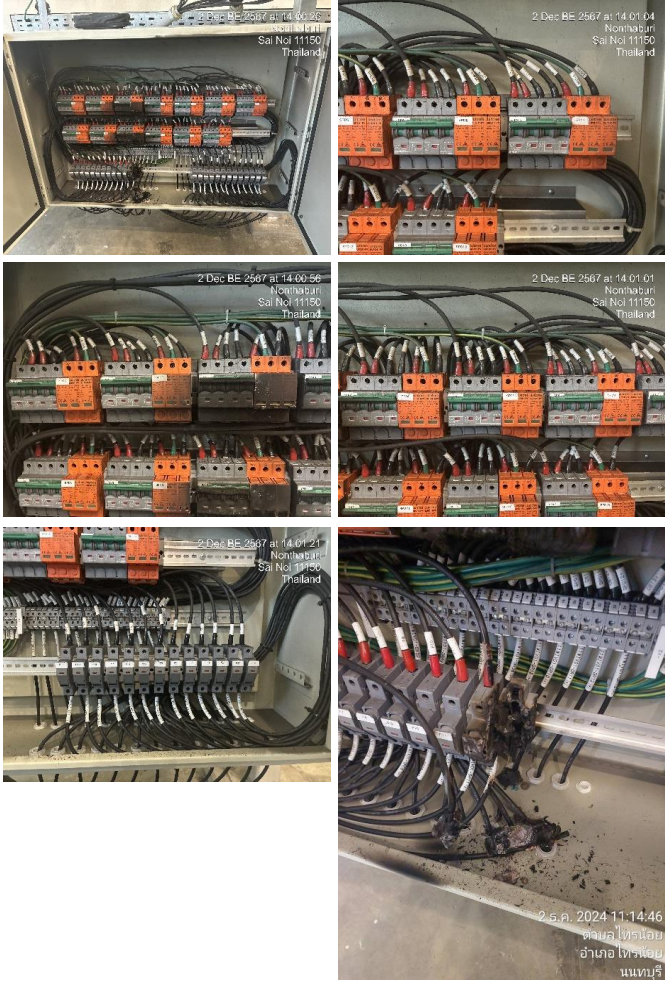
| Item | Photo | Cause | Solution |
|---|---|---|---|
| 1 | | <p>The equipment is damaged by heat as listed below.</p> <ol style="list-style-type: none"> <li>SPD2 : Surge Protection Device Model:SUP2H1-PV = 1 ea.</li> <li>CB3 : MCB Model:SL7N-63 = 1 ea.</li> <li>SPD3 : Surge Protection Device Model:SUP2H1-PV = 1 ea.</li> <li>CB4 : MCB Model:SL7N-63 = 1 ea.</li> <li>SPD9 : Surge Protection Device Model:SUP2H1-PV = 1 ea.</li> <li>CB10 : MCB Model:SL7N-63 = 1 ea.</li> <li>SPD10 : Surge Protection Device Model:SUP2H1-PV = 1 ea.</li> <li>CB11 : MCB Model:SL7N-63 = 1 ea.</li> <li>F12 : Fuse Holder Model:SRD-30 = 1 ea.</li> <li>Fuse Model:SRF-30 = 1ea.</li> <li>F13 : Fuse Holder Model:SRD-30 = 1 ea.</li> <li>Fuse Model:SRF-30 = 1ea.</li> </ol> | <ol style="list-style-type: none"> <li>Replace equipment as list below <ul style="list-style-type: none"> <li>- SPD2 : Surge Protection Device Model:SUP2H1-PV = 1 ea.</li> <li>- CB3 : MCB Model:SL7N-63 = 1 ea.</li> <li>- SPD3 : Surge Protection Device Model:SUP2H1-PV = 1 ea.</li> <li>- CB4 : MCB Model:SL7N-63 = 1 ea.</li> <li>- SPD9 : Surge Protection Device Model:SUP2H1-PV = 1 ea.</li> <li>- CB10 : MCB Model:SL7N-63 = 1 ea.</li> <li>- SPD10 : Surge Protection Device Model:SUP2H1-PV = 1 ea.</li> <li>- CB11 : MCB Model:SL7N-63 = 1 ea.</li> <li>- F12 : Fuse Holder Model:SRD-30 = 1 ea.</li> <li>- Fuse Model:SRF-30 = 1ea.</li> <li>- F13 : Fuse Holder Model:SRD-30 = 1 ea.</li> <li>- Fuse Model:SRF-30 = 1ea.</li> </ul> </li> <li>Replace new cable lugs as list below <ul style="list-style-type: none"> <li>- At SPD2</li> <li>- At CB3</li> <li>- At SPD3</li> <li>- At CB4</li> <li>- At SPD9</li> <li>- At CB10</li> <li>- At SPD10</li> </ul> </li> </ol> |

| Item | Photo | Cause | Solution |
|---|---|---|---|
| 1 | | | <ul style="list-style-type: none"> <li>- At CB11</li> <li>- At F12</li> <li>- At F13</li> <li>3. Cable continuous test</li> <li>4. Cabinet cleaning</li> </ul> |
