| <input type="checkbox"/> Category III Inspection | <input type="checkbox"/> Category IV Inspection | <input checked="" type="checkbox"/> Assessment / Verification |

Company: PT. PERTAMINA EP PRABUMULIH FIELD

Project Name: RIG KB 150-C

Location: TALANG JIMAR

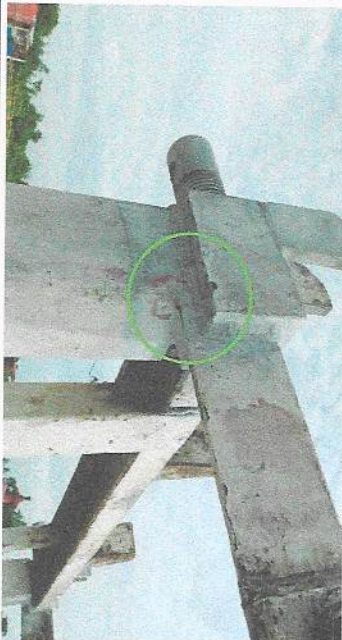
| No. | ITEMS TO BE CHECKED | INSPECTION METHOD | | | | RECOMMENDATION | REMARKS |
|---|---|---|---|---|--|---|---|
| 1 | Lower Mast | Crack welding 1 titik pada siku main frame ke TS bracing ODS<br> | Visual / hasil NDT | API RP 4G 5 Ed Table 3 | | Repair welding | Lakukan proses sesuai kolom rekomendasi |

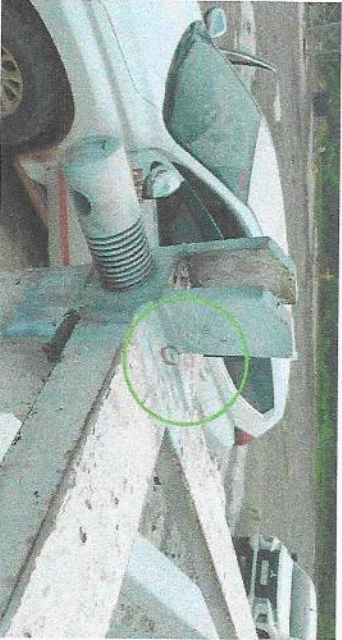
| No. | ITEMS TO BE CHECKED | INSPECTION METHOD | | | | RECOMMENDATION | REMARKS |
|---|---|---|---|---|--|---|---|
| 2 | Lower Mast | Crack welding 1 titik pada pad eye locking DS<br> | Visual / hasil NDT | API RP 4G 5 Ed Table 3 | | Repair welding | Lakukan proses sesuai kolom rekomendasi |

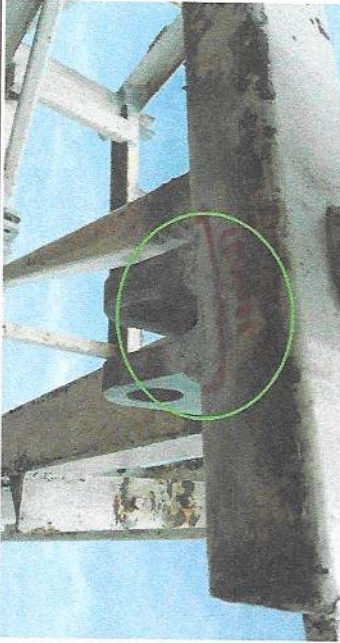
| No. | ITEMS TO BE CHECKED | INSPECTION METHOD | | REFERENCE | RECOMMENDATION | REMARKS |
|---|---|---|---|---|---|---|
| 3 | Lower Mast | Crack welding 1 titik pada pad eye raising ram DS<br> | Visual / hasil NDT | API RP 4G 5 Ed Table 3 | Repair welding | Lakukan proses sesuai kolom rekomendasi |

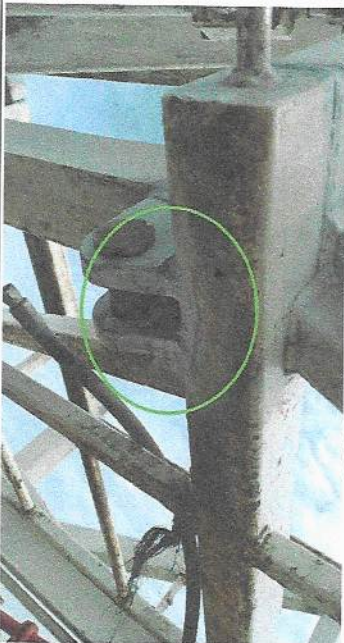
| No. | ITEMS TO BE CHECKED | INSPECTION METHOD | | REFERENCE | RECOMMENDATION | REMARKS |
|---|---|---|---|---|---|---|
| 4 | Lower Mast | Crack welding 1 titik pada pad eye raising ram ODS<br> | Visual / hasil NDT | API RP 4G 5 Ed Table 3 | Repair welding | Lakukan proses sesuai kolom rekomendasi |
