# PT. PJ-TEK MANDIRI

| Client | : PT Pertamina EP Zona 4 Field Prabumulih | Height of Mast | : 21,03 meter |
| Rig ID | : BW KB150 C | Hook Load | : 34,02 ton |

## DAILY INSPECTION CAT III REPORT

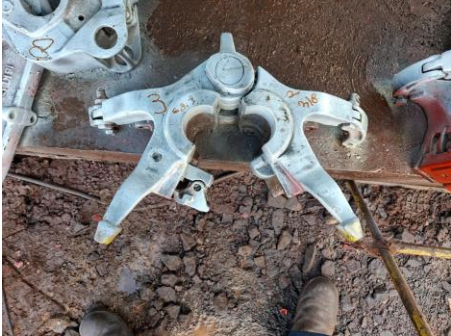
| No. | Equipment | Deficiencies | Categories | Remarks / Recommendation |
|---|---|---|---|---|
| 1. | Elevator Tubing 2 3/8" | | N/A | <b>Finding : N/A</b><br><b>MPI Result : No Discontinuity</b><br><b>Acceptance Criteria :</b><br>API RP 8B Sect. 5.3.2.4<br><b>Total Progress : 100%</b> |

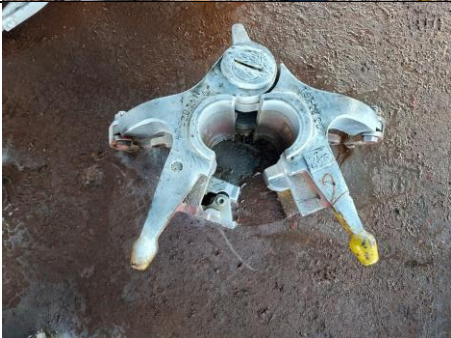
| No. | Equipment | Deficiencies | Categories | Remarks / Recommendation |
|---|---|---|---|---|
| 2. | Elevator Tubing 2 7/8" | | N/A | <b>Finding : N/A</b><br><b>MPI Result : No Discontinuity</b><br><b>Acceptance Criteria :</b><br>API RP 8B Sect. 5.3.2.4<br><b>Total Progress : 100%</b> |

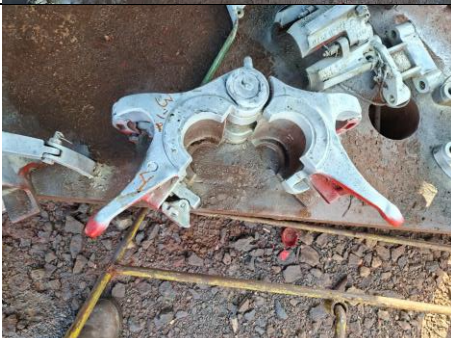
| No. | Equipment | Deficiencies | Categories | Remarks / Recommendation |
|---|---|---|---|---|
| 3. | Elevator Tubing 3 1/2" | | N/A | <b>Finding : N/A</b><br><b>MPI Result : No Discontinuity</b><br><b>Acceptance Criteria :</b><br>API RP 8B Sect. 5.3.2.4<br><b>Total Progress : 100%</b> |

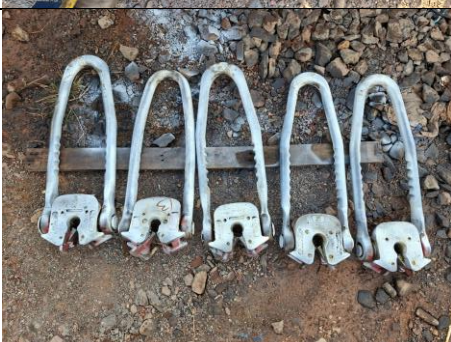
| No. | Equipment | Deficiencies | Categories | Remarks / Recommendation |
|---|---|---|---|---|
| 4. | Elevator Sucker Rod Sea | | N/A | <b>Finding : N/A</b><br><b>MPI Result : No Discontinuity</b><br><b>Acceptance Criteria :</b><br>API RP 8B Sect. 5.3.2.4<br><b>Total Progress : 100%</b> |

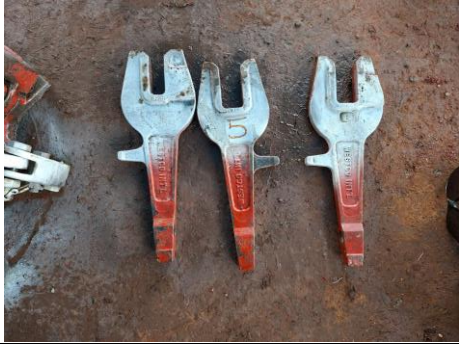
| 5. | Back Up Tong 3ea | | N/A | <b>Finding : N/A</b><br><b>MPI Result : No Discontinuity</b><br><b>Acceptance Criteria :</b><br>- API 7L Sect. 4.1.3<br><b>Total Progress : 100%</b> |

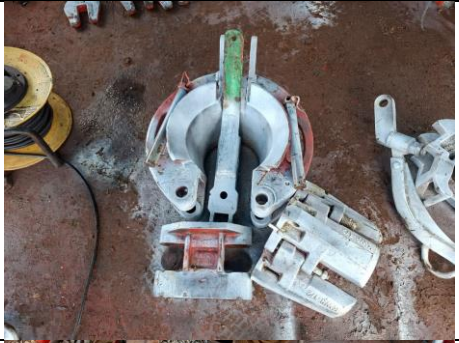
| 6. | Spider Slip 3 ½" | | N/A | <b>Finding : N/A</b><br><b>MPI Result : No Discontinuity</b><br><b>Acceptance Criteria :</b><br>- API 7L Sect. 4.1.3<br><b>Total Progress : 100%</b> |

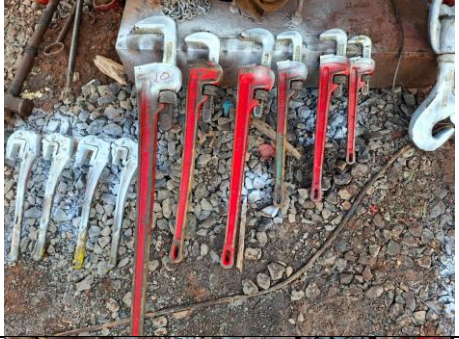
| 7. | Ridgid Pipe 6ea | | N/A | <b>Finding : N/A</b><br><b>MPI Result : No Discontinuity</b><br><b>Acceptance Criteria :</b><br>- API 7L Sect. 4.1.3<br><b>Total Progress : 100%</b> |

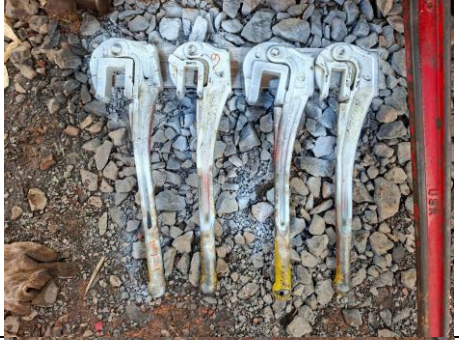
| 8. | Petol Wrench 4ea | | N/A | <b>Finding : N/A</b><br><b>MPI Result : No Discontinuity</b><br><b>Acceptance Criteria :</b><br>- API 7L Sect. 4.1.3<br><b>Total Progress : 100%</b> |

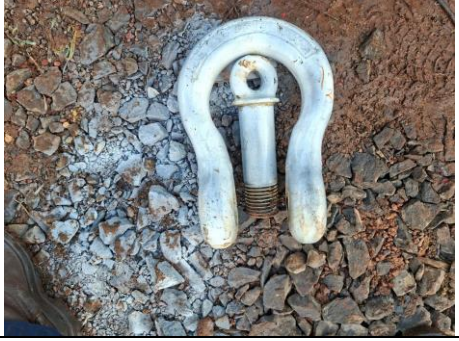
| 9 | Shackle 35 T | | N/A | <b>Finding : N/A</b><br><b>MPI Result : No Discontinuity</b><br><b>Acceptance Criteria :</b><br>- ASME B30.26<br><b>Total Progress : 100%</b> |

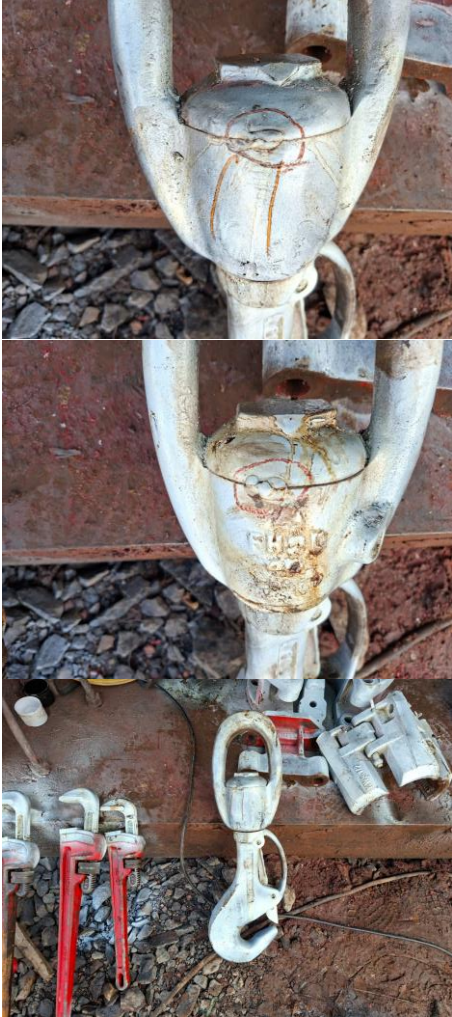
| 10. | Sucker Rod Hook | | Critical | <p><b>Finding :</b> Terdapat pengelasan dan crack di area critical</p> <p><b>MPI Result :</b> Discontinuity</p> <p><b>Acceptance Criteria :</b></p> <ul style="list-style-type: none"><li>- API 8B Sect. 5.2.3.4</li></ul> <p><b>Total Progress : 100%</b></p> <p><b>Recommendation:</b> Segera lakukan pergantian sesuai spesifikasi.</p> |

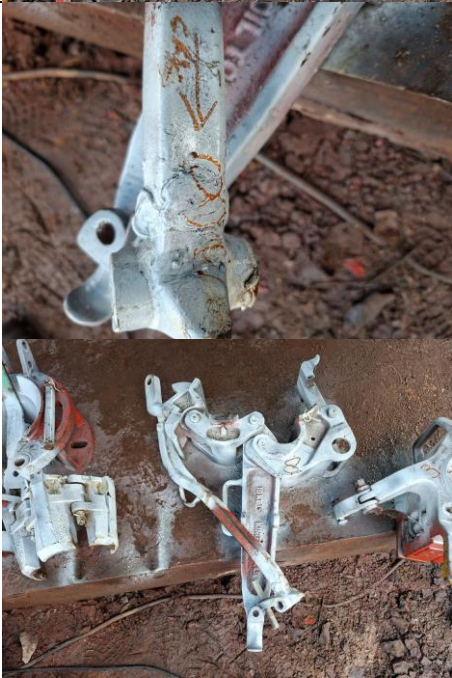
| 11. | Manual Tong | | Critical | <p><b>Finding :</b></p> <ul style="list-style-type: none"><li>- Crack 1 titik</li><li>- Terdapat pengelasan di area critical</li></ul> <p><b>MPI Result :</b> Discontinuity</p> <p><b>Acceptance Criteria :</b></p> <ul style="list-style-type: none"><li>- API 7L Sect. 4.1.3</li></ul> <p><b>Total Progress : 100%</b></p> <p><b>Recommendation:</b> Segera lakukan pergantian sesuai spesifikasi pabrikan.</p> |

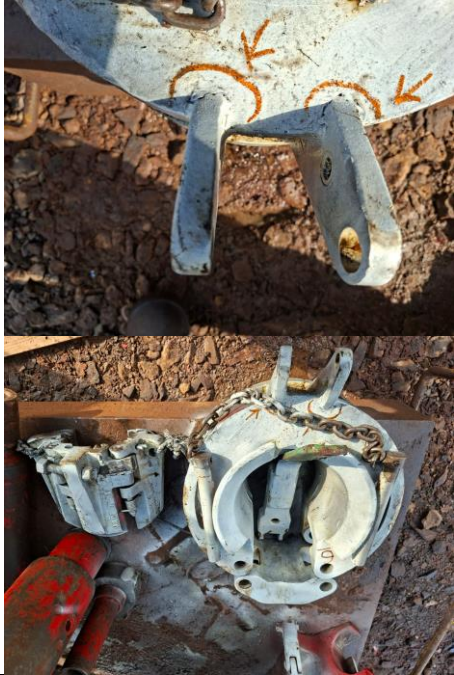
| 12. | Tubing Spider Slip 2 7/8" | | <b>Critical</b><br><br><b>Finding :</b> Crack 2 titik pada structure pad eyes;<br><b>MPI Result :</b> Discontinuity<br><b>Acceptance Criteria :</b><br>- API 7L Sect. 4.1.3<br><b>Total Progress : 100%</b><br><b>Recommendation:</b> Segera lakukan pergantian sesuai spesifikasi |
