# PT. PJ-TEK MANDIRI

TECHNICAL INSPECTION & CERTIFICATION

| Rig ID | : RIG BW H35KD | Hook Load | : 97,5 Ton Metric | |
| DAILY INSPECTION CAT III REPORT | | | | |

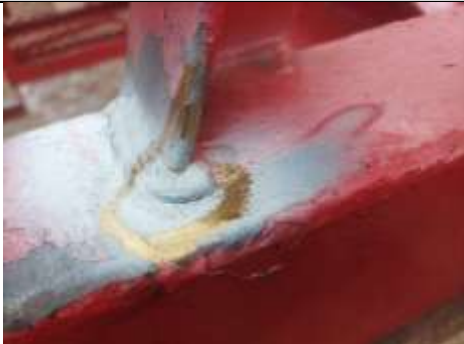
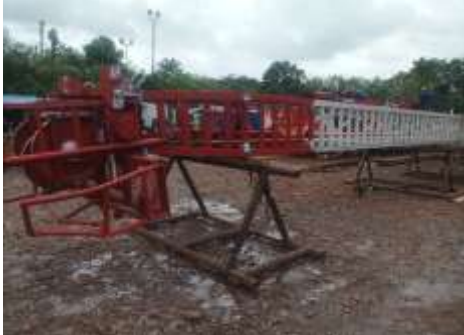
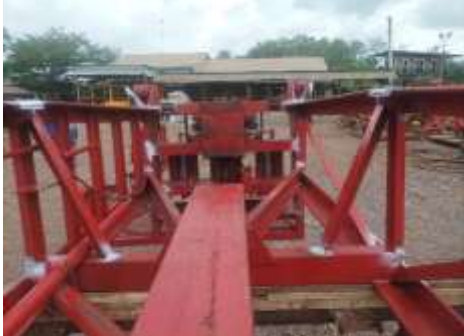
| 1. | Upper Mast | <br><br> | Critical | <b>Finding</b> : Ditemukan 1 spot crack pada lasan L Beam 2 " x 2 "<br><br><b>MPI Result</b> : Discontinuity<br><b>Acceptance Criteria</b> :<br>- API RP 4G Sect 6.2.3<br><b>Total Progress</b> : 100%<br><b>Recommendation</b> : Segera lakukan perbaikan sesuai standar dan prosedur. |

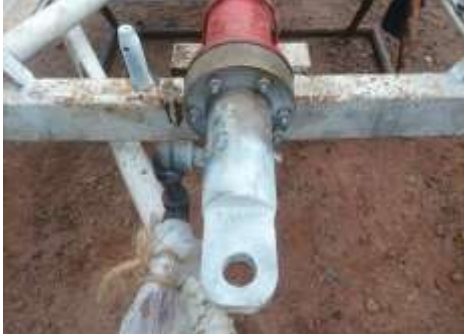
| 2. | Telescopic Mast | | N/A | <b>Finding</b> : N/A<br><b>MPI Result</b> : No Discontinuity<br><b>Acceptance Criteria</b> :<br>- API RP 4G Sect 6.2.3<br><b>Total Progress</b> : 100% |

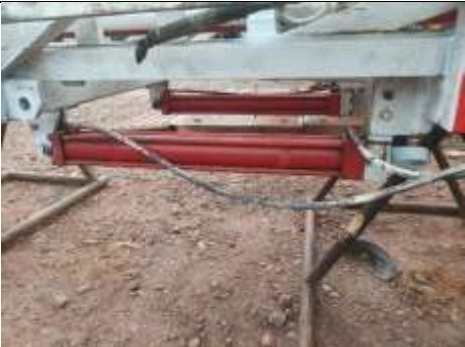
| 3. | Make Up Tong | | N/A | <b>Finding :</b> N/A<br><b>MPI Result :</b> No Discontinuity<br><b>Acceptance Criteria :</b><br>-API RP 4G Sect 6.2.3<br><b>Total Progress :</b> 100 |

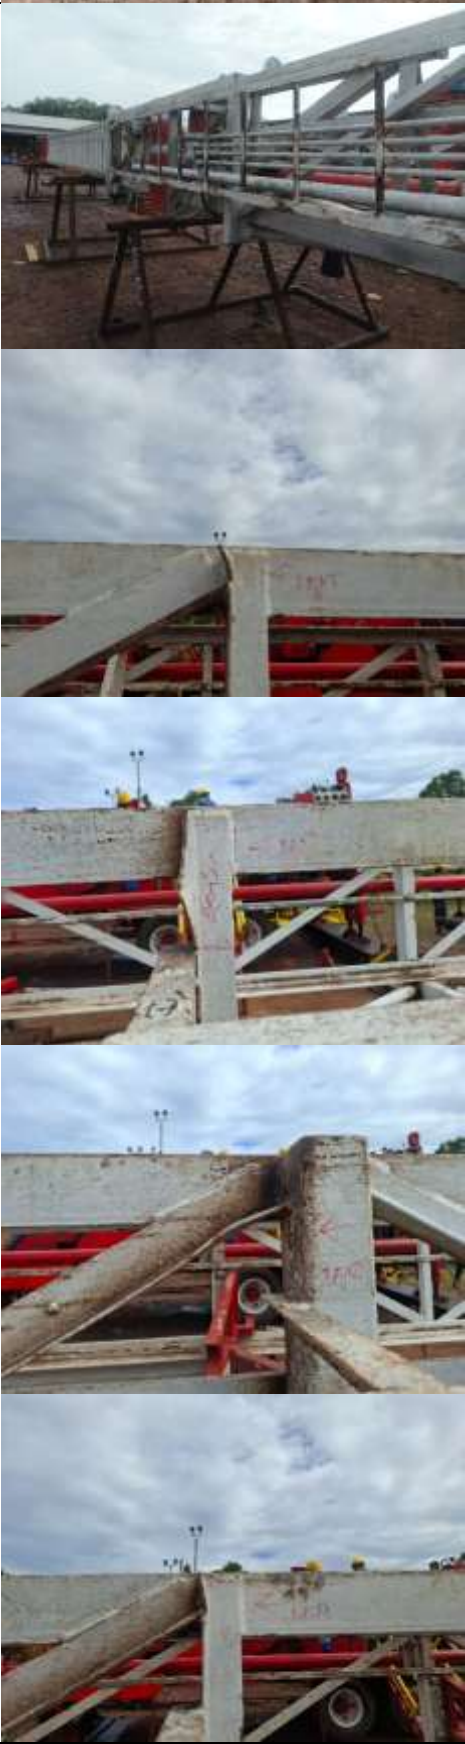
| 4. | Lower Mast | | Major | <b>Finding :</b> Bent 3 Spot Struktur L<br>Beam 2 "x 2"<br><b>MPI Result :</b> No Discontinuity<br><b>Acceptance Criteria :</b><br>-API RP 4G Sect 6.2.3<br><b>Total Progress :</b> 100%<br><b>Recommendation:</b> Segera lakukan perbaikan dengan mengacu standard dan prosedur |

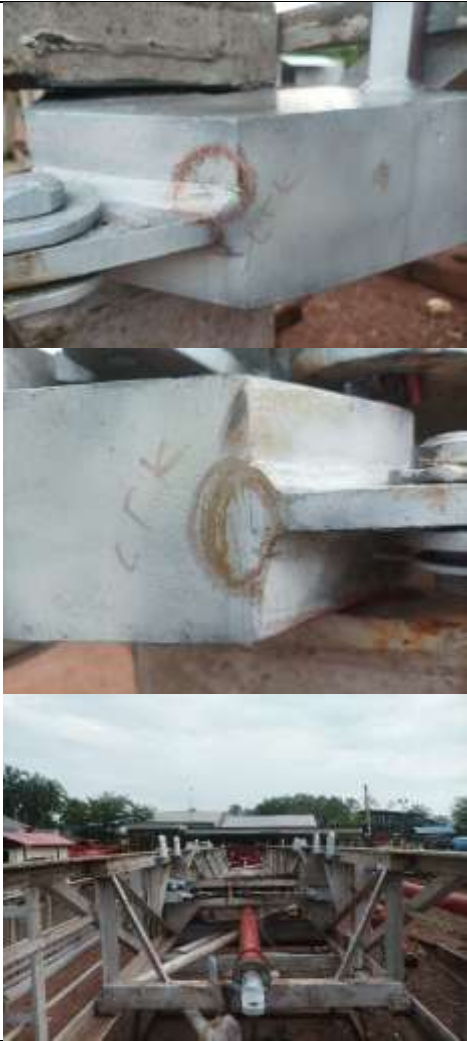
| 5. | Locking Pawl | | Critical | <p><b>Finding :</b> Ditemukan 2 spot crack lasan</p> <p><b>MPI Result :</b> Discontinuity</p> <p><b>Acceptance Criteria :</b></p> <ul style="list-style-type: none"><li>-API RP 4G Sect 6.2.3</li><li>-API RP 4G Sect 7.1</li></ul> <p><b>Total Progress : 100%</b></p> <p><b>Recommendation:</b> Segera lakukan perbaikan sesuai standard dan prosedur.</p> |

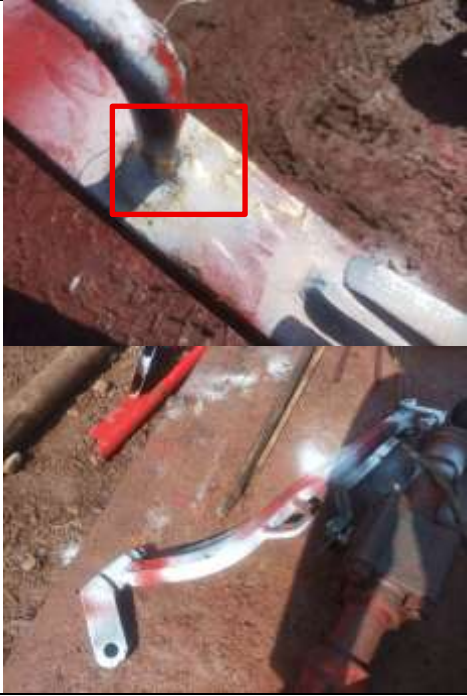
| 6. | Hanging Manual Tong | | Major | <p><b>Finding :</b> 1 Spot Crack</p> <p><b>MPI Result :</b> Discontinuity</p> <p><b>Acceptance Criteria :</b></p> <ul style="list-style-type: none"><li>-API RP 7L Sect 4.1.3</li></ul> <p><b>Total Progress : 100%</b></p> <p><b>Recommendation:</b> Segera lakukan perbaikan atau pergantian sesuai spesifikasi</p> |

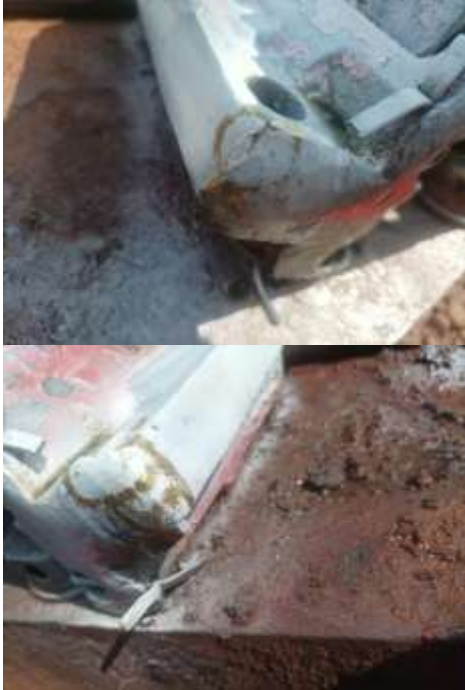
| 7. | Slip Spider 2 7/8" | | Critical | <p><b>Finding:</b> 2 Spot crack pada bodi slip</p> <p><b>MPI Result:</b> Discontinuity</p> <p><b>Acceptance Criteria:</b></p> <ul style="list-style-type: none"> <li>- API RP 7L Sect 4.1.3</li> </ul> <p><b>Total Progress:</b> 100%</p> <p><b>Recommendation:</b></p> <ul style="list-style-type: none"> <li>- Grinding surface crack dan MPI ulang</li> <li>- Segera lakukan pergantian sesuai spesifikasi.</li> </ul> |

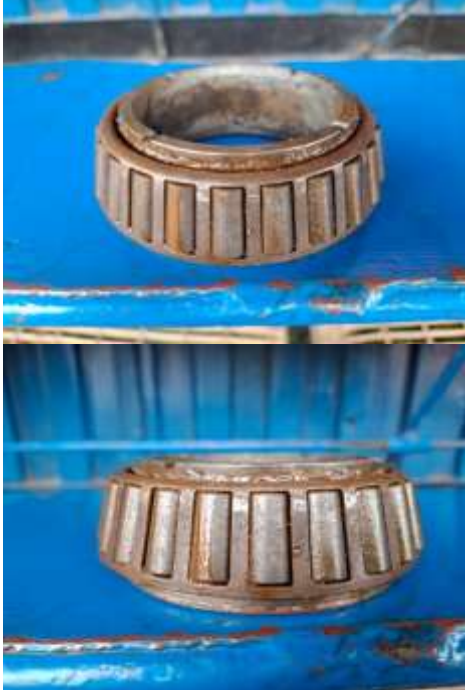
| 8. | Bearing Sheave Dead Line 2ea | | Critical | <p><b>Finding :</b></p> <ul style="list-style-type: none"> <li>- Ditemukan 2 Spot korosi pada Bearing Sheave</li> </ul> <p><b>MPI Result :</b> N/A</p> <p><b>Acceptance Criteria :</b></p> <ul style="list-style-type: none"> <li>- API RP 7L Sect 6.3</li> </ul> <p><b>Total Progress :</b> 100%</p> <p><b>Recommendation:</b> Segera lakukan pergantian sesuai spesifikasi</p> |

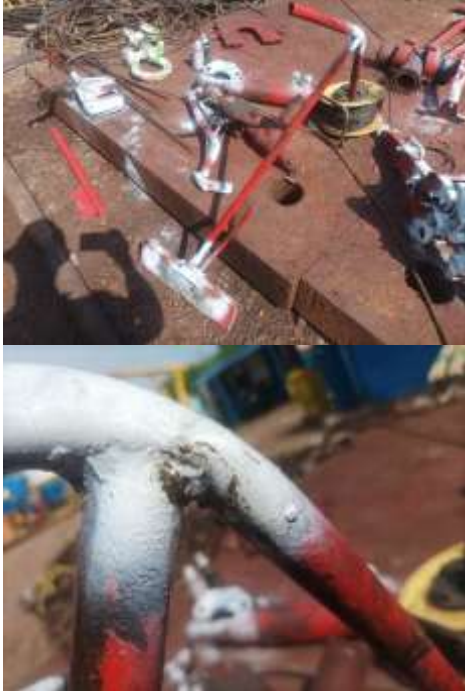
| | Escape Chair | | Critical | <p><b>Finding :</b></p> <ul style="list-style-type: none"> <li>- Ditemukan 1 Spot crack</li> </ul> <p><b>MPI Result :</b> N/A</p> <p><b>Acceptance Criteria :</b></p> <ul style="list-style-type: none"> <li>- API RP 54</li> </ul> <p><b>Total Progress :</b> 100%</p> <p><b>Recommendation:</b> Segera lakukan perbaikan sesuai standard dan prosedur.</p> |
