# PT. PJ-TEK MANDIRI

TECHNICAL INSPECTION & CERTIFICATION

| Rig ID | : RIG BW H35KD | Hook Load | : 97,5 Ton Metric | |
| DAILY INSPECTION CAT III REPORT | | | | |

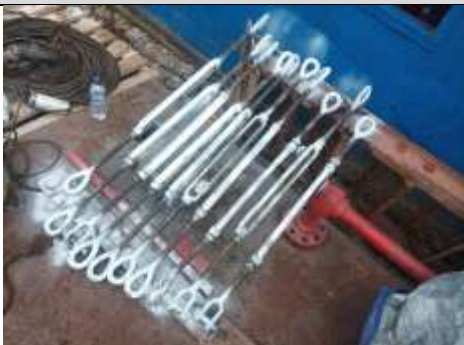
| 1. | Turnbuckle 10ea | | N/A | <b>Finding:</b> N/A<br><b>MPI Result :</b> No Discontinuity<br><b>Acceptance Criteria:</b><br>-ASME B30.26<br><b>Total Progress: 100%</b> |

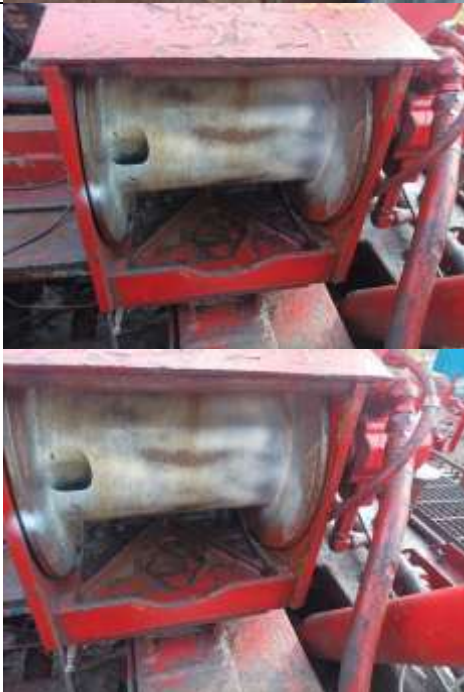
| 2. | Air Winch 2ea | | N/A | <b>Finding:</b> N/A<br><b>MPI Result :</b> No Discontinuity<br><b>Acceptance Criteria:</b><br>-API RP 7L Sect 4.1.3<br><b>Total Progress: 100%</b> |

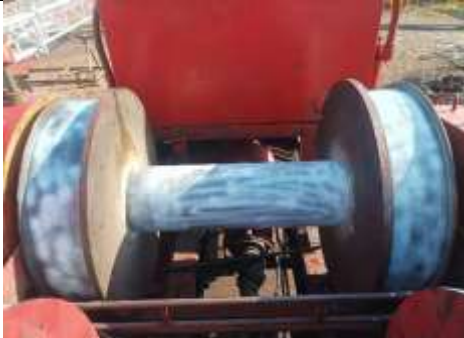
| 3. | Sand Line | | N/A | <b>Finding:</b> N/A<br><b>MPI Result :</b> No Discontinuity<br><b>Acceptance Criteria:</b><br>-API RP 7L Sect 4.1.3<br><b>Total Progress: 100%</b> |

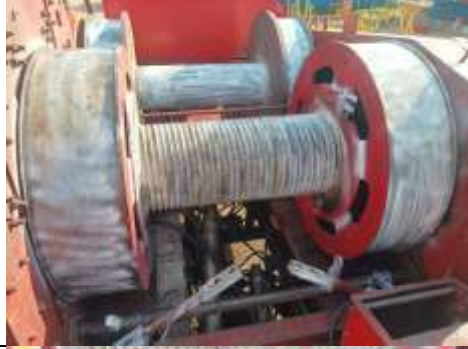
| 4. | Drawwork | | N/A | <b>Finding:</b> N/A<br><b>MPI Result :</b> No Discontinuity<br><b>Acceptance Criteria:</b><br>-API RP 7L Sect 4.1.3<br><b>Total Progress: 100%</b> |

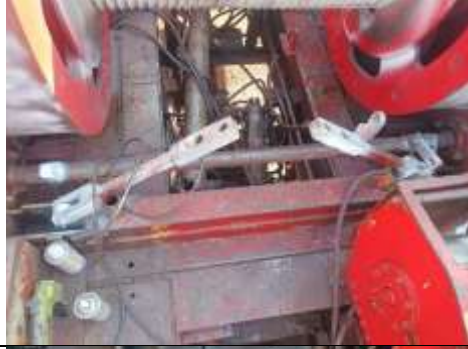
| 5. | Equalizer Drawwork | | N/A | <b>Finding:</b> N/A<br><b>MPI Result :</b> No Discontinuity<br><b>Acceptance Criteria:</b><br>-API RP 7L Sect 4.1.3<br><b>Total Progress: 100%</b> |

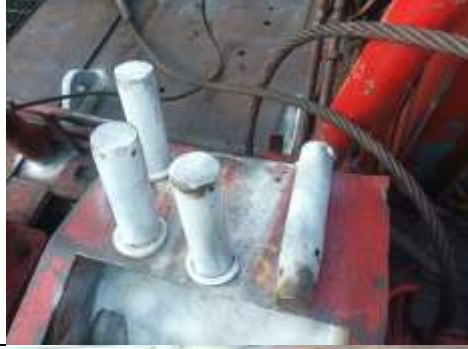
| 6. | Pin | | N/A | <b>Finding:</b> N/A<br><b>MPI Result :</b> No Discontinuity<br><b>Acceptance Criteria:</b><br>-API RP 4G Sect 6.2.3<br><b>Total Progress: 100%</b> |

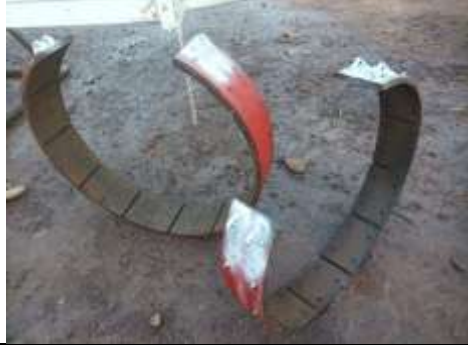
| 7. | Brake Band | | N/A | <b>Finding:</b> N/A<br><b>MPI Result :</b> No Discontinuity<br><b>Acceptance Criteria:</b><br>-API RP 7L Sect 4.1.3<br><b>Total Progress: 100%</b> |

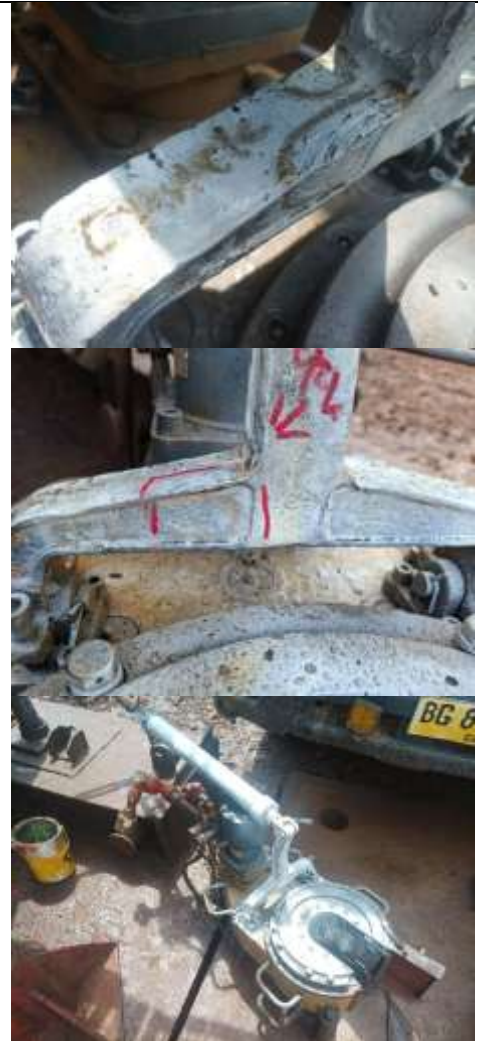
| 8. | Tubing Power Tong | | Major | <p><b>Finding:</b> Ditemukan 2 spot crack</p> <p><b>MPI Result:</b> Discontinuity</p> <p><b>Acceptance Criteria:</b><br/>-API RP 7L Sect 4.1.3</p> <p><b>Total Progress: 100%</b></p> <p><b>Recommendation:</b> Segera lakukan pergantian sesuai spesifikasi</p> |

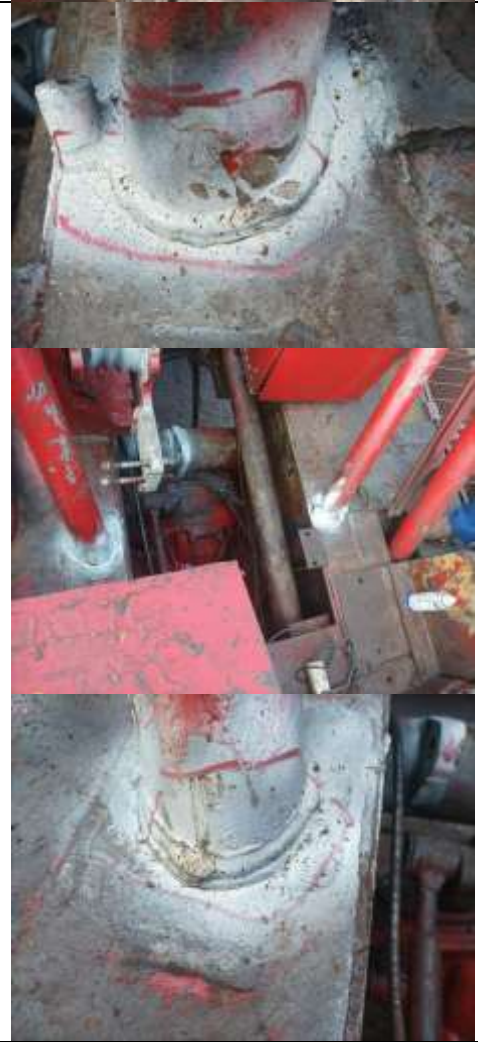
| 9. | Samson Post | | Critical | <p><b>Finding:</b> Ditemukan 2 spot crack pada lasan</p> <p><b>MPI Result :</b> Discontinuity</p> <p><b>Acceptance Criteria:</b><br/>-API RP 4G Sect 6.2.3</p> <p><b>Total Progress: 100%</b></p> <p><b>Recommendation:</b> Segera lakukan perbaikan dengan mengacu standard dan prosedur.</p> |

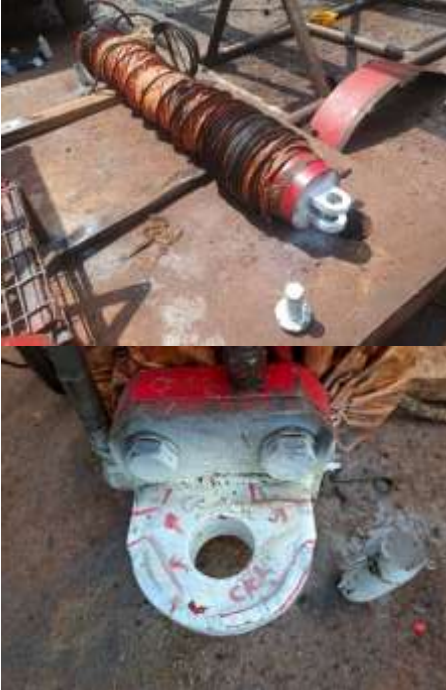
| 10. | Hydraulick Jack | | Critical | <p><b>Finding:</b> Ditemukan 4 spot crack pada pada eyes</p> <p><b>MPI Result :</b> Discontinuity</p> <p><b>Acceptance Criteria:</b><br/>-API RP 4G Sect 6.2.3</p> <p><b>Total Progress: 100%</b></p> <p><b>Recommendation:</b> Segera lakukan perbaikan dengan mengacu standard dan prosedur.</p> |

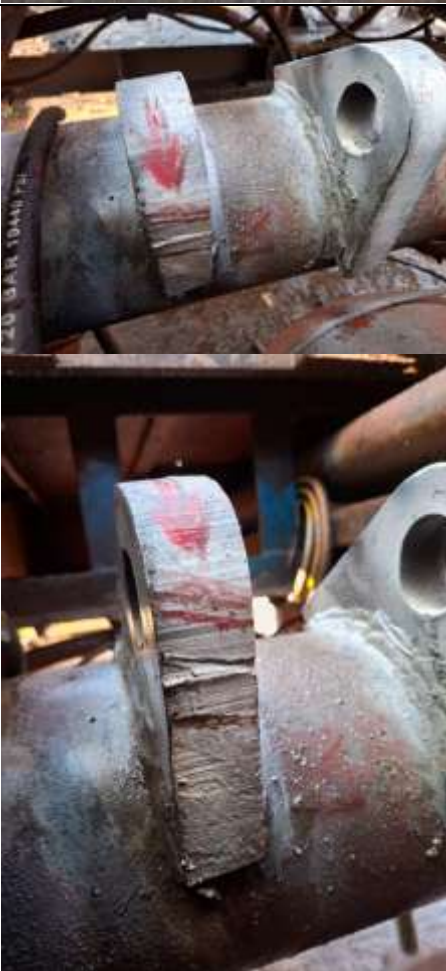
| 11. | Support Hydraulick Jack | | Critical | <p><b>Finding:</b> Ditemukan 1 spot crack pada pada eyes</p> <p><b>MPI Result :</b> Discontinuity</p> <p><b>Acceptance Criteria:</b><br/>-API RP 4G Sect 6.2.3</p> <p><b>Total Progress: 100%</b></p> <p><b>Recommendation:</b> Segera lakukan perbaikan dengan mengacu standard dan prosedur.</p> |

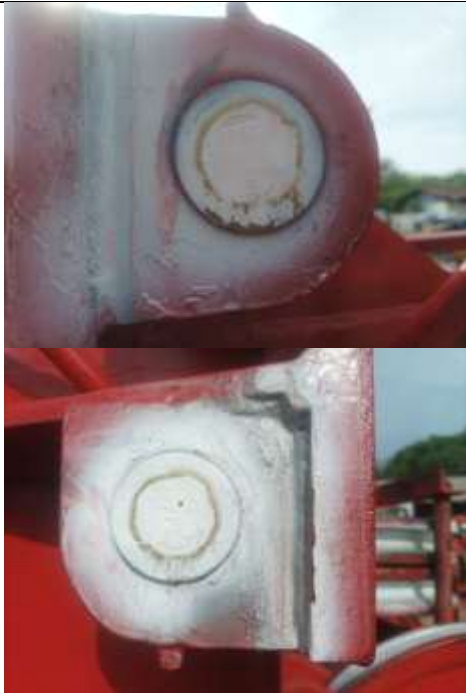
| 12. | Poley Sling Bordes | | Critical | <b>Finding:</b> Ditemukan 2 spot crack pada PIN<br><b>MPI Result :</b> Discontinuity<br><b>Acceptance Criteria:</b><br>-API RP 4G Sect 6.2.3<br><b>Total Progress: 100%</b><br><b>Recommendation:</b> Segera lakukan perbaikan dengan mengacu standard dan prosedur. |

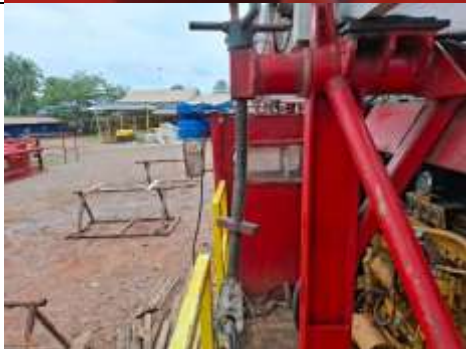
| 13. | Turnbuckle Rest Mast | | Major | <b>Finding:</b> 1 Spot Bent<br><b>MPI Result :</b> No Discontinuity<br><b>Acceptance Criteria:</b><br>-API RP 4G Sect 6.2.3<br><b>Total Progress: 100%</b><br><b>Recommendation:</b> Segera lakukan pergantian sesuai spesifikasi |
