# PT. PJ-TEK MANDIRI

TECHNICAL INSPECTION & CERTIFICATION

| Rig ID | : RIG BW H35KD | Hook Load | : 97,5 Ton Metric | |
| DAILY INSPECTION CAT III REPORT | | | | |

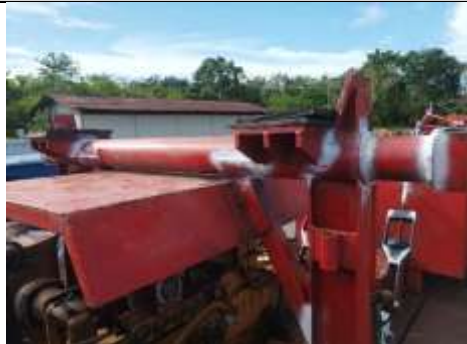
| 1. | Rest Mast | | N/A | <b>Finding</b> : N/A<br><b>MPI Result</b> : No Discontinuity<br><b>Acceptance Criteria</b> :<br>-API RP 4G Sect 6.2.3<br><b>Total Progress</b> : 100% |

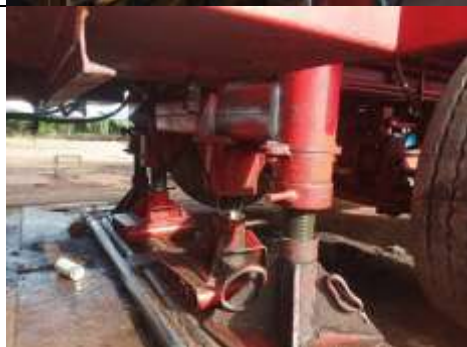
| 2. | Leveling Jack | | N/A | <b>Finding</b> : N/A<br><b>MPI Result</b> : No Discontinuity<br><b>Acceptance Criteria</b> :<br>-API RP 4G Sect 6.2.3<br><b>Total Progress</b> : 100% |

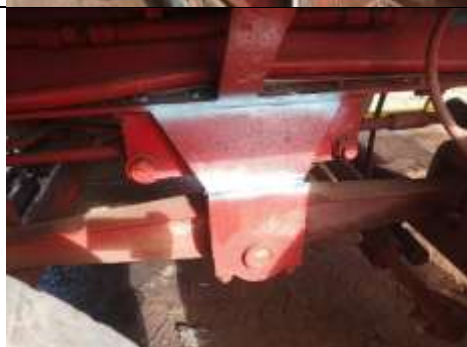
| 3. | Mounting Axle | | N/A | <b>Finding</b> : N/A<br><b>MPI Result</b> : No Discontinuity<br><b>Acceptance Criteria</b> :<br>-API RP 4G Sect 6.2.3<br><b>Total Progress</b> : 100 |

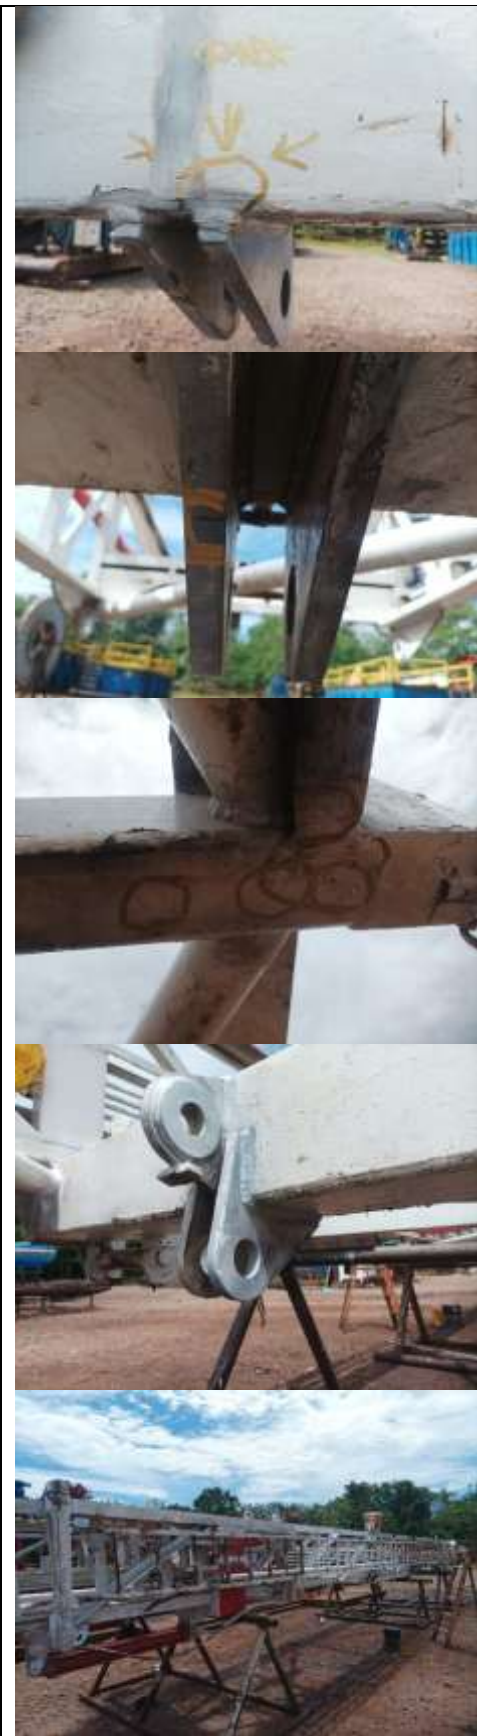
| <div>4.</div> | <div>Lower Mast</div> | | <div>Critical</div> | <div><b>Finding :</b> Ditemukan 3 spot crack area lasan dan pad eyes</div> <div><b>MPI Result :</b> Discontinuity</div> <div><b>Acceptance Criteria :</b></div> <div><div>- API RP 4G Sect 6.2.3</div><div>- API RP 4G Sect 7.1</div><div>- Table 3</div></div> <div><b>Total Progress :</b> 100%</div> <div><b>Recommendation:</b> Segera lakukan perbaikan dengan mengacu standard dan prosedur yang berlaku.</div> |

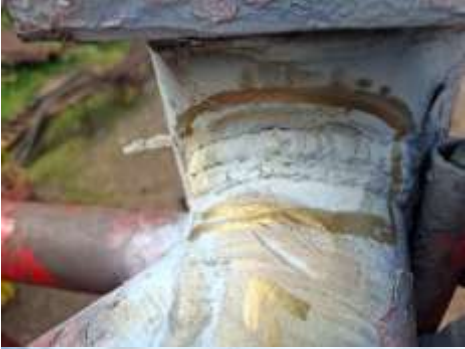
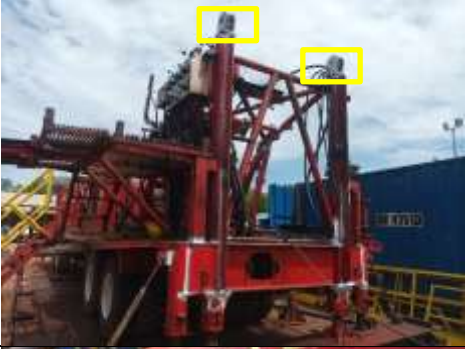
| 5. | Base Mast | | <p><b>Critical</b></p> <p><b>Finding :</b> Ditemukan 2 spot crack pada lasan</p> <p><b>MPI Result :</b> Discontinuity</p> <p><b>Acceptance Criteria :</b></p> <ul style="list-style-type: none"> <li>-API RP 4G Sect 6.2.3</li> <li>-API RP 4G Sect 7.1</li> <li>-Table 3</li> </ul> <p><b>Total Progress : 100%</b></p> <p><b>Recommendation:</b> Segera lakukan perbaikan sesuai standard dan prosedur yang berlaku.</p> |

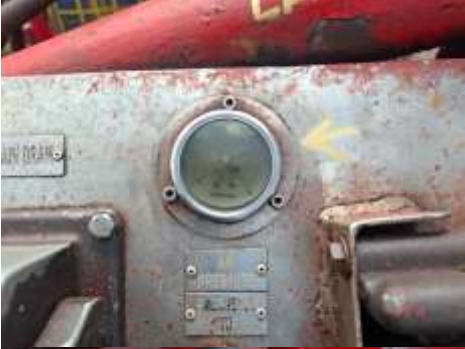
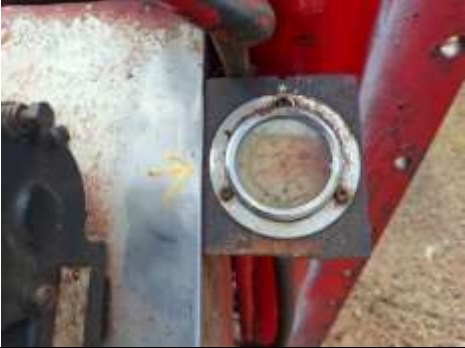
| 6. | Drilling Console | | <p><b>Major</b></p> <p><b>Finding :</b> Ditemukan kerusakan pressure gauge 2ea</p> <p><b>MPI Result :</b> N/A</p> <p><b>Acceptance Criteria :</b></p> <ul style="list-style-type: none"> <li>-API RP 54 Sect 7.11.4</li> </ul> <p><b>Total Progress : 100%</b></p> <p><b>Recommendation:</b> Segera lakukan pergantian sesuai spesifikasi.</p> |
