# Bearing damage and failure analysis

**SKF®**

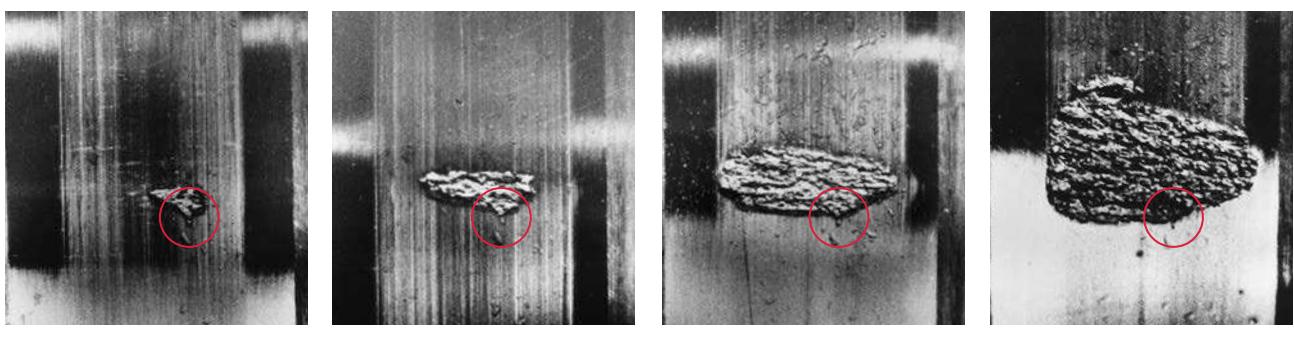
Fig. 1

A hard contaminant was over-rolled and made an indentation in the inner ring raceway of a cylindrical roller bearing (a). The surface initiated fatigue resulting in a spall started just behind the indentation. Over a period of time, spalling became more and more pronounced (b, c). If the machine was not stopped in time, secondary damage to machine components could have occurred. The initial indentation is no longer recognizable (d).

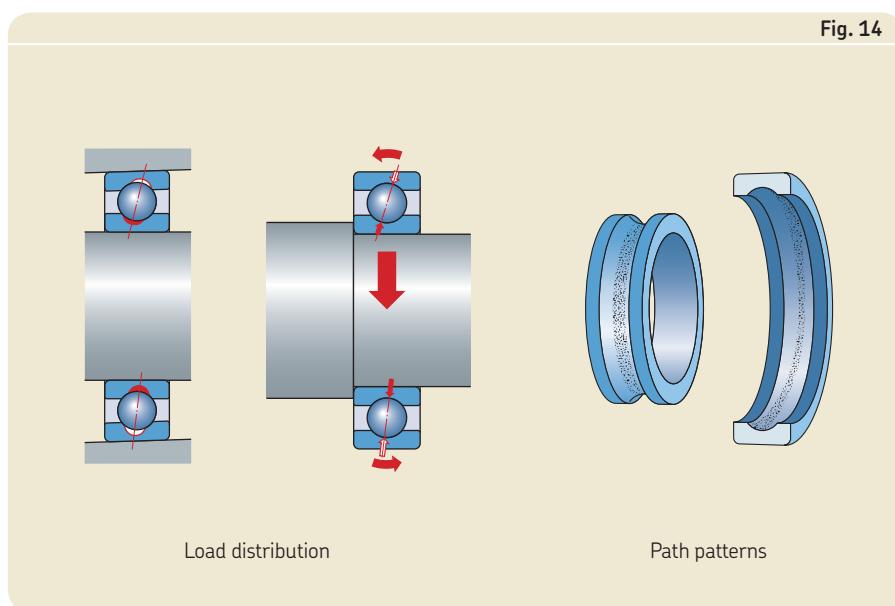
Fig. 14

**Fig. 14** illustrates how an applied unidirectional and constant radial load acting on the rotating inner ring of a bearing is distributed to the stationary and misaligned outer ring by the rolling elements.

This condition can occur when the bearing seats are misaligned, abutment faces not perpendicular or the shaft deflects beyond normal limits.

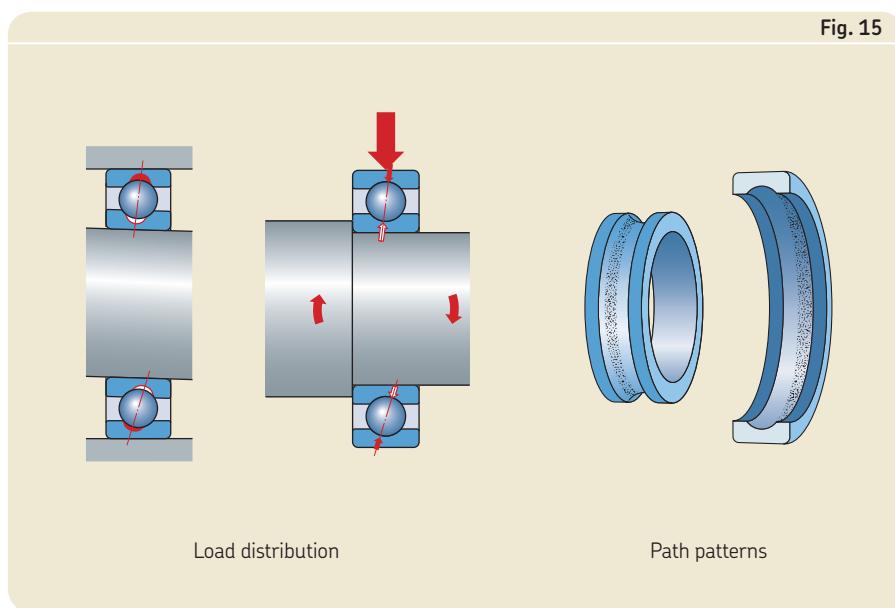
Fig. 15

**Fig. 15** illustrates how an applied unidirectional and constant radial load acting on the rotating outer ring of a bearing is distributed to the stationary and misaligned inner ring by the rolling elements.

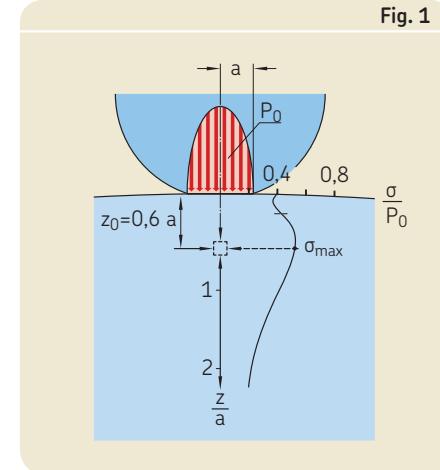
**Fig. 1**  
Compressive and shear stresses beneath the raceway

Consider the rotating inner ring of a radial bearing with a radial load acting on it. As the ring rotates, one particular point on the raceway enters the load zone and continues through an area to reach a maximum load (stress) before it exits the load zone. During each revolution, as that one point on the raceway enters and exits the load zone, compressive and shear stresses occur (→ fig. 1).

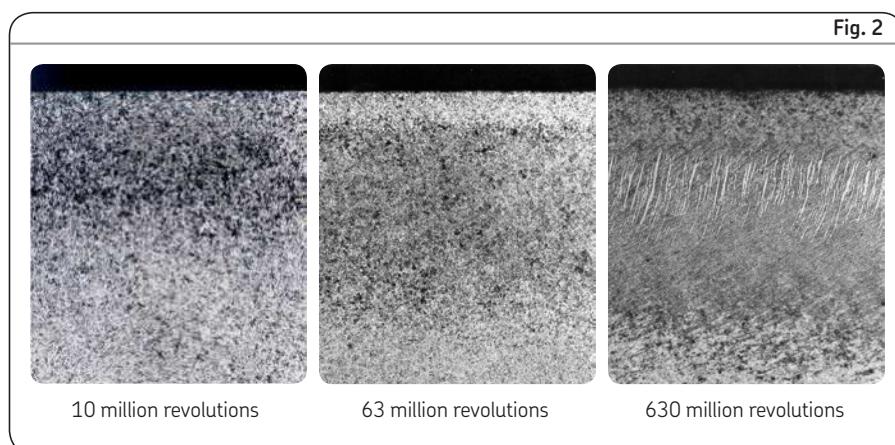
Depending on the load, temperature and the number of stress cycles over a period of time, there is a build-up of residual stresses that cause the material to change from a randomly oriented grain structure to fracture planes.

*Changes in structure beneath the raceway surface over time (highly stressed, well lubricated small deep groove ball bearing)*

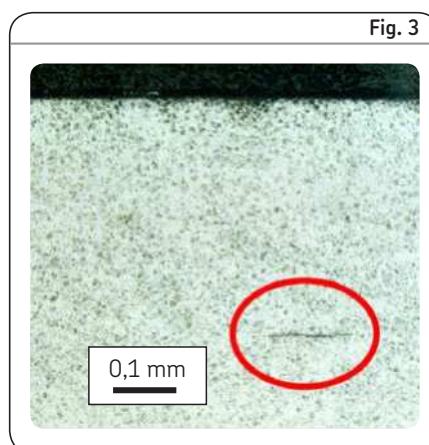
In these planes, so-called subsurface microcracks develop beneath the surface at the weakest location, around the zone of maximum shear stress, typically at a depth of 0,1 to 0,5 mm (→ figs. 2 and 3). The depth depends on the load, material, cleanliness, temperature and the microstructure of the steel. The crack finally propagates to the surface and spalling occurs (→ fig. 4).

*Crack development beneath the raceway surface (~ 0,3 mm)*

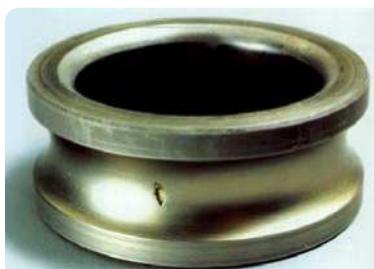
Fig. 4

The bearing is damaged as soon as spalling occurs. This does not mean that the bearing cannot remain in service. Spalling gradually increases and gives rise to noise and vibration levels in the machine. The machine should be stopped and repaired before the bearing collapses.

*Initial subsurface spalling on the inner ring of a deep groove ball bearing*

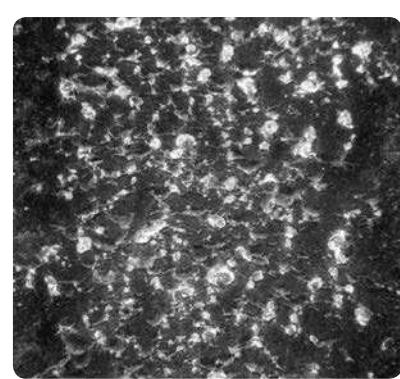
Fig. 8

Generally, these microspalls are only a few microns in size and the surface just looks dull and grey (→ fig. 7). Only under a micro-

*Microspalls and cracks on the raceway surface (high magnification)*

scope can cracks and spalls be detected (→ fig. 8).

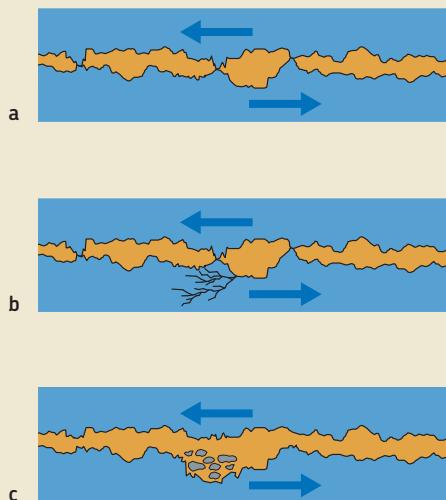
Fig. 6

Surface initiated fatigue, in general, is the consequence of surface asperities coming in direct contact under mixed or boundary lubrication conditions (→ fig. 6a). When the loading and the frictional forces reach a given magnitude, small cracks form on the surface (→ fig. 6b). These cracks may then develop into microspalls (→ fig. 6c).

### Mechanism of surface initiated fatigue

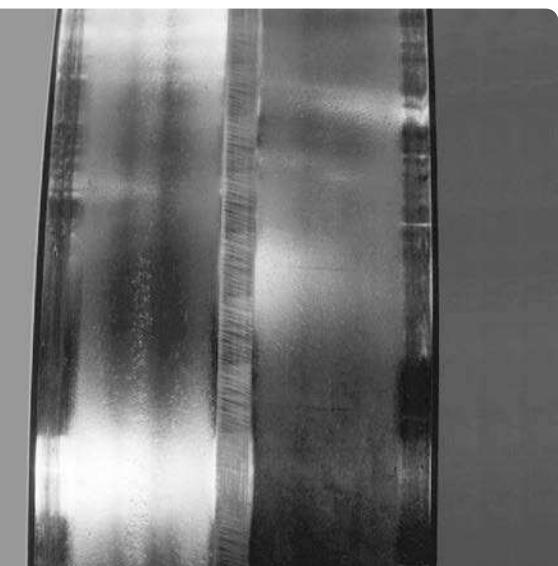
Fig. 7

### Microspalls on the inner ring raceways of a spherical roller bearing

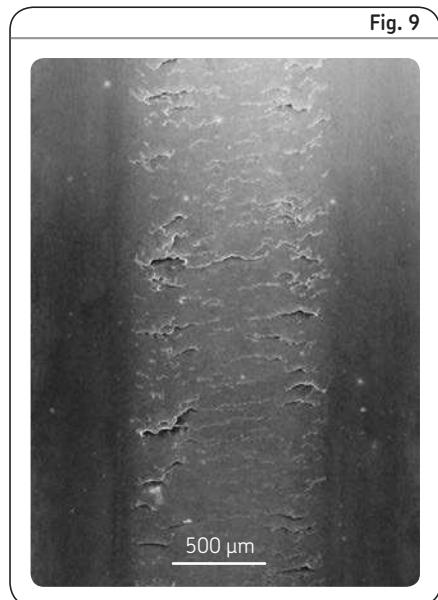
Fig. 9

**Fig. 9** shows the start of spalling following surface initiated fatigue due to inadequate lubrication.

*Initial spalling resulting from surface initiated fatigue on the inner ring raceway of a deep groove ball bearing*

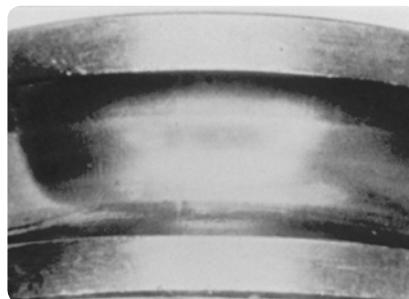
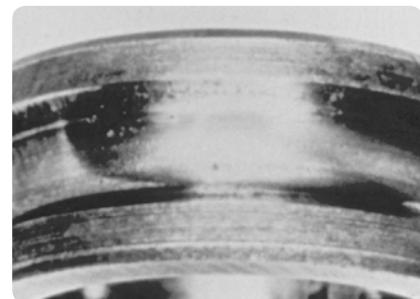
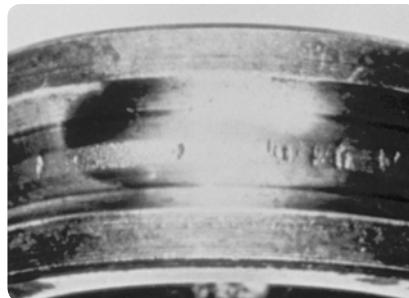
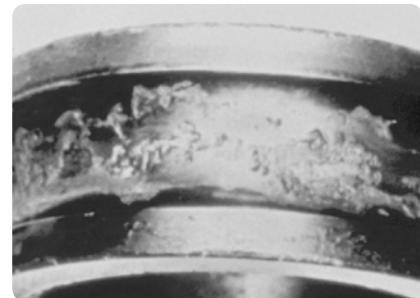
Fig. 10

**Fig. 10** shows the progression of surface initiated fatigue into overall spalling.

*Progress of surface initiated fatigue on the inner ring of a deep groove ball bearing*

1 Fine roughening or waviness

2 Small cracks

3 Local spalling

4 Spalling over the entire surface

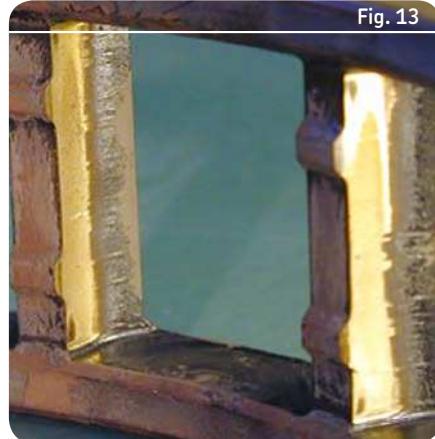
The cage is a critical part of the bearing. Rings and rolling elements are hardened to approximately 60 HRC. Most metal cages are unhardened (sheet metal or brass). Under poor lubrication conditions, the cage may be the first component to wear. **Fig. 13** shows pocket wear in a solid brass cage.

*Abrasive wear on the cage bars of a cylindrical roller bearing*

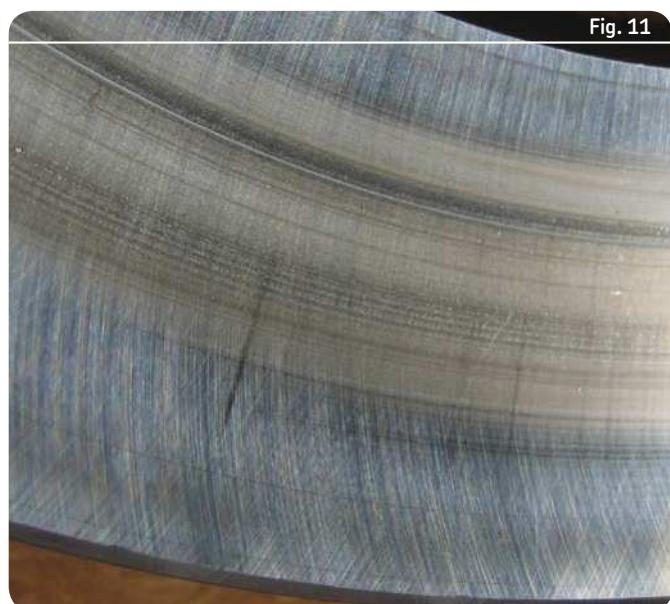
*Light abrasive wear on the outer ring of a spherical roller thrust bearing*

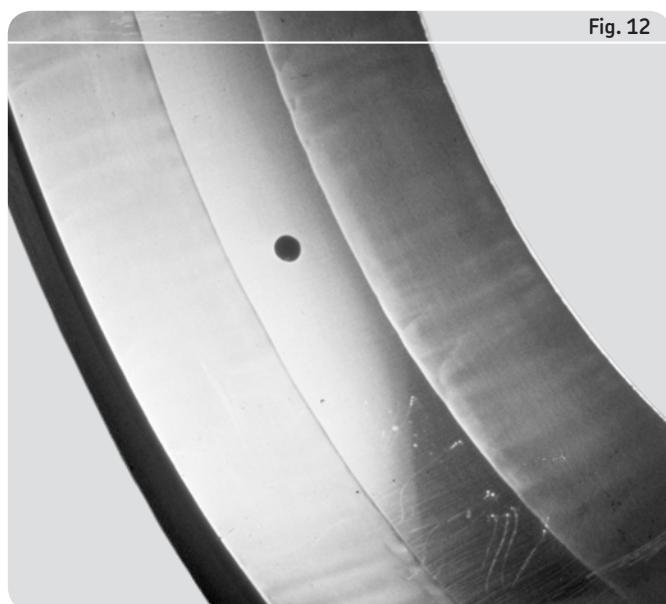
*Advanced abrasive wear on the outer ring of a spherical roller bearing (dull and matt raceways)*

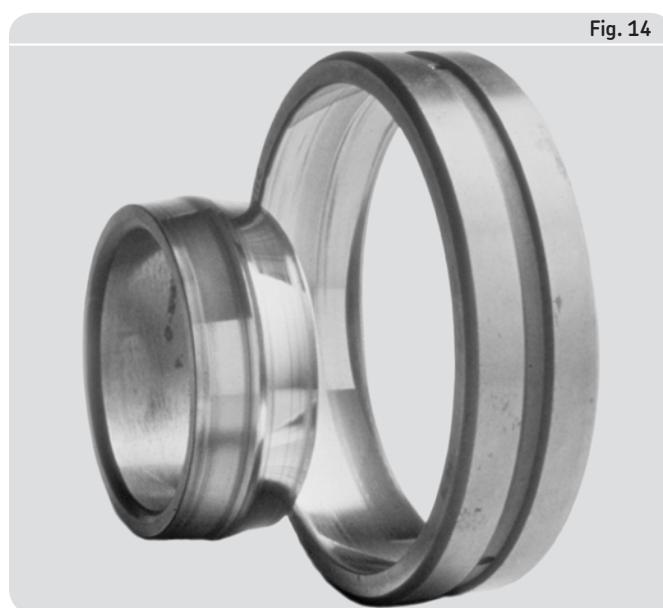
Fig. 14

*Polishing wear (mirror-like raceway surfaces) on the inner and outer rings of a spherical roller bearing*

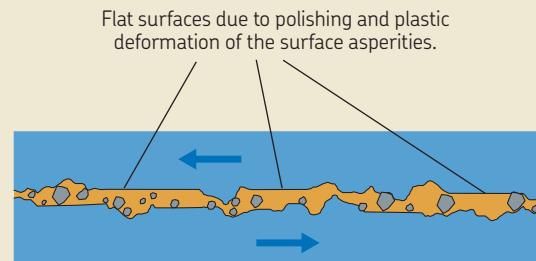
Fig. 15

*Process of polishing wear in a bearing*

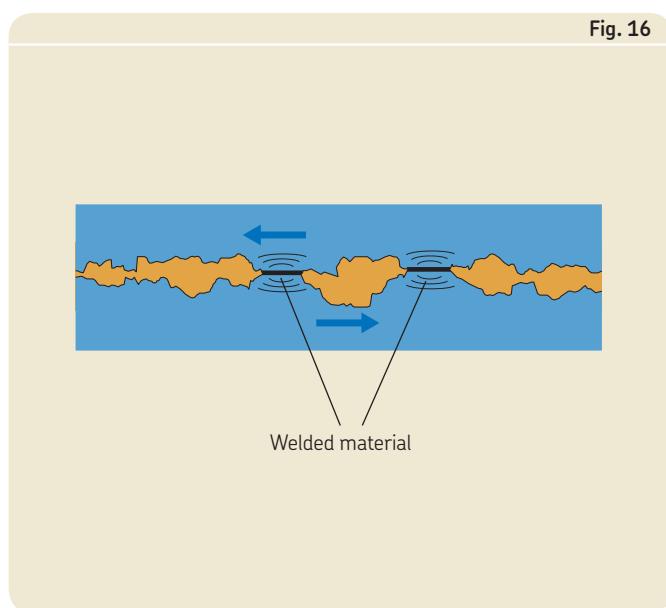
Adhesive wear is a type of lubricant-related damage that occurs between two mating surfaces sliding relative to each other (→ fig. 16).

Principle of adhesive wear

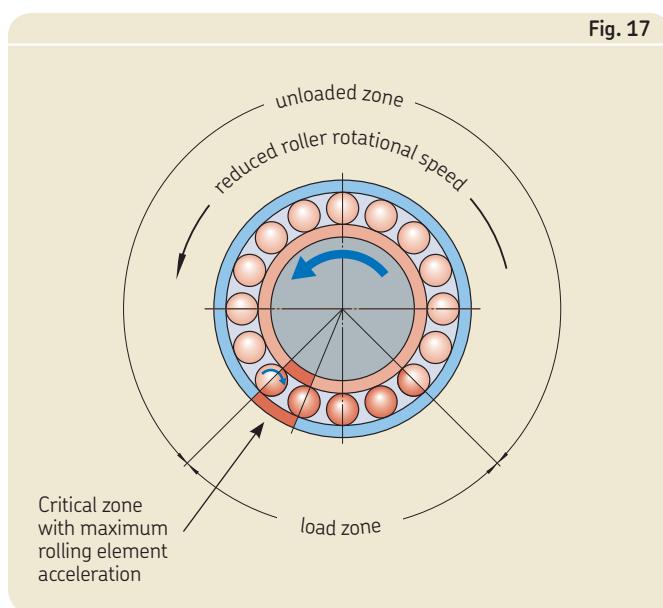
The rolling elements are therefore subjected to rapid (sudden) acceleration when they enter the load zone (→ fig. 17). This sudden acceleration can cause sliding, which can generate enough heat, so that the two surfaces melt together at the points of metal-to-metal contact (→ fig. 16). This welding process causes material to be transferred from one surface to the other, which also leads to higher friction (→ fig. 18).

Highest risk for adhesive wear when rolling elements accelerate as they enter the load zone

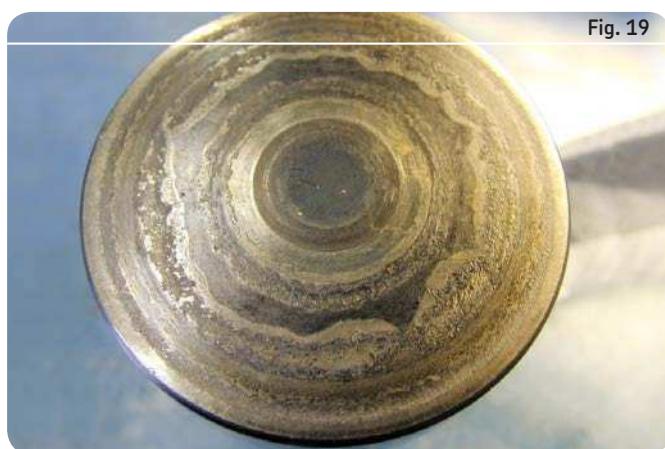
Fig. 19

Smearing can also occur between the cage and its contact surface and between the roller ends and guide flanges. **Fig. 19** shows a roller from a spherical roller thrust bearing that was riding against the guide flange. The roller end has smearing damage caused by inadequate lubrication.

*Smearing on a roller thrust face of a spherical roller thrust bearing*

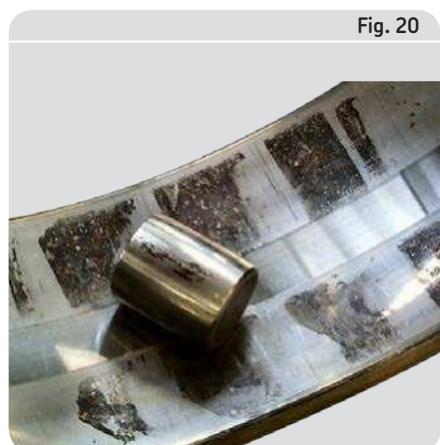
Fig. 20

Corrosion is perhaps the most common cause of premature bearing failure in paper machines and process equipment in the food and beverage industries. Bearings in these machines are exposed to the ingress of water and other liquids as part of the operational process. Water can also be introduced during washdowns while the machine is being cleaned at standstill, resulting in greyish-black patches coinciding with the rolling element pitch (**→ fig. 20**).

**Corrosion on the outer ring and roller of a spherical roller bearing**

Etching usually leads to premature, extended spalling as the material is subjected to a structural change and the surfaces in the load zone are reduced to such an extent that overloading occurs. The best way to avoid corrosion is to keep the lubricant free from water and aggressive liquids by adequately sealing the application. Using a lubricant with good rust-inhibiting properties also helps.

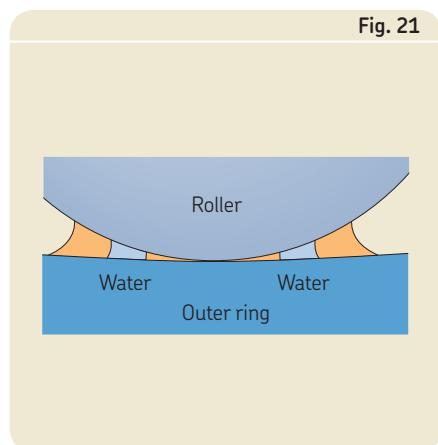
Fig. 21

At standstill, free water in the lubricant will accumulate at the bottom of the bearing. The water concentration will be highest at a certain distance from the rolling contact (**→ fig. 21**). The reason is that the free water is heavier than the oil and will sink until it comes to a suitable gap between the rolling element and the raceway. This can lead to deep-seated corrosion, called etching (**→ fig. 22**). Etching is even more likely to occur in applications where there are aggressive chemicals and high temperatures, like the dryer section of a paper machine.

**Free water in the lubricant accumulates at the bottom of the bearing**

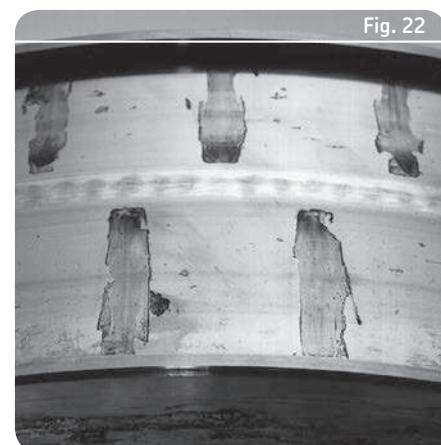
Fig. 22

**Initial patches of etching at rolling element pitch on the inner ring raceways of a spherical roller bearing**

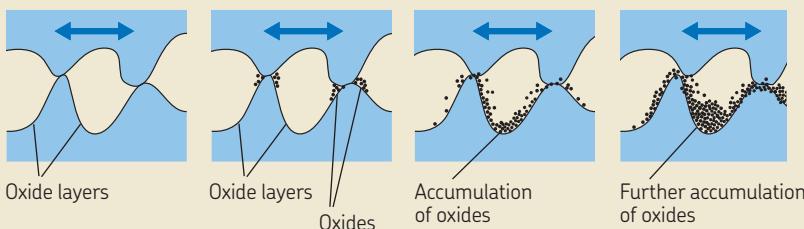
Fig. 23

*Schematic view of different stages in development of fretting corrosion*

The relative movement may cause small particles of material to become detached from the bearing surface and its seat. These particles oxidize quickly when exposed to air and the result is iron oxide (→ fig. 23). Iron oxide is larger in volume than iron (steel). As a result of the fretting corrosion, the bearing rings may not be evenly supported, which can have a detrimental effect on the load distribution in the bearing.

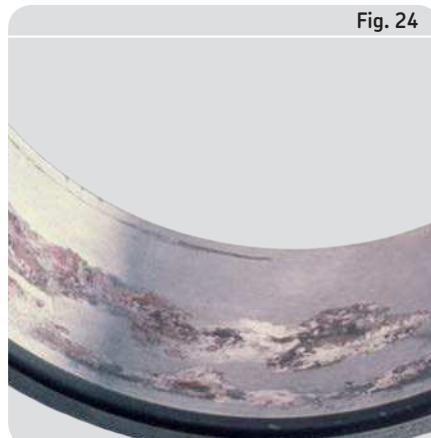
Fig. 24

**Fig. 24** shows fretting corrosion resulting from a shaft surface that was not properly machined or from shaft bending (due to a cantilever load or an overhung load).

*Fretting corrosion on an inner ring bore resulting from an inadequate shaft seat or shaft bending*

To avoid fretting corrosion or to slow the process, either the tolerances (fit) should be adjusted, or a special anti-fretting paste or coating should be applied.

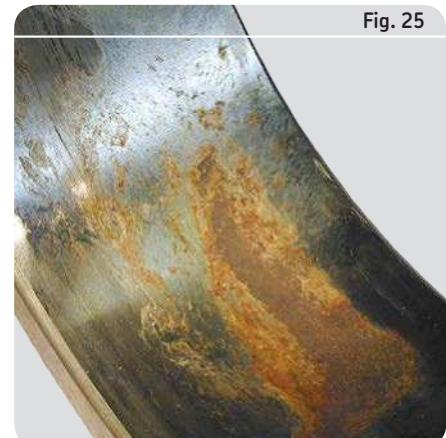
Fig. 25

**Fig. 25** shows fretting corrosion from very heavy loading or an inadequate seat.

*Fretting corrosion on an inner ring bore resulting from heavy load or inadequate shaft seat*

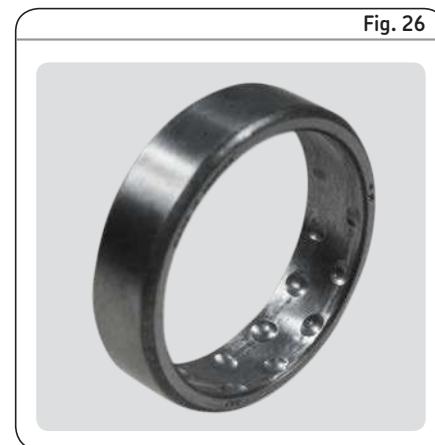
**Fig. 26** shows severe false brinelling damage caused to the outer ring of a self-aligning ball bearing at standstill.

*Severe false brinelling on the outer ring raceway of a self-aligning ball bearing*

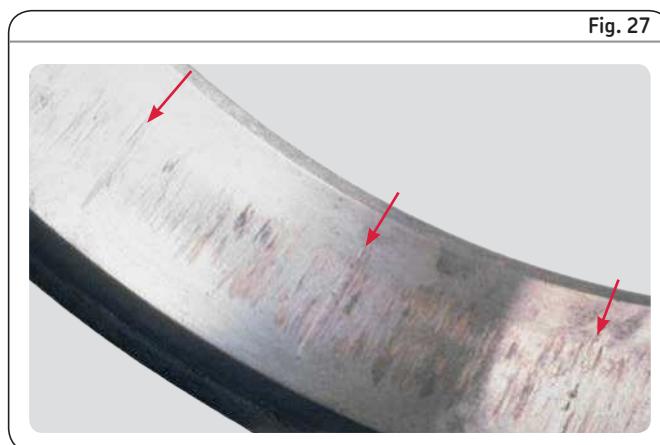
**Fig. 27** shows false brinelling damage on the outer ring of a cylindrical roller bearing. The root cause is vibration during standstill. The bearing was mounted in auxiliary equipment, with long standstill periods. Several sets of “flutes” can be observed at roller pitch, each set resulting from a period of standstill. The magnitude of damage depends on the level of vibration, frequency of vibration, and length of standstill.

*False brinelling (“flutes”) on the outer ring raceway of a cylindrical roller bearing*

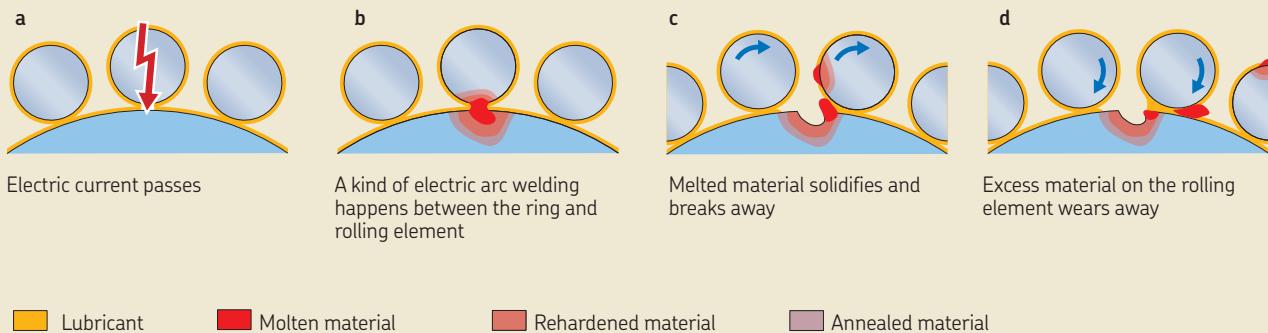
Fig. 28

### Mechanism of excessive current erosion

When an electric current (→ fig. 28) passes from one ring to the other via the rolling elements, damage will occur (a). At the contact surfaces, the process is similar to electric arc welding (high current density over a small contact surface, b). The material is heated to temperatures ranging from tempering to melting levels. This leads to the appearance of discoloured areas, varying in size, where the material has been tempered, rehardened or melted. Craters also form where the material has melted and consequently broken away due to the rotation of

the rolling element (c). The excess material on the rolling element wears away (d). Appearance: Craters in raceways and rolling elements. Sometimes zigzag burns can be seen in ball bearing raceways. Local burns are visible on the raceways and rolling elements.

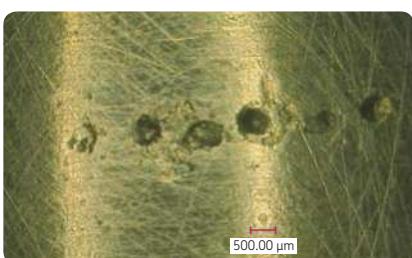
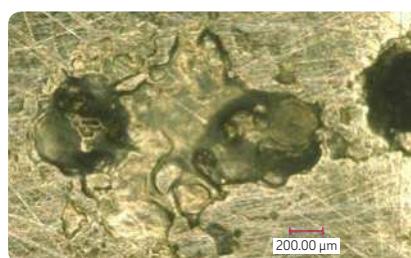
Fig. 29

**Fig. 29** shows an example of a spherical roller bearing subjected to an excessive electrical current. A number of rather large craters can be seen on the roller. A magnification clearly shows the craters with the molten material around their edges.

### Excessive current erosion on the roller of a spherical roller bearing

Craters of 0,5 mm in size

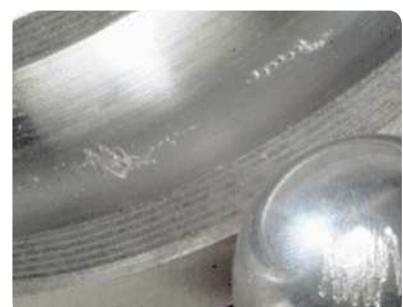
Fig. 30

**Fig. 30** shows damage caused by excessive electrical current in a deep groove ball bearing, both on the outer ring raceway and ball. Notice the zigzag burns.

### Excessive current erosion on the outer ring raceway and ball of a deep groove ball bearing

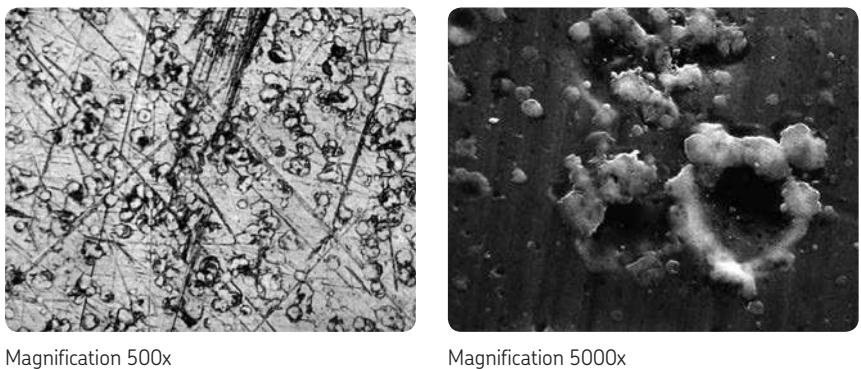
**Fig. 31**

In the initial stage of current leakage erosion damage, the surface is typically damaged by shallow craters that are closely positioned to one another and smaller in diameter compared to the damage from excessive current. This happens even if the intensity of the current is comparatively low. The craters are shown in **fig. 31** at 500x magnification and 5000x magnification.

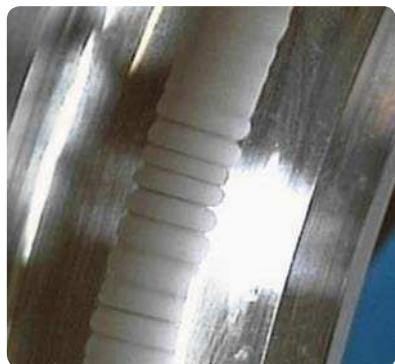
A washboard pattern may develop from craters over time. The pattern appears on the raceways ( $\rightarrow$  **figs. 32** and **34**). For roller bearings, the washboard pattern also appears on the rollers ( $\rightarrow$  **fig. 34**). In ball bearings, the balls typically become discoloured (dull, light to dark grey) over their entire surface.

*Craters from current leakage erosion***Washboarding caused by current leakage erosion****Fig. 32**

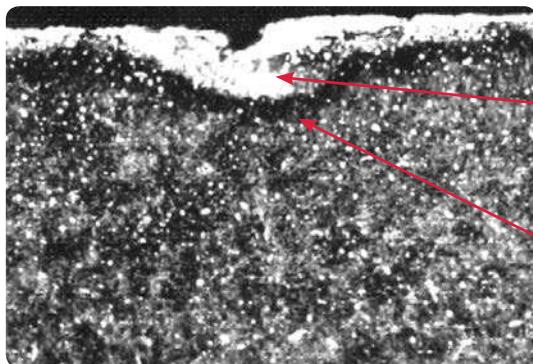
A cross section of a bearing is shown in **fig. 33** at 500x magnification. The white area shows that the metal has been rehardened, typically 66 to 68 HRC. This material is very hard and brittle. Below the rehardened area is a black layer, annealed by the heat, which is softer (56 to 57 HRC) than the surrounding bearing material.

**Changes in material hardness resulting from current leakage****Fig. 33**

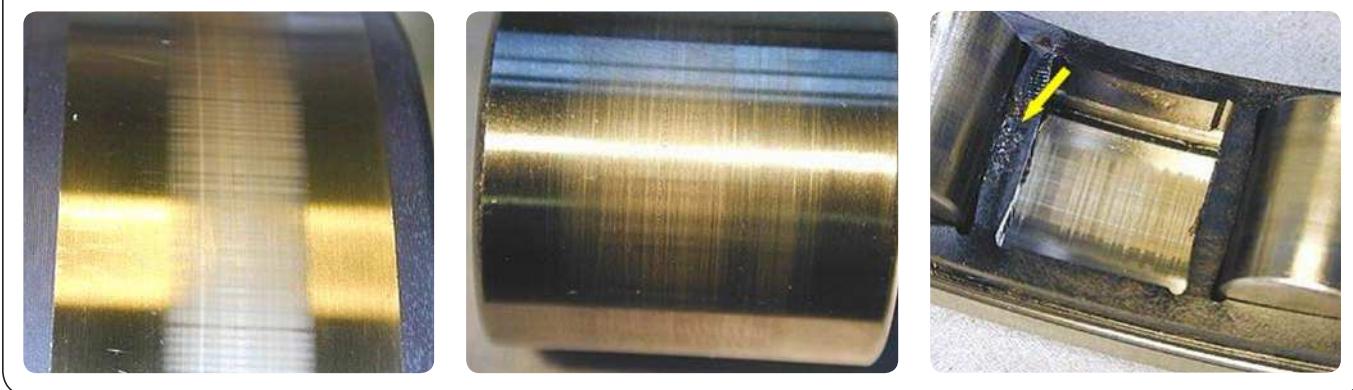
**Fig. 34** shows damage to a cylindrical roller bearing due to current leakage. Washboarding is developing on the raceways and rollers. Notice the grease on the cage pockets. At the start of this failure mode, the grease is gradually carbonized and loses its ability to form a lubricant film. This eventually leads to surface initiated fatigue, spalling and even sudden seizure.

*Washboarding on inner and outer rings and roller raceways*

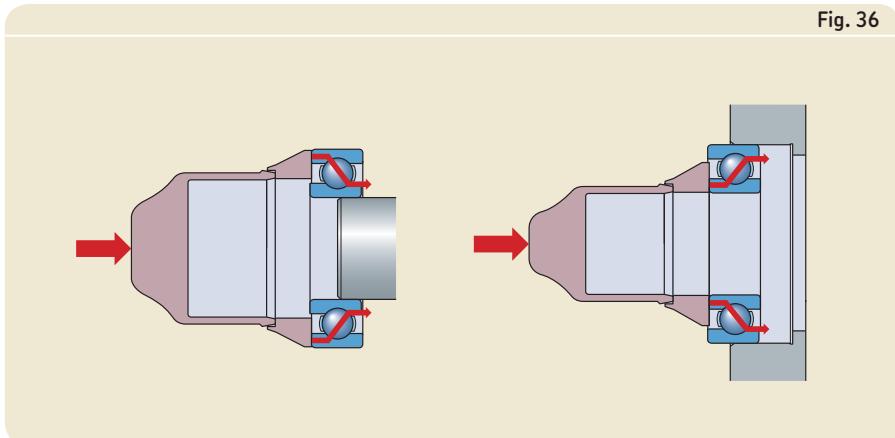
Raceways and rolling elements may become dented if the mounting force is applied through the rolling elements (**→ fig. 36**), or if the bearing is subjected to abnormal loading while stationary. The distance between the indentations is at rolling element pitch (**→ fig. 37**).

*Overload deformation resulting from an incorrect mounting method*

The solution: always use the correct mounting tools and methods ( $\rightarrow$  fig. 38).

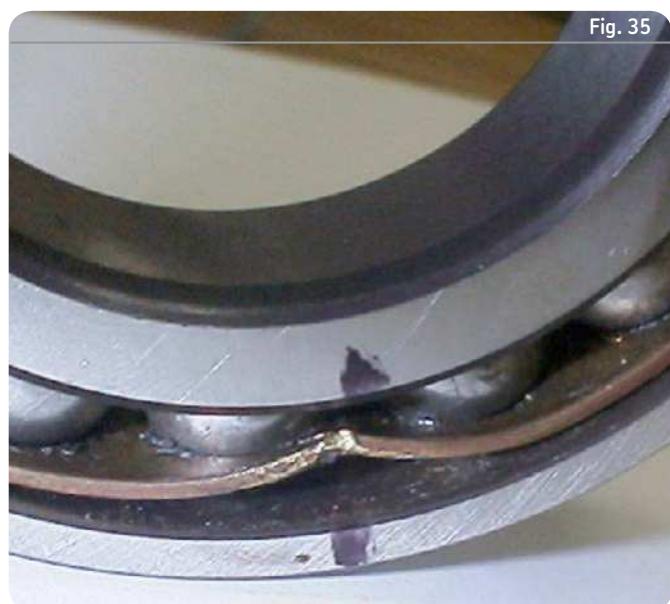
**Fig. 35** shows a case where a cage was hit directly, causing it to deform. If this bearing were put into operation, high noise and vibration levels would result.

*Plastic deformation on the cage of an angular contact ball bearing resulting from poor handling*

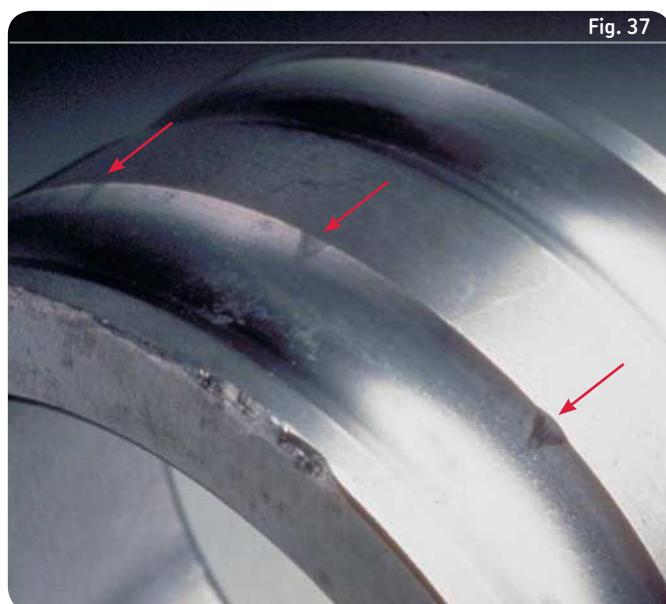
*Indentations at ball pitch on the raceway of a double row angular contact ball bearing resulting from incorrect mounting*

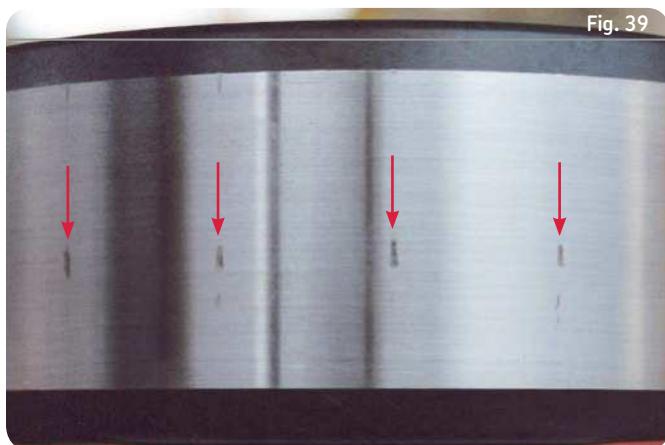
Handling is critical during manufacturing, transport, storage and mounting. Poor handling is characterized by local overloading and visible "nicks" caused by hard and/or sharp objects. Fig. 39 shows an example of poor assembly of a cylindrical roller bearing in the mounting stage. The rollers have made nicks on the inner ring raceway at roller pitch. If put into service, high noise and vibration levels will result.

*Inner ring of a cylindrical roller bearing with nicks that occurred during mounting*

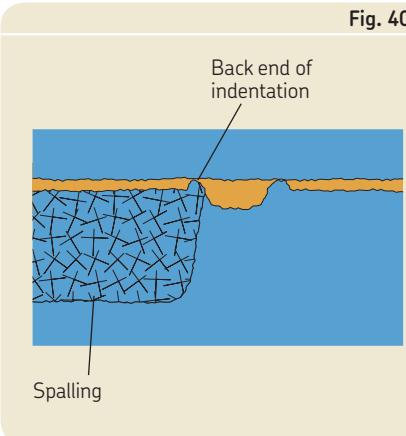
**Fig. 40**

Raised material around the edges of an indentation initiate fatigue. When the fatigue level reaches a certain point, it leads to premature spalling, originating at the back end of the indentation (→ fig. 40). The spall starts as a surface crack.

*Spalling starting at the back end of an indentation*

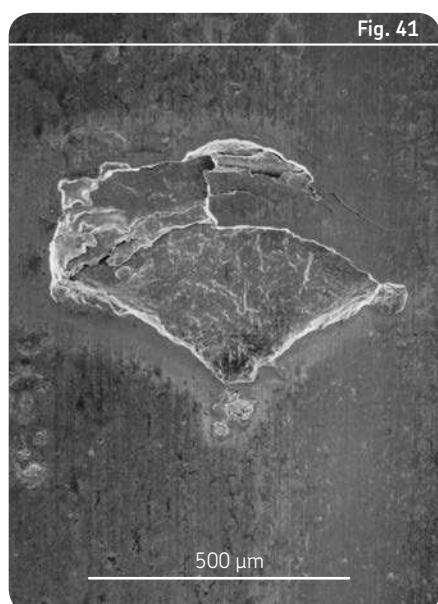
**Fig. 41** shows spalling in a deep groove ball bearing, resulting from an indentation. The over-rolling direction is from bottom to top. The V-shape is a typical sign of indentation damage in a bearing where the initial spalling opens up from the back end of the indentation.

*Spalling resulting from an indentation in the inner ring of a deep groove ball bearing*

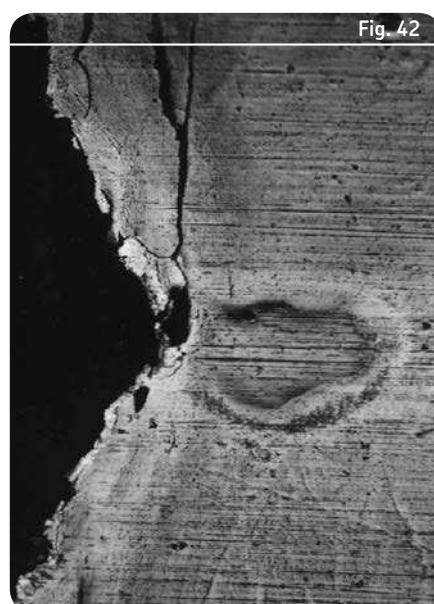
**Fig. 42** clearly shows the consequences of indentations (spherical roller bearing inner ring). The over-rolling direction is from right to left. A rather large and soft contaminant was trapped in the raceway and over-rolled. At the bottom of the dent, grinding lines are still visible. Also notice the raised rim around the dent. To the left, behind the dent, there is a large spall (black colour) where material has been detached. There are also some cracks, where the material is about to be detached.

*Spalling resulting from an indentation in a spherical roller bearing*

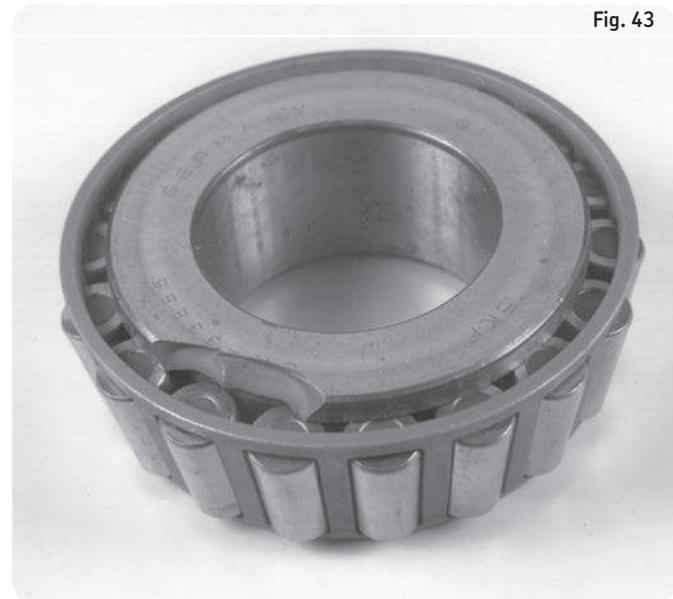
Fig. 43

The same result may occur when bearings are heated and mounted on oversized shafts.

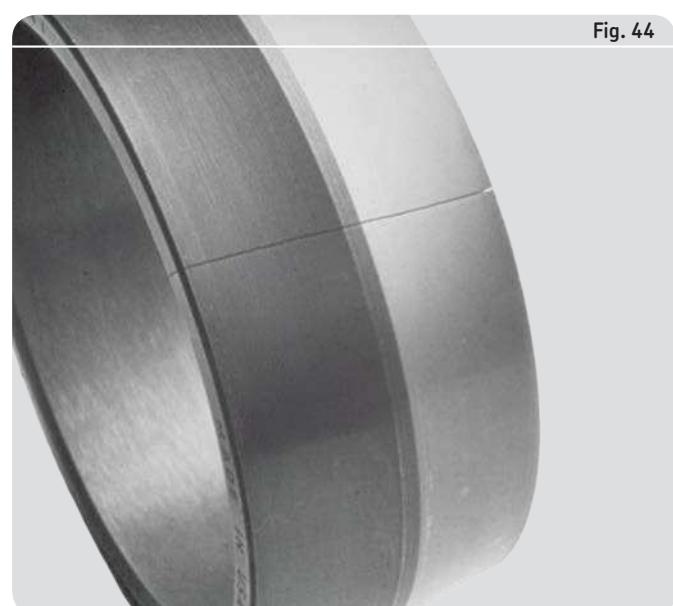
Fig. 44

*Fractured inner ring of a spherical roller bearing with a tapered bore resulting from excessive drive-up*

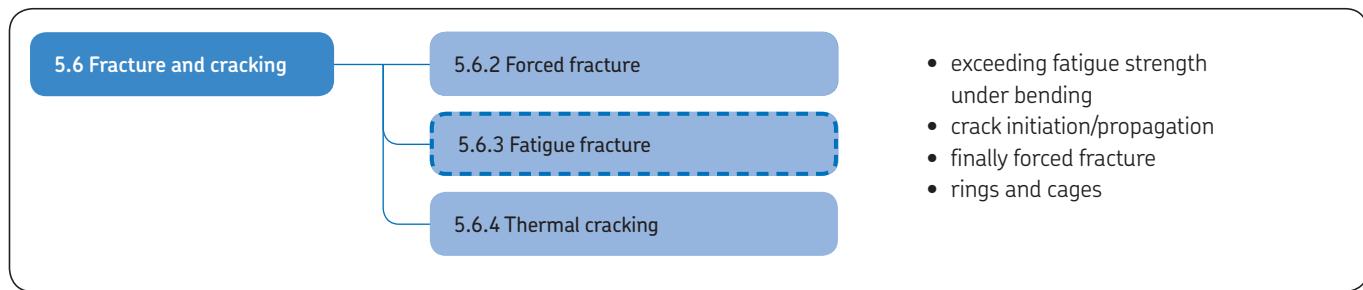
Excessive drive-up (**→ fig. 44**) on a tapered seat can cause an inner ring to fracture. The hoop (tensile) stresses, arising in the ring as a result of excessive drive-up, cause the ring to crack through in service. Martensite hardened rings are more sensitive to this than bainite hardened rings.

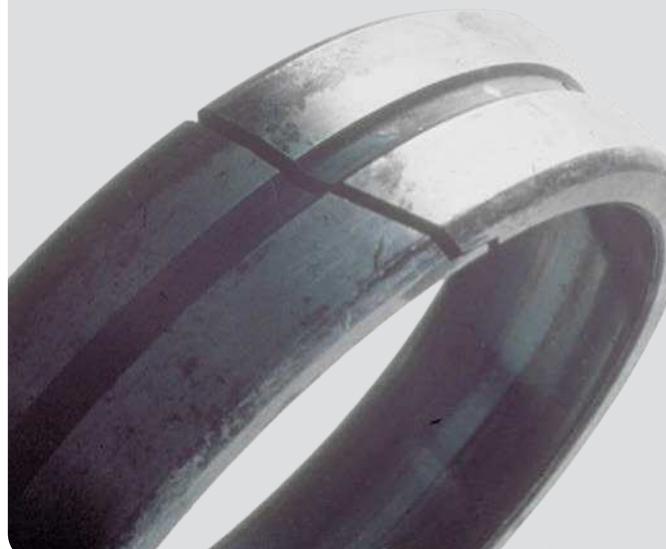
**Fig. 45** shows an example of a cracked outer ring of a spherical roller bearing. The bearing was mounted in a housing with insufficient support in the load zone. As a result, the bearing outer ring was subjected to cyclical bending stress, until the ring developed a through crack.

*Fatigue fracture of an outer ring of a spherical roller bearing*

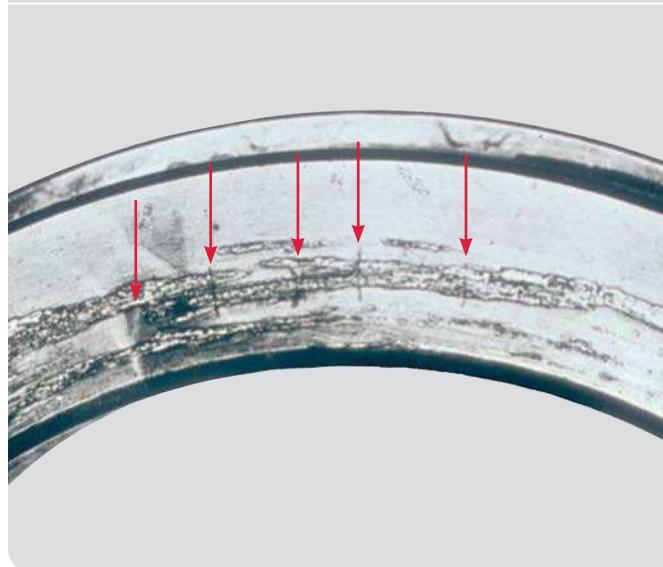
Fig. 46

A typical example is shown in **fig. 46**. A rotating inner ring was fitted with a loose fit and subjected to an axial load. Due to creep, there was a sliding movement between the bearing side face and the shaft shoulder or spacer, which resulted in smearing. The frictional heat results in transverse cracks and eventually the ring will crack through.

*Transverse thermal cracks on the small side face of the inner ring of a tapered roller bearing*

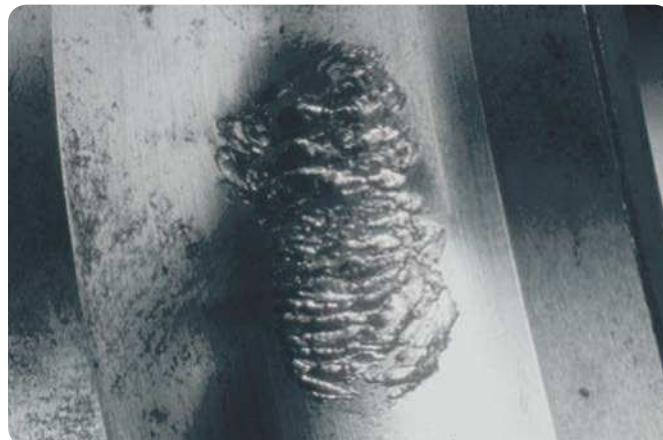
**Deep groove ball bearing inner ring**  
Material fatigue

- Make sure you have the right bearing for the actual application conditions and their variations (load, temperature, speed, misalignment, mounting, etc.)
- Use modern, state-of-the-art quality bearings
- If available, use SKF Explorer performance class bearings, which provide extended life
- Make sure adjacent components are properly designed and manufactured
- Mount correctly

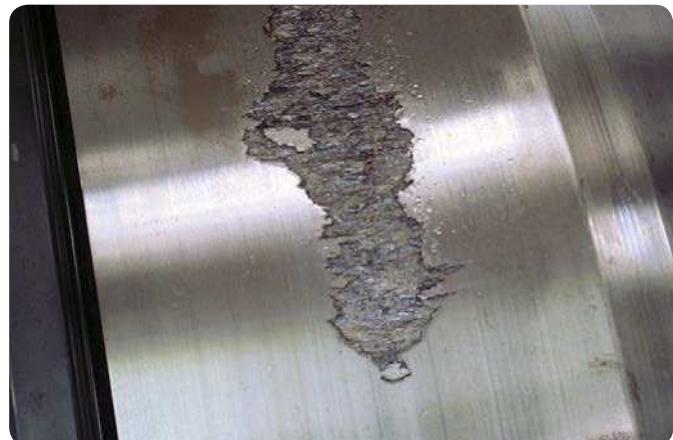
**Spherical roller bearing inner ring**  
Material fatigue

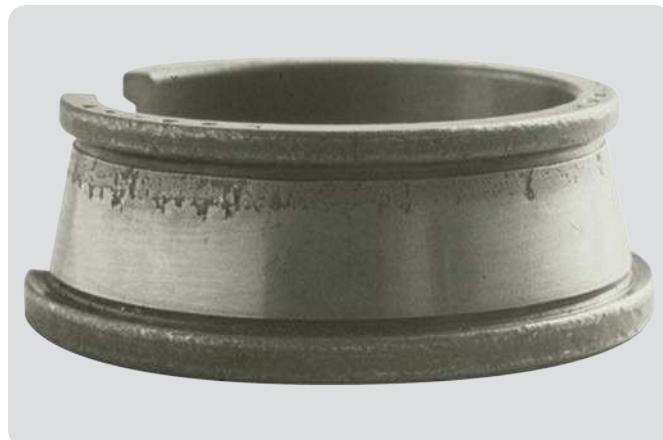
**Tapered roller bearing inner ring**  
Spalling on one side of the raceway only, resulting from misalignment and consequent edge loading, leading to higher stress and failure

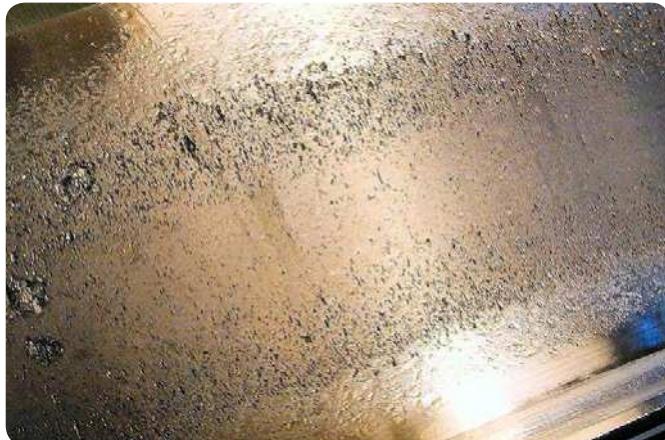
**Spherical roller bearing inner ring**

Inadequate lubrication, surface distress with incipient spalling

- Make sure you have the right bearing for the actual application conditions and their variations (load, temperature, speed, misalignment, mounting, etc.)
- Make sure the lubrication is adequate: right lubricant, right quantity, right time
- Improve the surface separation capability of the lubricant (lubricant viscosity, additives, grease formulation)
- Check the lubricant quality at regular intervals
- Reduce the contamination (improved sealing, oil filtration)

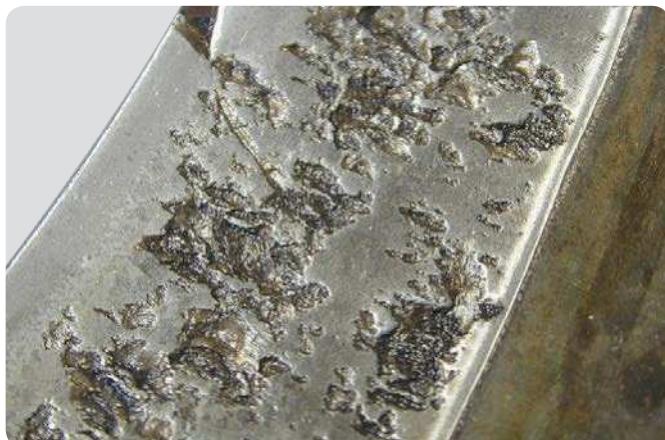
**Spherical roller bearing outer ring**

Initially, abrasive wear due to contamination, developed into surface distress and advanced spalling

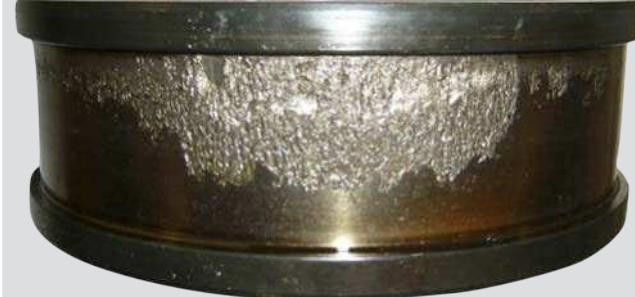
**Cylindrical roller bearing inner ring**

Inadequate lubricant film, excessive misalignment, advanced surface distress

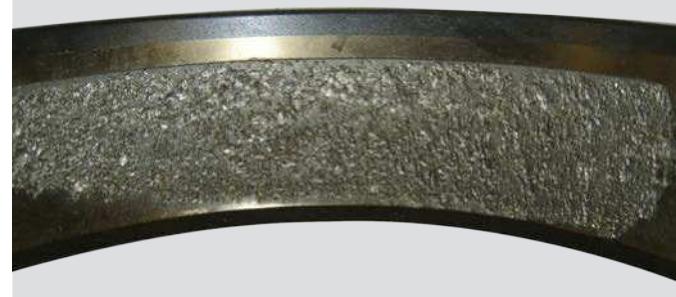
**Cylindrical roller bearing outer ring**

Inadequate lubricant film, some misalignment, advanced surface distress

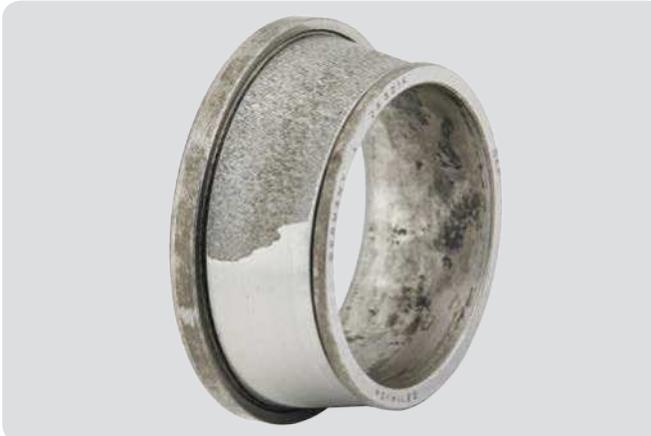
**Tapered roller bearing inner ring**

Inadequate lubricant film, surface distress over a large area

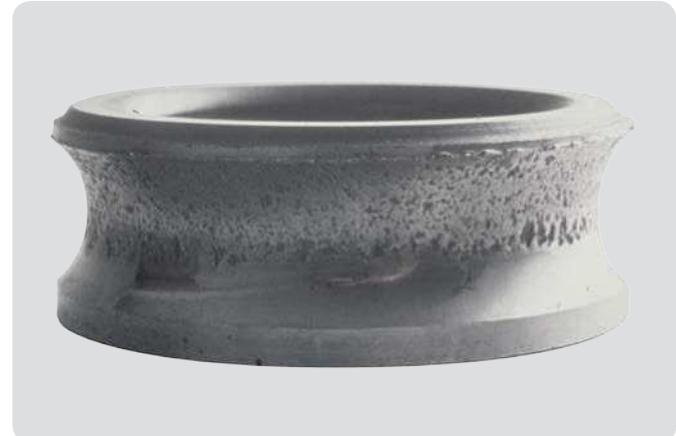
**Deep groove ball bearing inner ring**

Excessive axial load, resulting in too thin lubricant film and surface distress

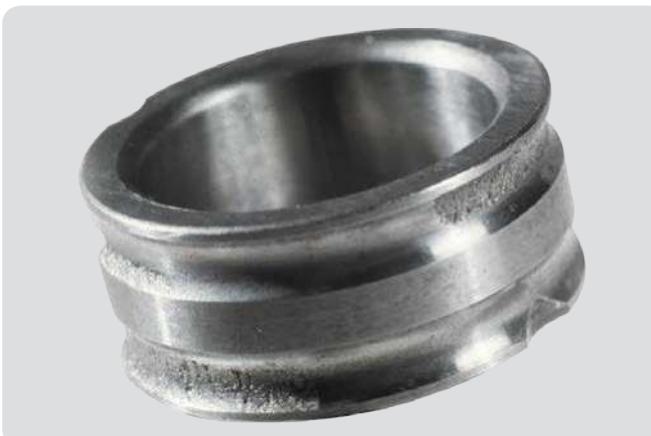
**Double row angular contact ball bearing inner ring**

Excessive misalignment, resulting in excessive loads, with two load zones 180° apart.

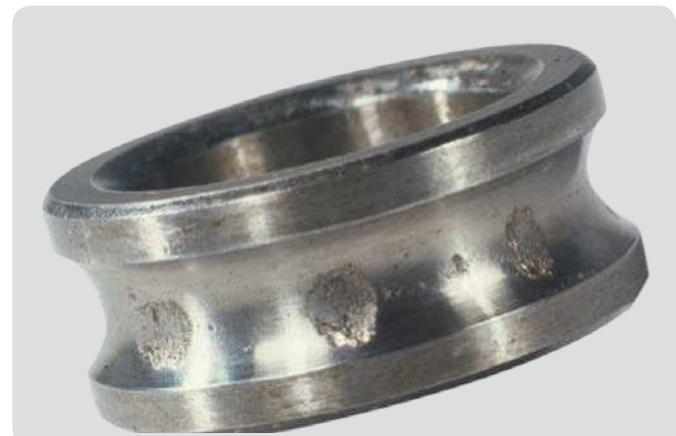
**Deep groove ball bearing inner ring**

Impact during mounting, resulting in spalling at ball pitch

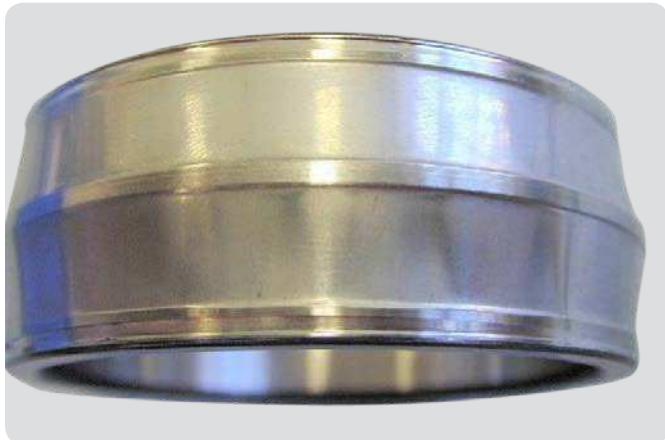
**Spherical roller bearing inner ring**

Contamination and resulting inadequate lubrication leading to abrasive wear of the raceway tracks – slightly shiny

- Make sure an adequate sealing arrangement is in place considering the operational conditions
- Make sure the lubrication is adequate: right lubricant, right quantity, right time
- Check the quality of the lubricant at regular intervals
- Check the quality of the sealing arrangement at regular intervals
- Make sure housing and shaft fits are adequate to avoid creep
