# Bearing damage and failure analysis

**SKF®**

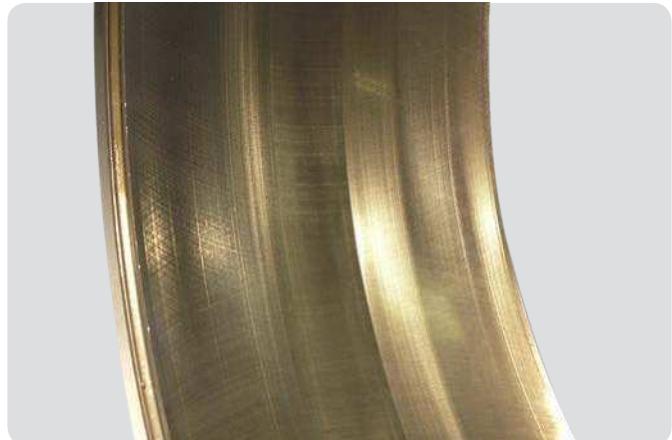
**Spherical roller bearing outer ring**

Abrasive wear of the raceway tracks in an early stage

- Make sure an adequate sealing arrangement is in place considering the operational conditions
- Make sure the lubrication is adequate: right lubricant, right quantity, right time
- Check the quality of the lubricant at regular intervals
- Check the quality of the sealing arrangement at regular intervals
- Make sure housing and shaft fits are adequate to avoid creep

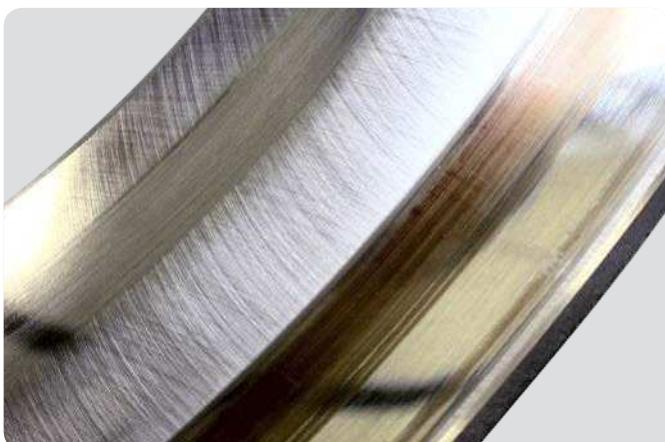
**Spherical roller bearing outer ring**

Abrasive wear of the raceway tracks. The axially loaded one also partly discolored indicating inadequate lubrication and heat generation. The other raceway track shows a narrower load pattern with a matt appearance.

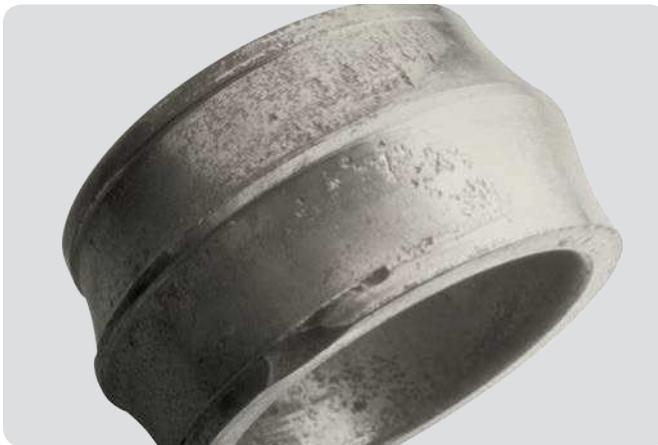
**Spherical roller bearing inner ring**

Contamination and resulting inadequate lubrication leading to abrasive wear of the raceway tracks – one raceway track more damaged due to axial load

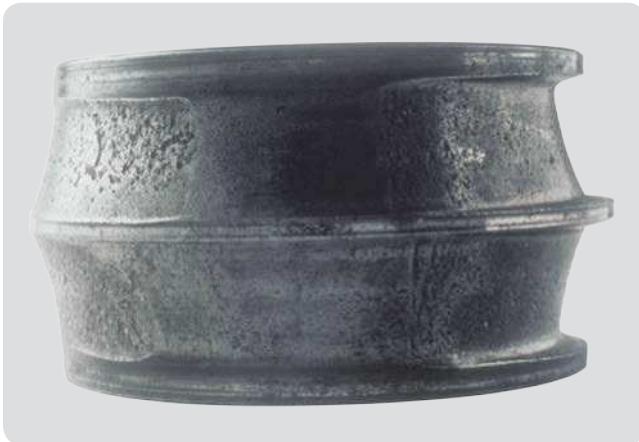
**Spherical roller bearing inner ring**

Inner ring stationary – heavy abrasive wear – two wear zones: one with heavy wear; then creep of the inner ring with subsequent second wear zone

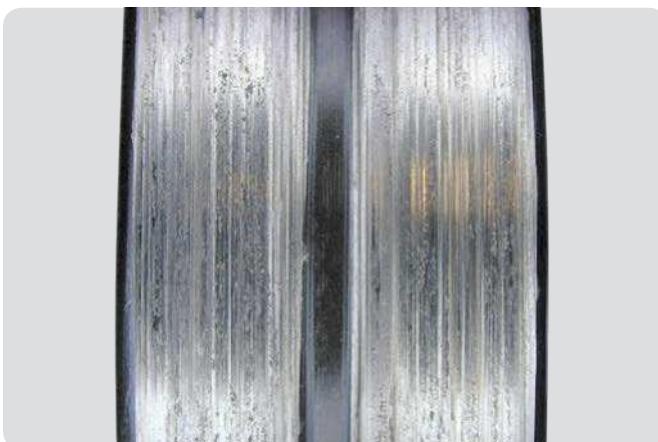
**Spherical roller bearing outer ring**

Ring creep in the housing from inadequate fit – abrasive wear marks on the outside surface

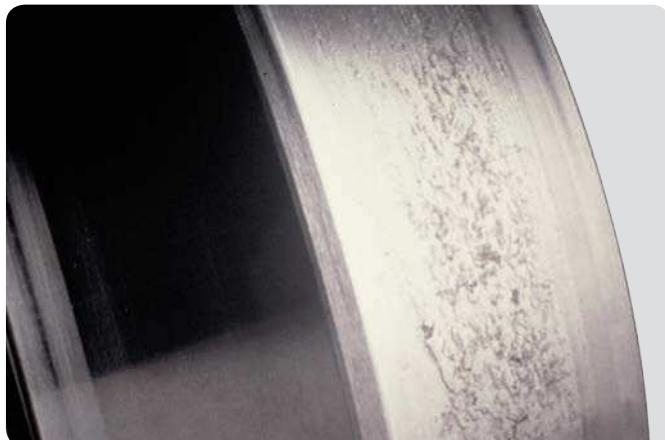
**Spherical roller bearing inner ring**

Too low load combined with inadequate lubrication

- Make sure the bearing is adequately loaded
- Make sure the sealing arrangement is operating efficiently
- Consider bearing downsizing
- Verify lubricant selection (viscosity, AW and EP additives)
- Consider using coatings
- Consider using hybrid bearings

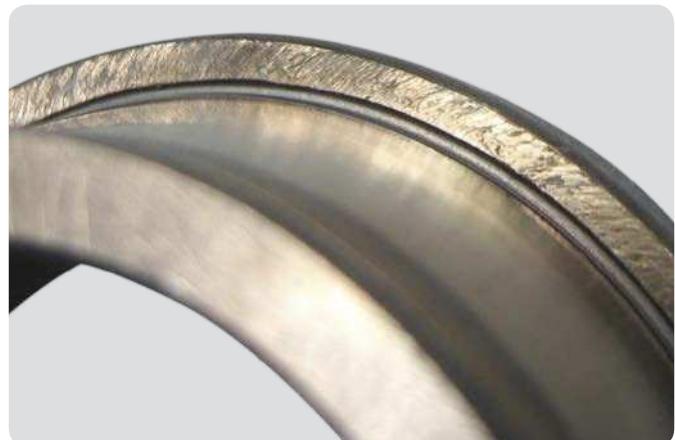
**Tapered roller bearing inner ring**

Contamination and inadequate lubrication resulting in adhesive wear of the flange as well as a shiny raceway

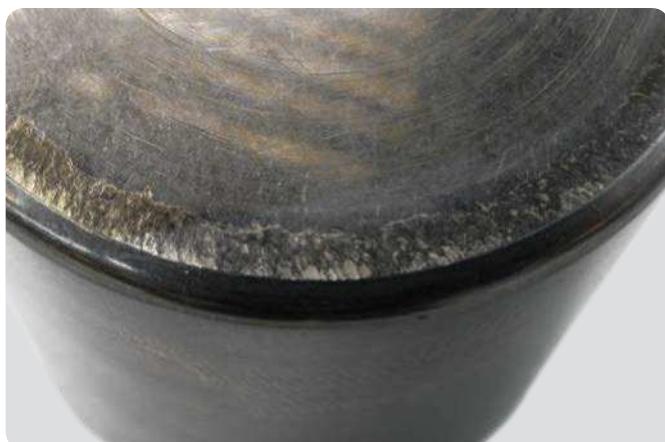
**Tapered roller bearing – roller**

Contamination and inadequate lubrication leading to adhesive wear marks on the large roller end face

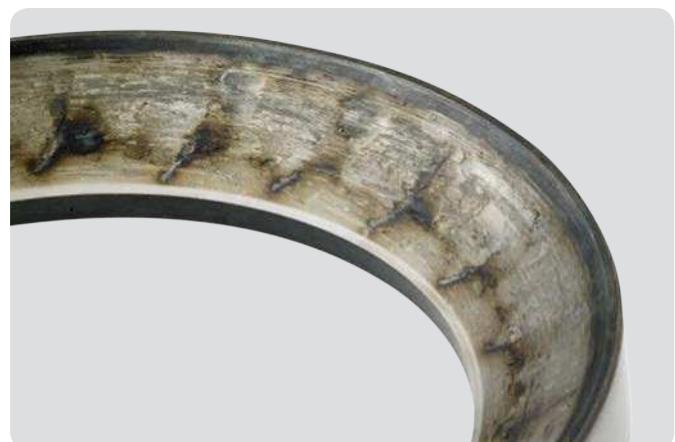
**Spherical roller thrust bearing outer ring**

Initially adhesive wear, then excessive heat generation, finally jamming

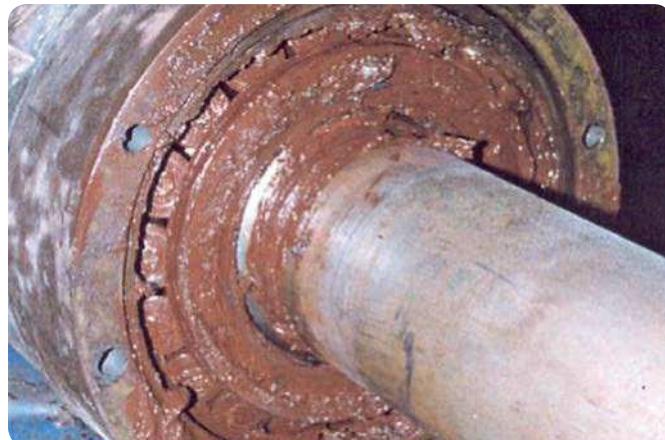
**Tapered roller bearing in a pump unit**  
Seal failure, bearing corrosion and reddish discolored grease

- Make sure the bearing arrangement is adequately protected
- Consider using sealed bearings in respect of the operating environment
- Make sure the lubrication is adequate: right lubricant, right quantity, right time
- Do not unpack bearings until mounting them
- Protect mounted bearings adequately

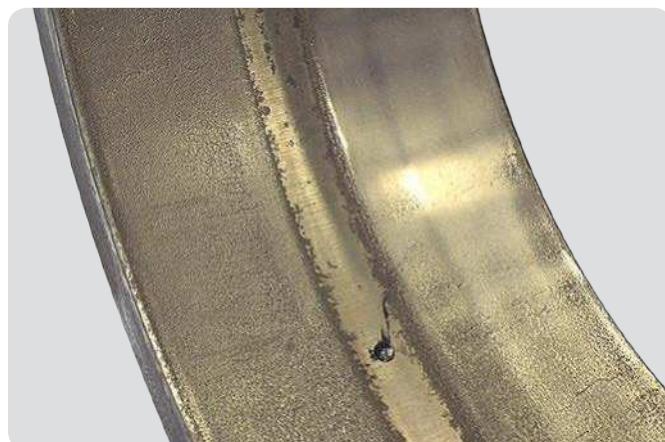
**Spherical roller bearing outer ring**  
Sealing arrangement failure, corrosive substance entered the bearing

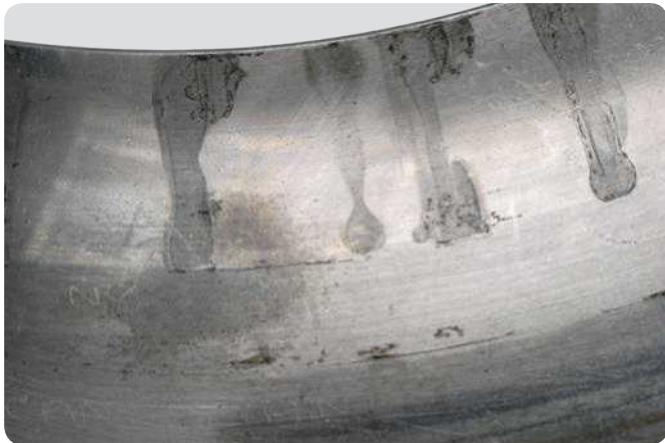
**Spherical roller bearing outer ring**

Too high water content in lubricant, sets of etching marks at roller pitch at standstill

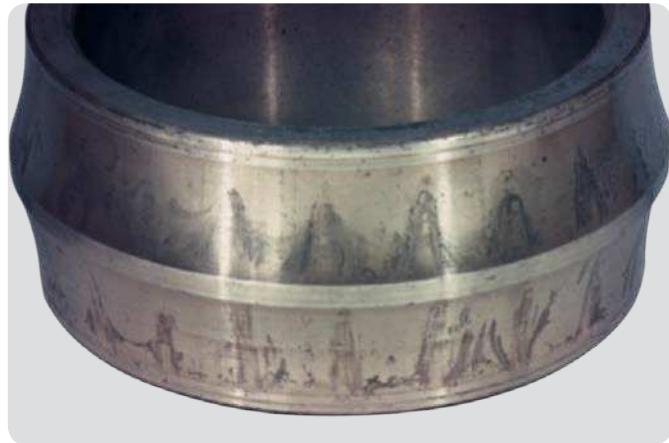
**Spherical roller bearing inner ring**

Lubricant contaminated by water, etching marks at roller pitch at standstill

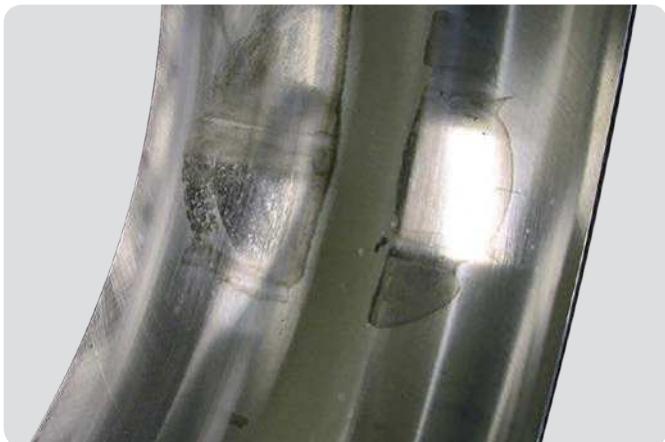
**Spherical roller bearing outer ring**

Sealing arrangement failure, corrosion at standstill

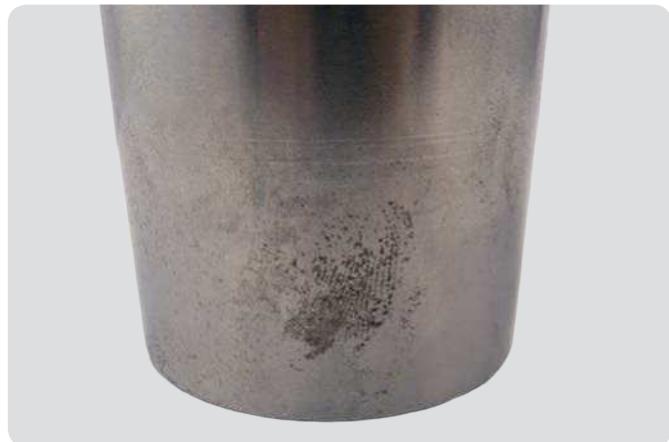
**Tapered roller bearing – roller**

Rusty surface on raceway resulting from finger perspiration

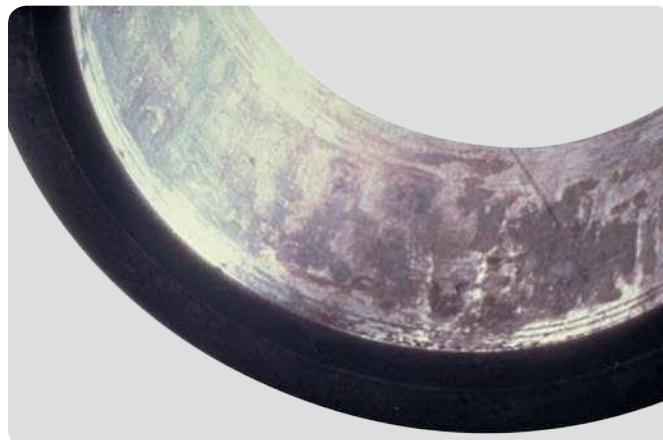
**Cylindrical roller bearing inner ring**  
Inappropriate shaft fit (too loose)

- Select appropriate fits
- Make sure the bearing seats are adequately machined
- Make sure the bearing seats conform to dimensional and geometrical specifications (even after overhaul of the machine)
- In the case of loose fits, consider applying an anti-fretting paste or coatings on one of the bearing surfaces

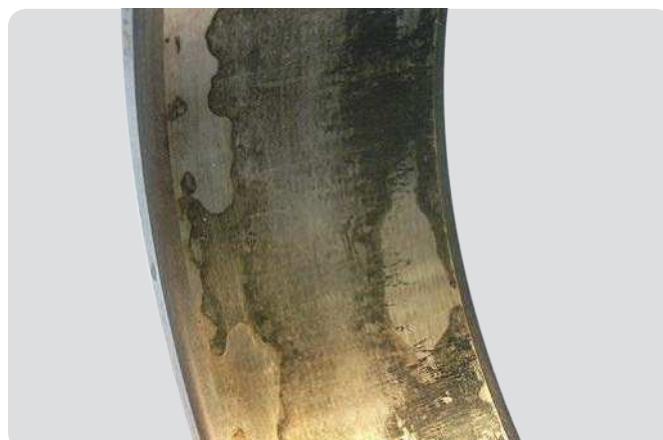
**Cylindrical roller bearing inner ring**  
Inappropriate shaft fit, uneven support

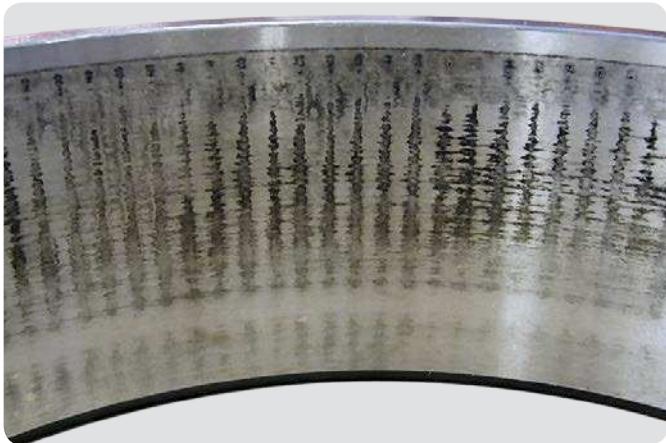
**Tapered roller bearing inner ring**  
*Micromovement marks corresponding to shaft machining waviness*

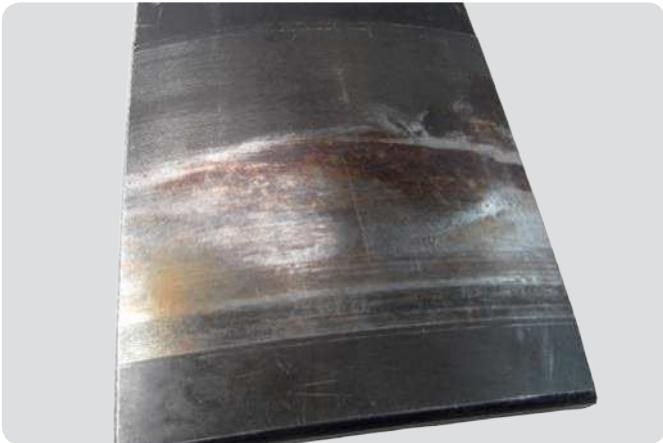
**Tapered roller bearing outer ring (phosphated)**  
*Uneven ring support*

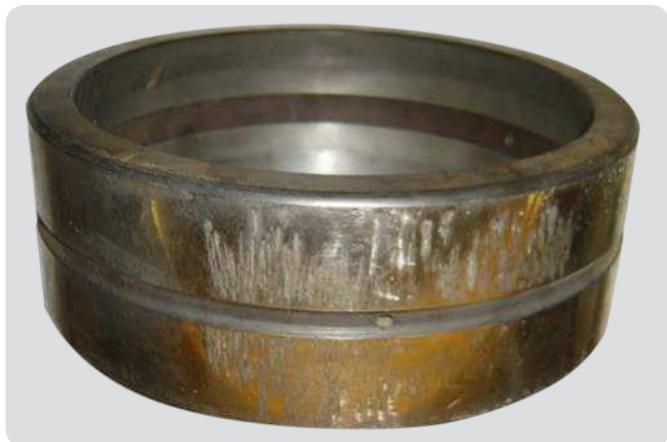
**Spherical roller bearing outer ring**  
*Brown coloured fretting corrosion area from micromovements due to advanced raceway spalling, with scratches due to dismantling*

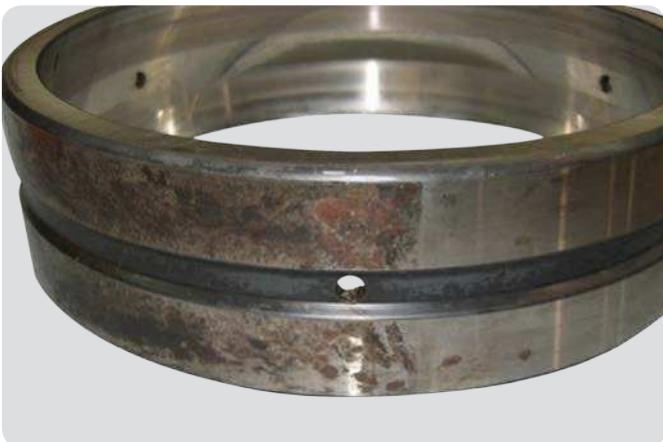
**Spherical roller bearing outer ring**  
*Inadequately supported ring*

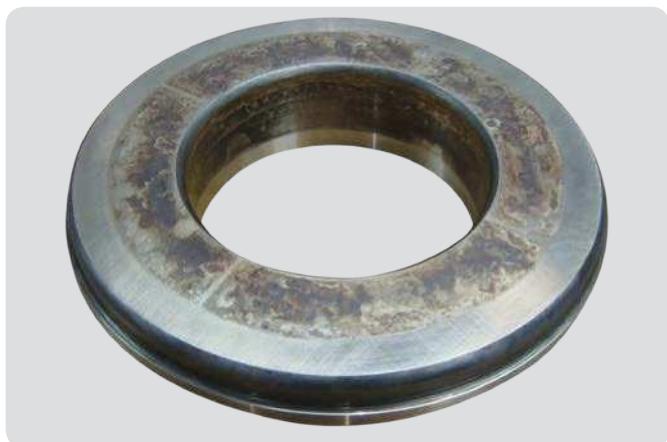
**Spherical roller thrust bearing shaft washer**  
*Inadequate seat*

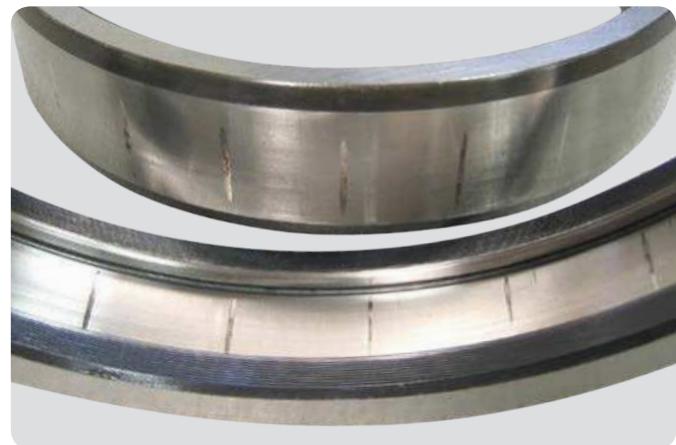
**Cylindrical roller bearing inner and outer rings**  
Exposure to vibrations at standstill, false brinelling marks at roller pitch

- Do not expose bearings to vibrations at standstill
- Consider installing vibration damping pads
- Apply lubricant with anti-brinelling properties
- Rotate standby machines at regular intervals
- Use adequate bearing designs for vibratory applications

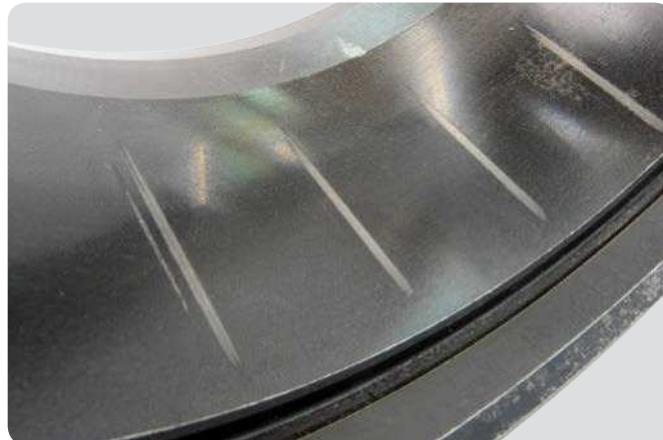
**Double row tapered roller bearing outer ring**  
Exposure to vibrations at standstill, false brinelling marks at roller pitch

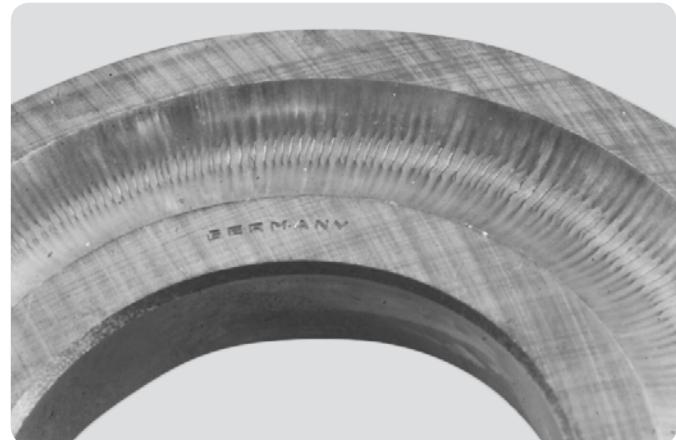
**Thrust ball bearing shaft washer**  
Exposure to vibrations at standstill, several sets of false brinelling marks at ball pitch

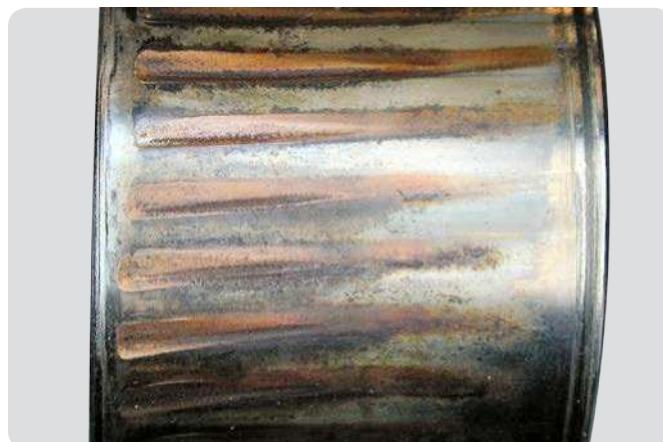
**CARB toroidal roller bearing inner ring**  
Exposure to vibrations at standstill with small oscillatory movements, false brinelling marks at roller pitch

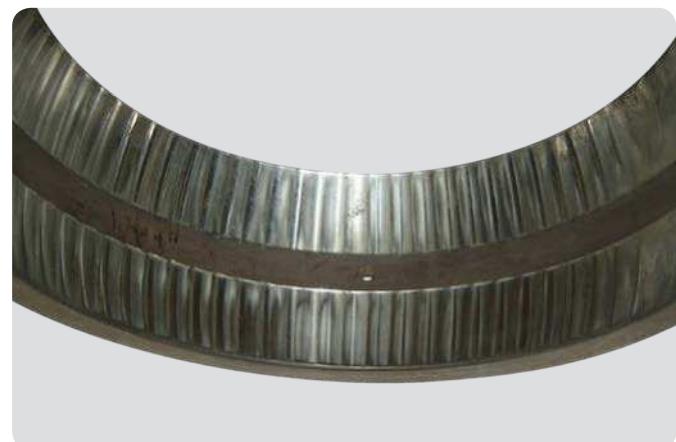
**Spherical roller bearing outer ring**  
Exposure to excessive vibrations at standstill, sets of false brinelling marks at roller pitch

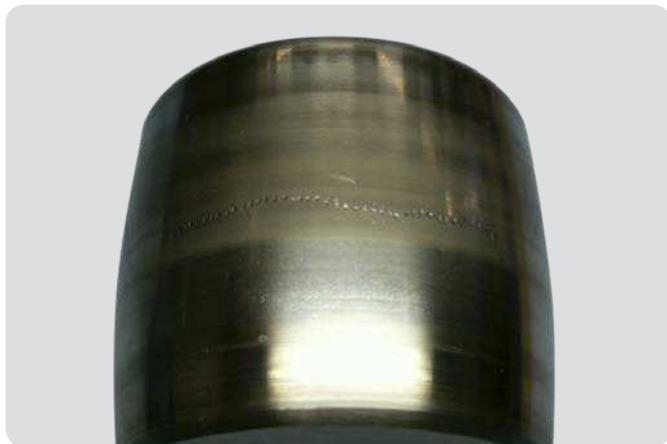
**Spherical roller bearing – roller**

Excessive current resulting in a large number of craters in a bead-like formation

- Make sure earthing connections are installed properly
- Use insulated bearings (INSOCOAT or hybrid bearings)

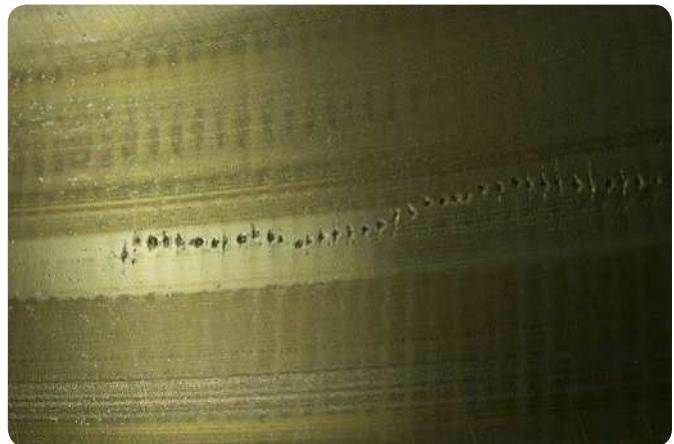
**Spherical roller bearing – roller**

Enlarged view of craters in a bead-like formation

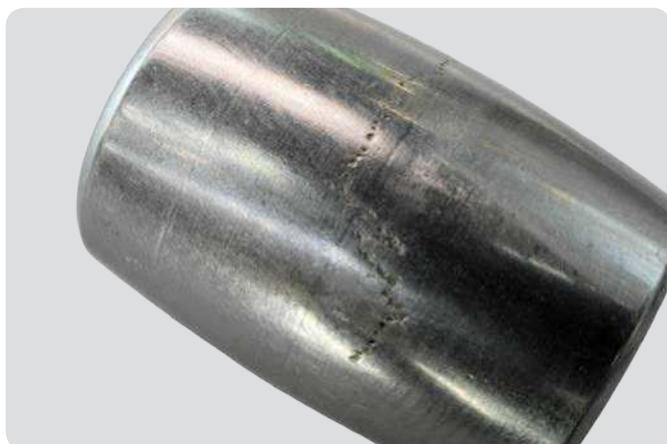
**Spherical roller bearing – roller**

Excessive current resulting in a large number of craters in a zig-zag formation

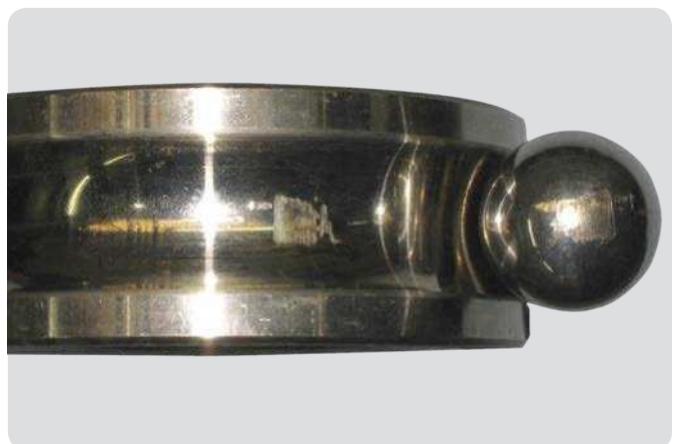
**Deep groove ball bearing inner ring and ball**

Excessive current resulting in a number of craters in zig-zag formation on the ball and raceway

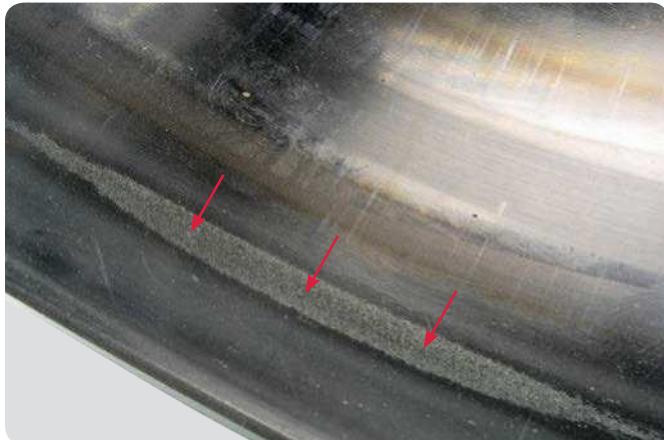
**Spherical roller bearing outer ring**  
Damage in early stage: dull grey zone with small shallow craters

- Use symmetric cabling
- Make sure the stator and rotor are properly aligned
- Use insulated bearings (INSOCOAT or hybrid bearings)
- Make sure earthing connections are installed properly

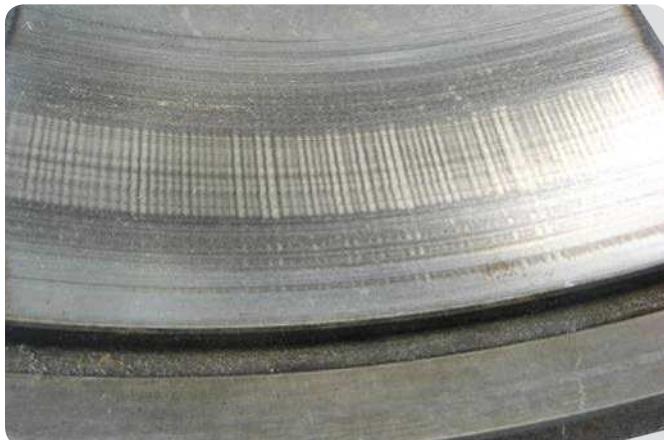
**Tapered roller bearing outer ring**  
Early stage of washboarding

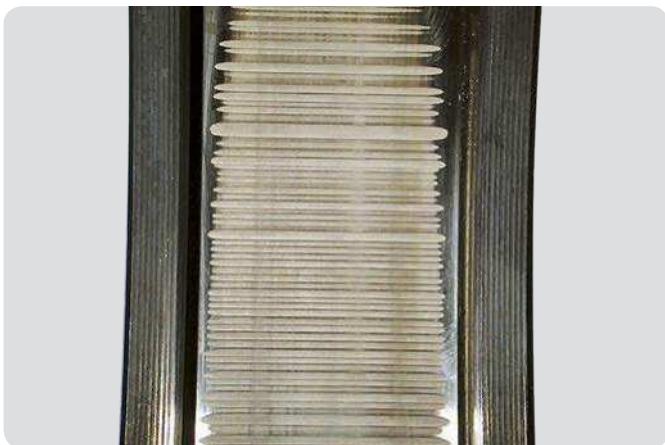
**Cylindrical roller bearing outer ring**  
Advanced stage of washboarding

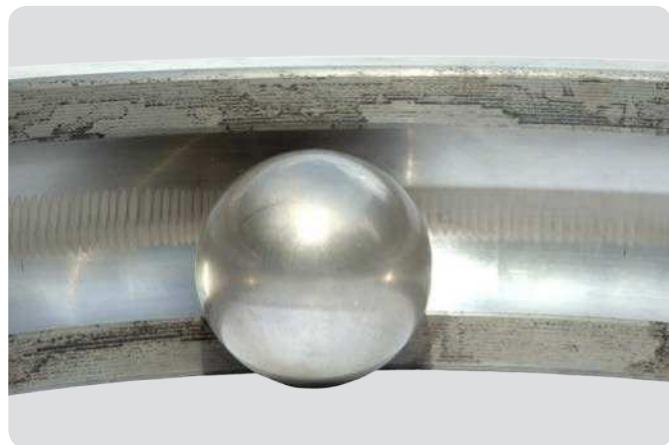
**Deep groove ball bearing outer ring and ball**  
Washboarding in the outer ring and dull ball surface

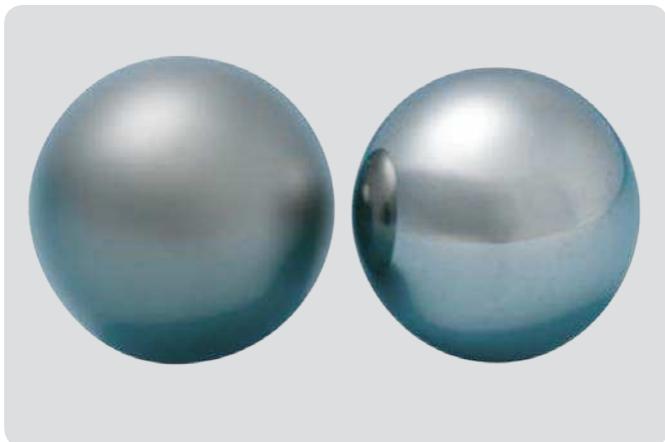
**Deep groove ball bearing – balls**  
Left: damaged ball – dull surface  
Right: new ball – shiny surface

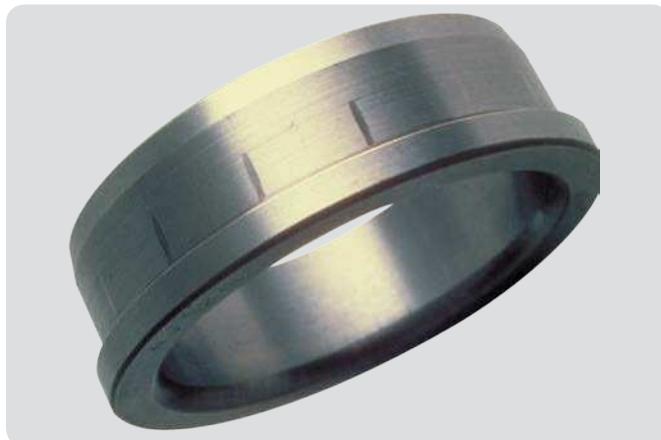
**Cylindrical roller bearing inner ring**

During mounting, inner and outer rings were not aligned properly. Axial marks at roller pitch.

- Use appropriate methods for mounting bearings
- Use appropriate tools or mounting dollies as required
- Follow mounting procedures and instructions carefully

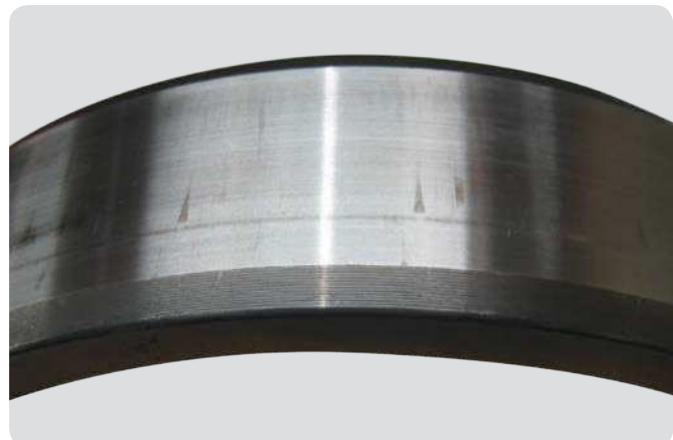
**Cylindrical roller bearing inner ring**

During mounting, inner and outer rings were not aligned properly. Axial marks at roller pitch.

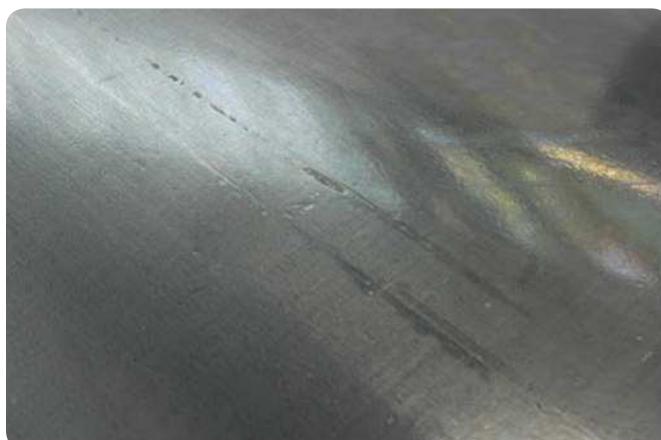
**Tapered roller bearing outer ring**

Scoring during handling

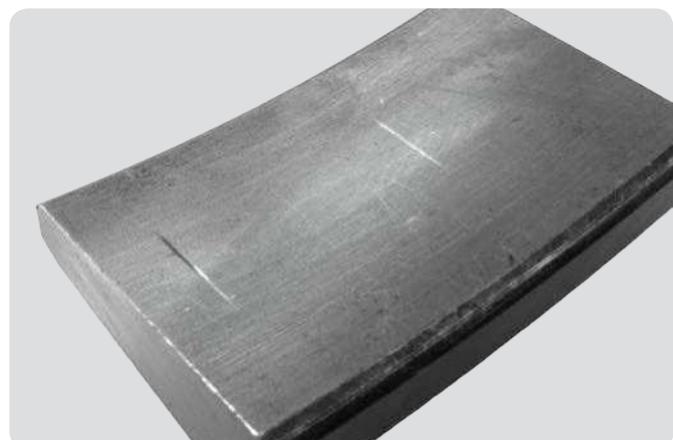
**Tapered roller bearing outer ring**

Scoring during mounting

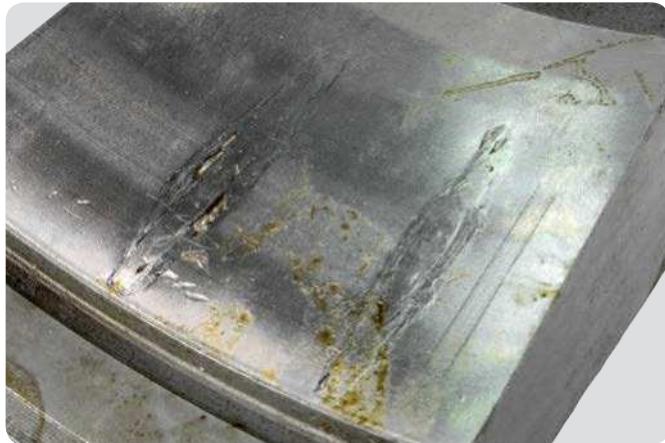
**Double row tapered roller bearing outer ring**

Overload impact and misalignment at standstill, resulting in deformation and subsequent spalling at roller pitch

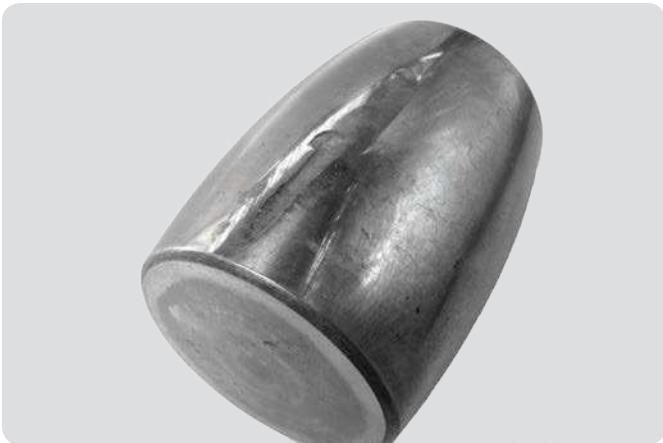
**Spherical roller thrust bearing – roller**

Heavy impact, plastic deformation

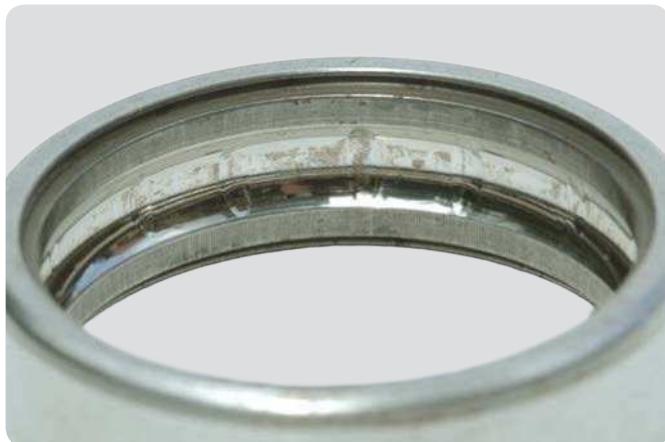
**Deep groove ball bearing outer ring**

Plastic deformation at ball pitch from applying mounting force to the wrong ring

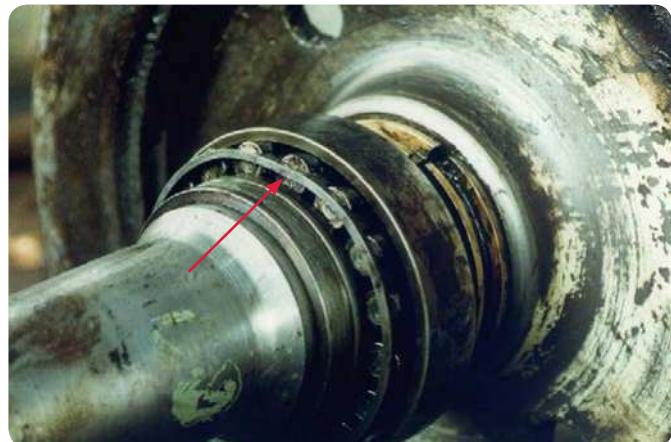
**Tapered roller bearing mounted on a railway wheel set**

Cage was hit directly during mounting, resulting in permanent deformation (flattening)

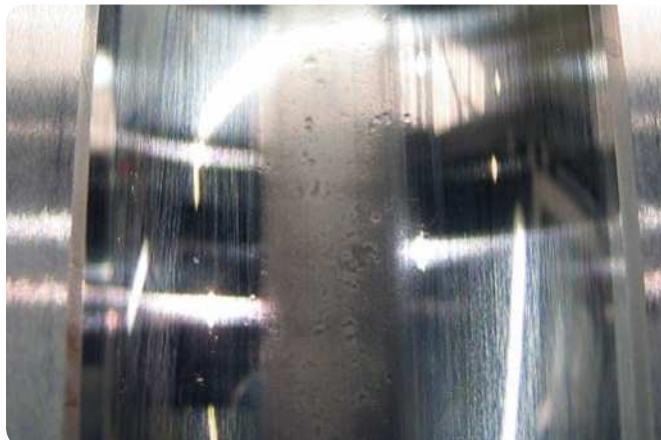
**Deep groove ball bearing inner ring**

Dents resulting from overrolling of hard particles – inadequate sealing arrangement

- Make sure to work in clean conditions
- Use adequate sealing to protect the bearing
- Make sure the lubrication is adequate: right lubricant, right quantity, right time
- Never drop a bearing
- Treat bearings carefully

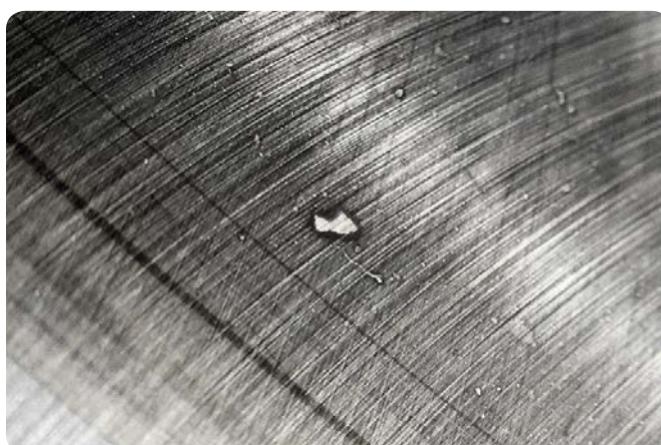
**Spherical roller bearing outer ring**

Overrolling of hard particles that entered the bearing during mounting – lack of cleanliness

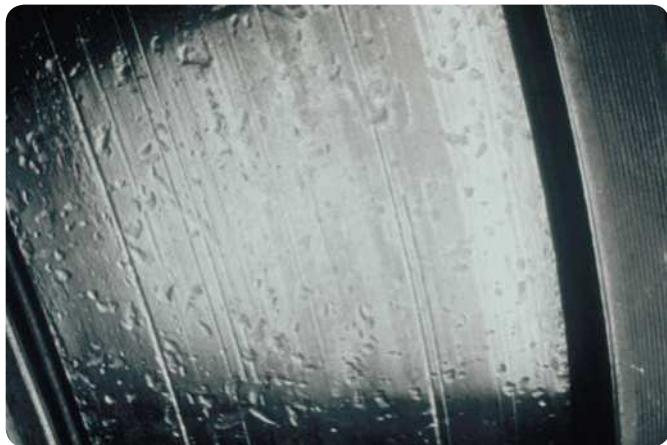
Overrolled swarf/chip will lead to spalling

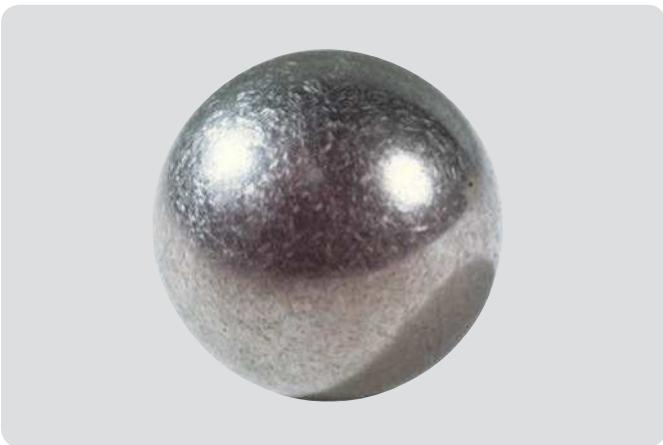
**Deep groove ball bearing – ball**

Damage resulting from hard particles in very contaminated lubricant

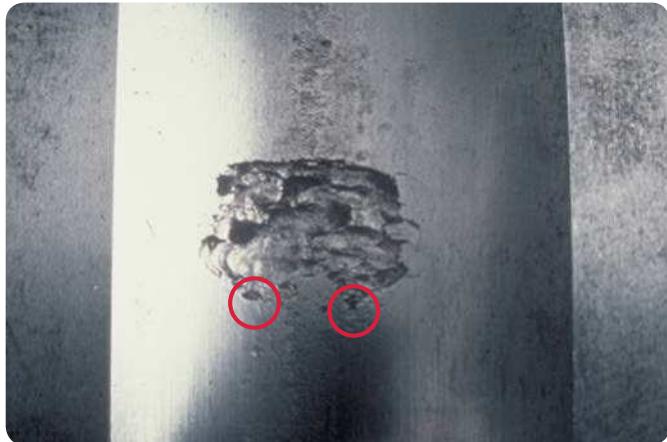
**Deep groove ball bearing inner ring**

Overrolling of particles with sequential spalling starting at the back of the dents

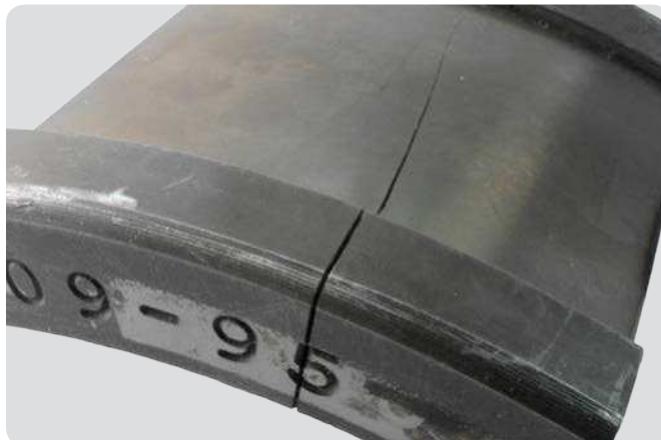
**Tapered roller bearing inner ring**  
The bearing was fitted to an oversized shaft

- Select appropriate fits
- Use appropriate methods for mounting bearings
- Use appropriate tools or mounting dollies as required
- Follow mounting procedures and instructions carefully
- Never use brute force on bearings or apply mounting forces through the rolling elements

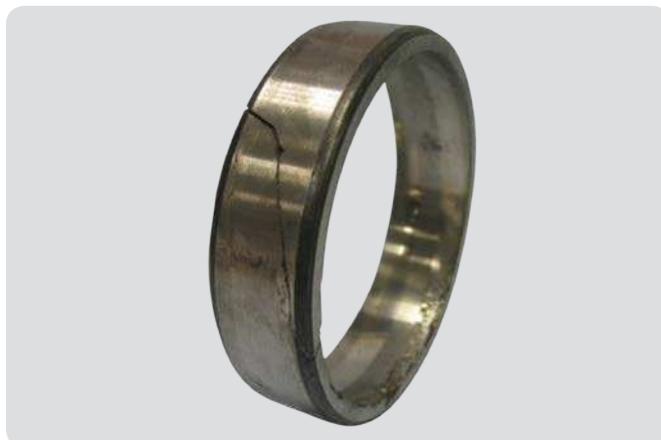
**Self-aligning ball bearing outer ring**  
Fracture resulting from excessive misalignment and balls running over the raceway edge

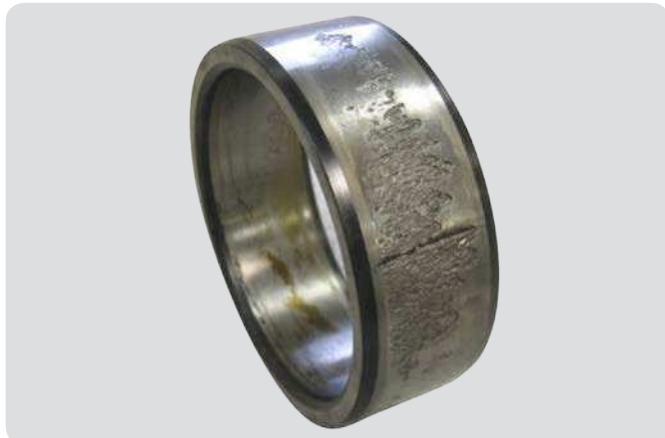
**Cylindrical roller bearing inner ring**  
Very heavy spalling – fatigue fracture as sequential damage

- Make sure bearing seats conform to geometrical specifications
- For split housings, make sure the two halves join correctly
- Bearing seats should be clean (no swarf or chips, which could create local stress rise)
- Use appropriate tools and methods for mounting

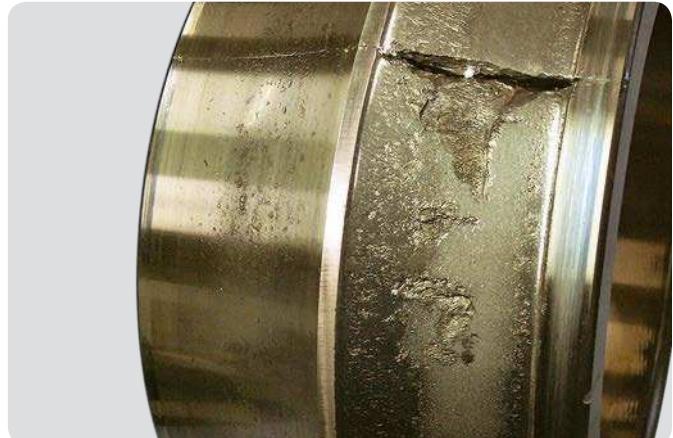
**Spherical roller bearing inner ring**  
Very heavy spalling – fatigue fracture as sequential damage

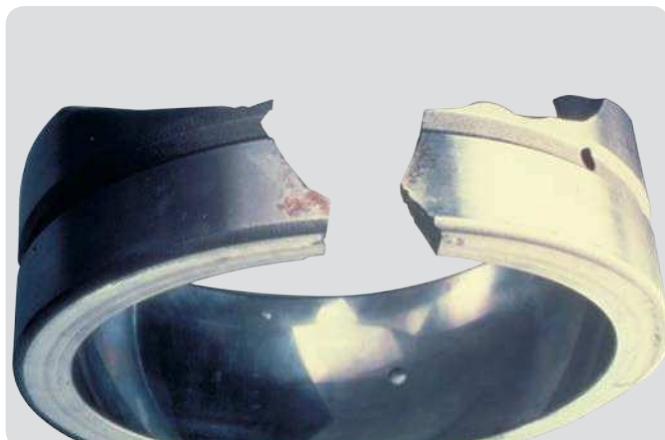
**Spherical roller bearing outer ring**  
Fatigue fracture resulting from inadequate housing seat (swarf trapped at the bottom of the housing)

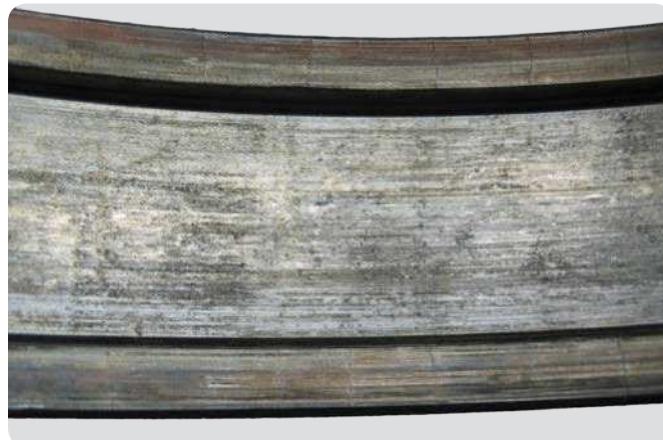
**Cylindrical roller bearing outer ring**

Thermal cracks at both shoulder-cage contact due to inadequate lubrication

- Lubricate sliding surfaces or apply coatings to reduce local peak temperatures
- Make sure the lubrication is adequate: right lubricant, right quantity, right time
- Check for application specific solutions with the SKF application engineering service

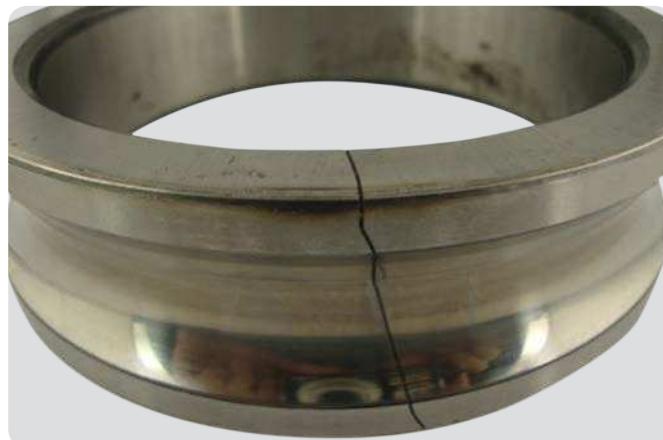
**Deep groove ball bearing inner ring**

Ring fractured due to excessive friction against a stationary part of the bearing assembly

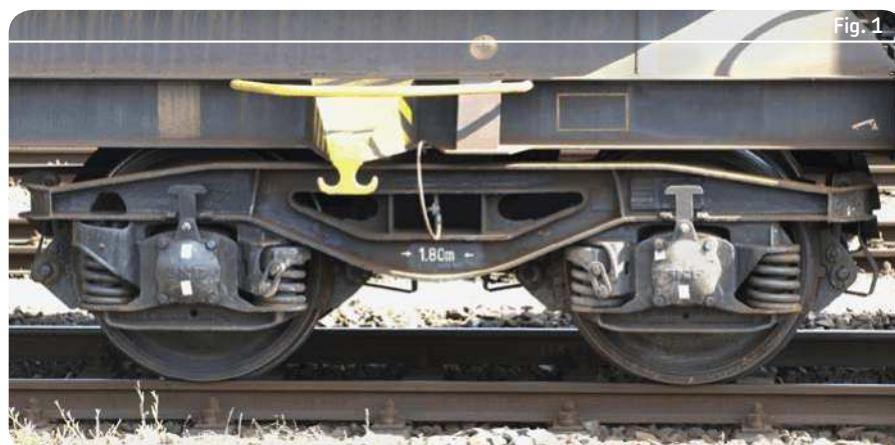
Fig. 1

But, 35 km later, the train derailed. The axle of a wheelset had broken. The wagon in question had been overhauled not long before by an authorized railway repair shop.

The shaft spacer had a width of only 14 mm.

Apparently, the shorter spacer was installed during the overhaul. As a result, the bearing inner rings were not properly axially clamped and able to move on their shaft seat towards the outboard side, which increased shaft bending. Also the outer rings were not properly positioned in the axle box housing, leading to axial contact in the labyrinth seals. This resulted in high frictional heat, bearing seizure, shaft fracture and derailment.

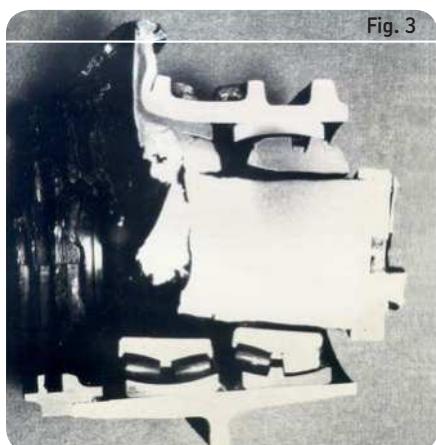
Fig. 3

This was clearly more than a “hot runner” (→ fig. 3). The outer ring of the inboard bearing was severely deformed. Based on the level of deformation, the metal reached a temperature well over 800 °C (1 470 °F).

There was a gap between the outer ring of the inboard bearing and the labyrinth seal, measuring 21 mm (fig. 3, bottom left).

*Remains of the failed axlebox (cut), as presented for the failure analysis*

The customer reviewed and improved the maintenance instructions, to make sure such accidents would not reoccur.

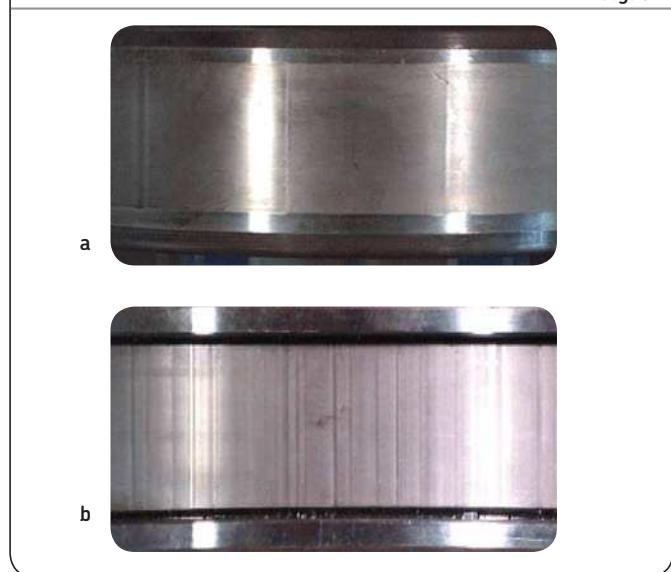
Fig. 5

There was heavy wear on the raceway. The wear was irregular; some flats were observed. The raceway was dull and grey in colour (→ fig. 5a).

There was heavy wear on the raceway (load zone). The wear was irregular. Marks similar to those caused by vibration (washboarding) were visible. The raceway was dull and grey in colour (→ fig. 5b).

The visual inspection only revealed an irregular waviness pattern, which looked like heavy wear from vibration.

Heavy wear and vibration marks on the inner ring (a) and outer ring (b) raceways of the cylindrical roller bearing

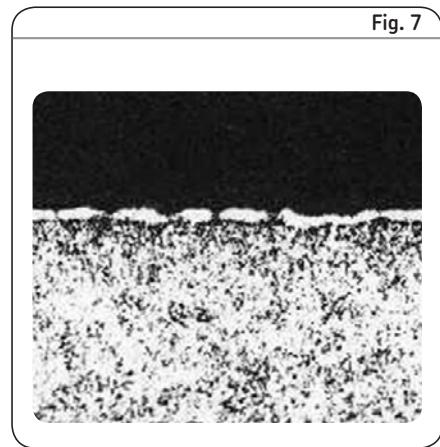
*Cross section of the inner ring under 500x magnification*

*The thin, light strip on top (underneath the black space) is the raceway surface. This is material that was rehardened due to the heat developed in the contact area. Below the light area, there is a thin, dark strip that had been annealed. The lower part is the steel with normal hardness.*

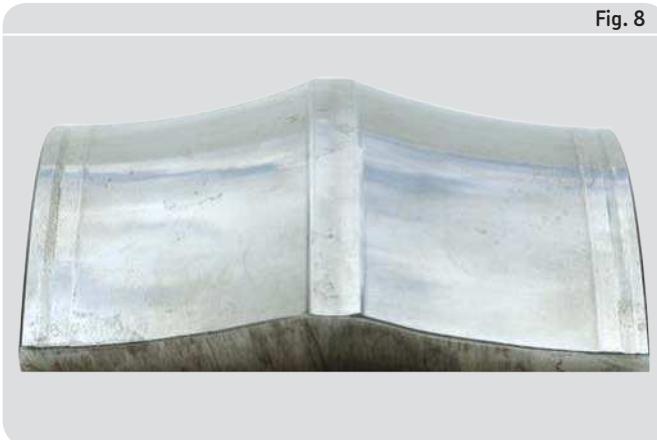
Fig. 8

The bore showed no signs of fretting corrosion and the side faces were undamaged. The raceways showed severe abrasive wear. On both raceways, the cages had cut a groove at the edge of the raceway, indicating that the cages were making contact with the raceways. The raceways were dull and grey in colour (→ fig. 8).

*Inner ring: Heavy abrasive wear on the raceways and a circumferential groove at both raceway edges*

There was a huge amount of abrasive wear in the bearing. The cage pocket clearance had increased substantially, making the cage drop and cut a groove at the edge of the raceway.

The customer improved the sealing arrangement and reduced lubrication intervals.

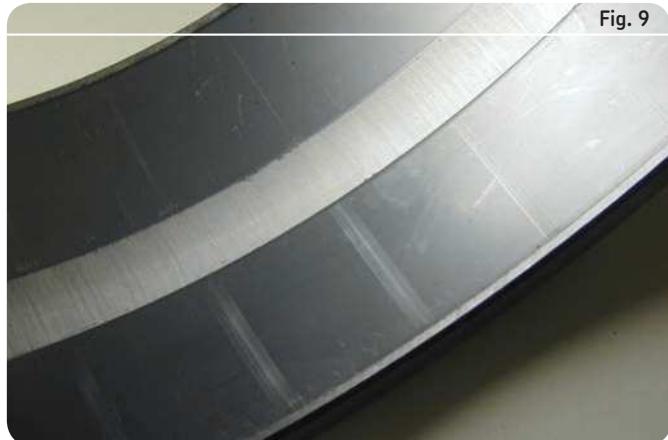
Fig. 9

The raceways showed heavy abrasive wear, and were dull and grey in colour (→ fig. 9). There were also transverse smearing marks (at roller pitch) from dismounting.

*Outer ring: Heavy abrasive wear on the raceways and transverse smearing marks*

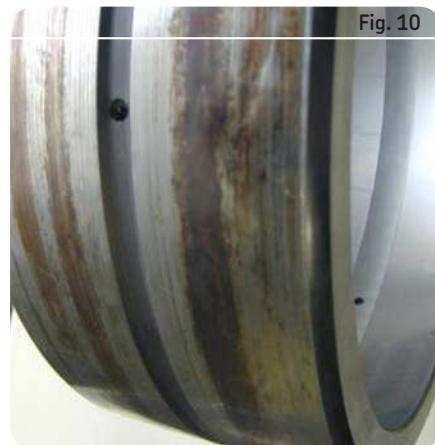
Severe fretting corrosion was visible on the outside surface (→ fig. 10), which was the result of ring creep movements under heavy load and uneven ring support.

*Outer ring: Fretting corrosion on the outside surface*

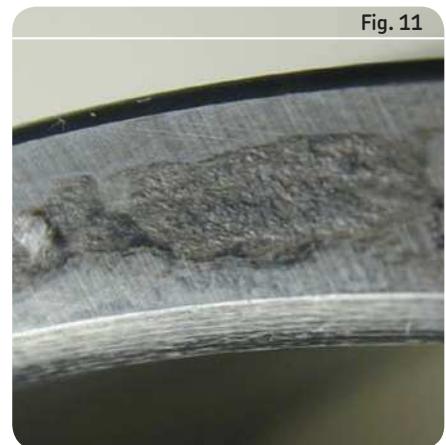
The side faces of the outer ring also showed fretting corrosion (→ fig. 11), which further confirms ring creep.

*Outer ring: Fretting corrosion on the side face*

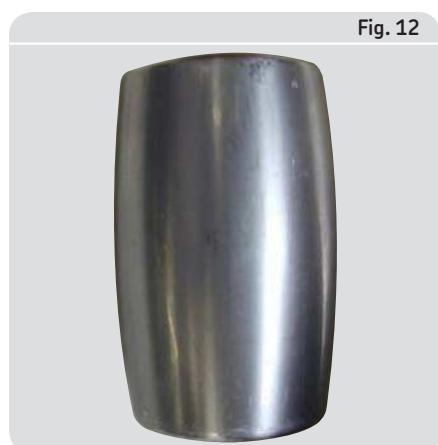
*Fig. 12*

The rollers were dull and grey in colour. Smearing marks from dismounting were visible (→ fig. 12).

*Roller: Dull and grey colour*

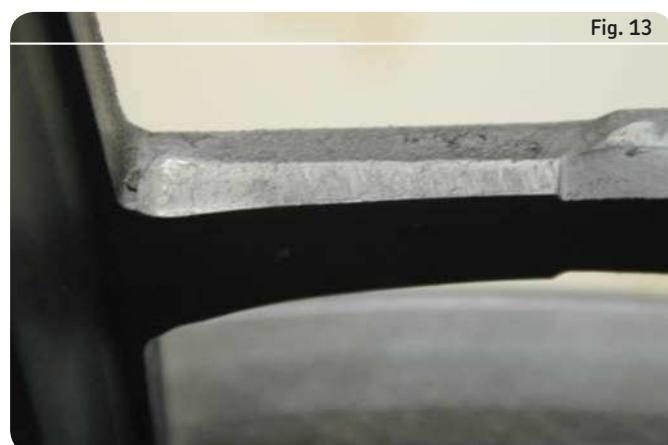
*Fig. 13*

*Cage: Pocket wear*
