# Bearing damage and failure analysis

**SKF®**

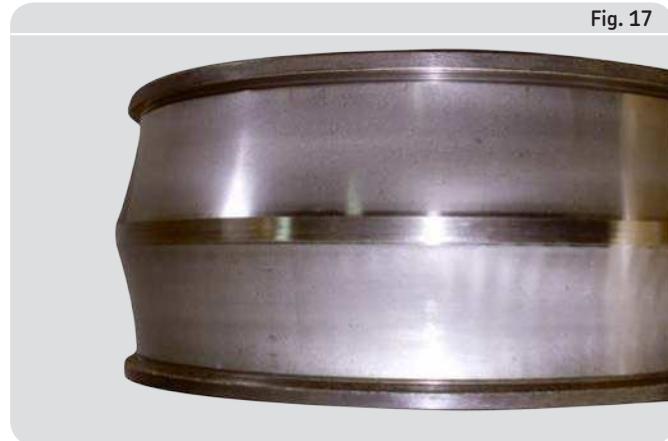
Fig. 17

There was heavy abrasive wear on the raceways (→ fig. 17). No other marks were visible.

The abrasive wear on the inner ring raceways was probably secondary damage due to the spalling, as the condition of the lubricant was found to be unacceptable.

*Inner ring: Abrasive wear on the raceways*

- 1) Check the bearing seat in the housing.  
Repair if needed.
- 2) Locate the source/cause of vibration during operation.

- 1) An inspection of the housing confirmed that the bearing seat had become worn and was no longer providing adequate support in the load zone. This caused severe fretting corrosion on the outside surface of the outer ring and subsequent distortion of the raceways in the load zone. The distortion caused premature spalling.
- 2) A thorough mechanical review of the application showed that material was not discharging adequately, which caused the crusher to "bottom out" and act as a compactor. This explained the excessive vibration and the heavy external loads that accelerated fretting corrosion and the waviness on the raceways.

During a planned shutdown, the bearing seat was repaired and the discharge end of the crusher redesigned. Since the modifications, no further problems have been reported.
