## HOME INSPECTION REPORT

Unit No-XXX, Tower XXX  
Address xxx  
City xxx

4<sup>th</sup> May 2022

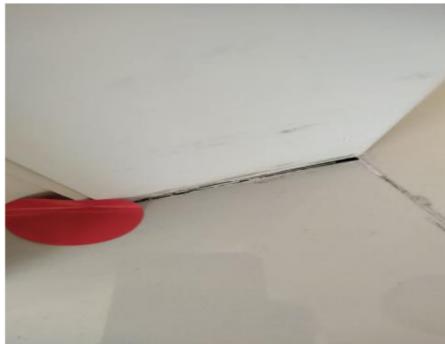
<b>BEDROOM 1</b>	<b>FLOORING</b>	1	Floor Tiles: Are the Butt filling and grooves uniform?	Tile grooves not properly grouted

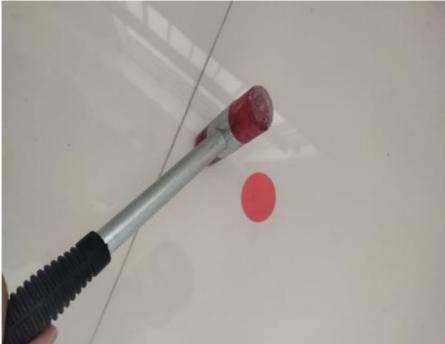
2	Floor Tiles: Tiles fixed are not sounding hollow or debonding not observed in floor tiles	Many tiles are sounding hollow (5% - 20% of tiles)

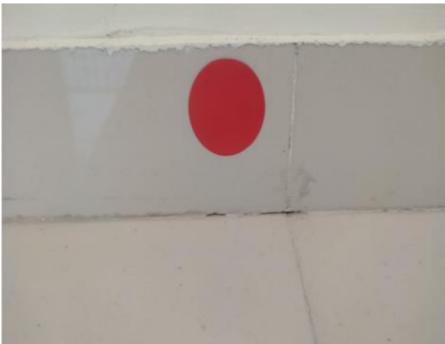
3	Flooring: Are gaps sealing of floor tiles / between skirting & flooring tiles filled properly	Gaps observed at skirting & floor tile joints

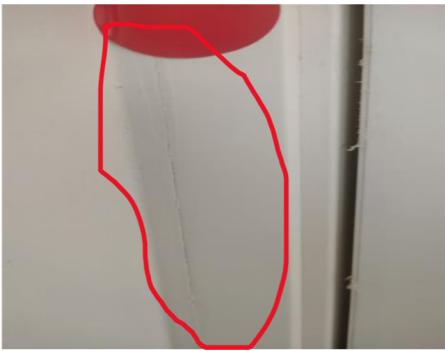
BEDROOM 1	DOORS	1	Doors: Sealant materials applied to fill up the gaps between walls & door frame	Sealant application not uniform

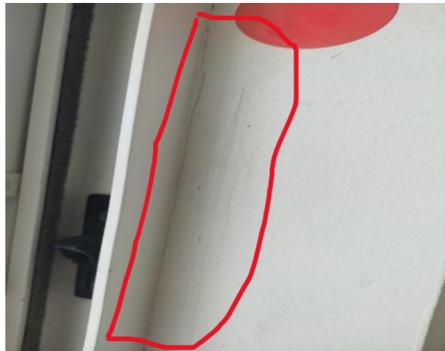
BEDROOM 1	WINDOWS	1	Windows: All gaps between frame are sealed with sealant from internal & external side	Sealant application incomplete

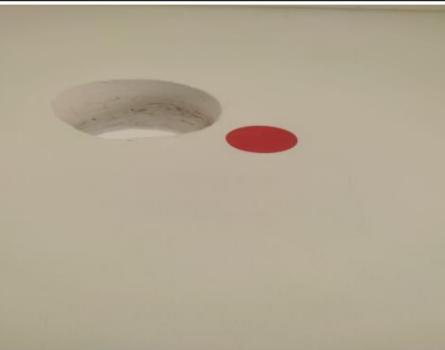
BEDROOM 1	WALL FINISH & ELECTRICAL	1	Wall Finish: Electrical cut outs in wall / false ceiling properly sealed	AC/Electrical provision not sealed

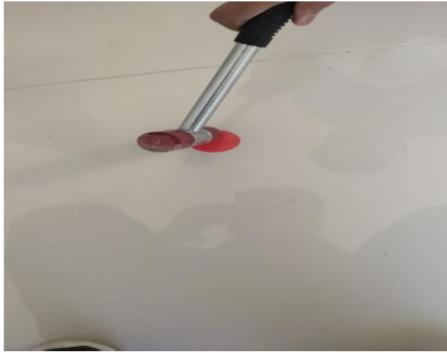
BEDROOM 2	<b>FLOORING</b>			
		1	Flooring: Are gaps sealing of floor tiles / between skirting & flooring tiles filled properly	Gaps observed at skirting & floor tile joints
		2	Floor Tiles: Tiles fixed are not sounding hollow or debonding not observed in floor tiles	Many tiles are sounding hollow (5% - 20% of tiles)

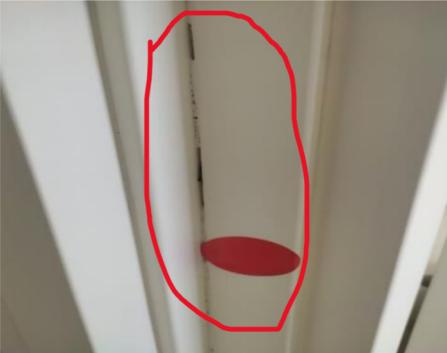
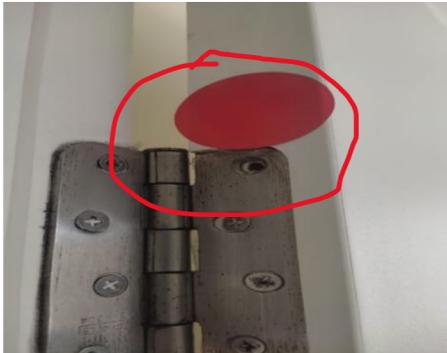
BEDROOM 2	<b>DOORS</b>			
		1	Doors: Sealant materials applied to fill up the gaps between walls & door frame	Sealant application not uniform
		2	Doors: All types of door fittings, hinges screwed properly & operating smoothly	Hinges not screwed properly

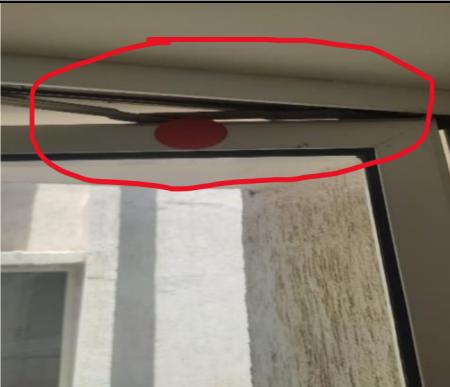
BEDROOM 2	WINDOWS	1	Windows: Windows shutters operating smooth & noise free	Noise observed while operating

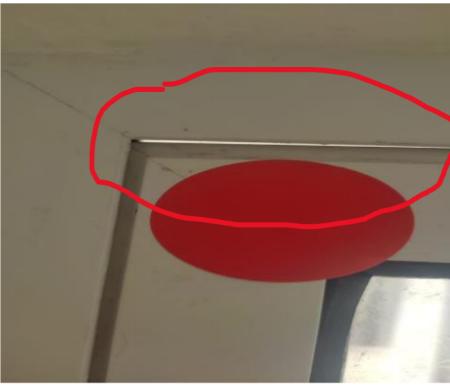
2	Windows: No gaps observed between shutter and frame member joints	Gaps observed between shutter and frame member joints.

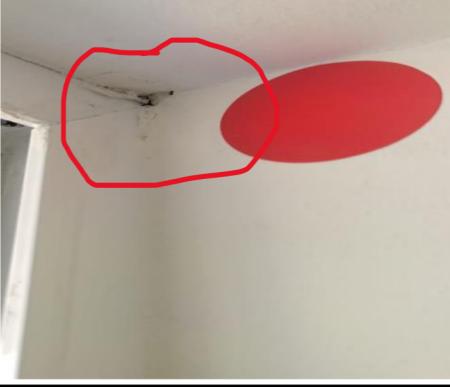
3	Windows: Is sealant application uniform without any bulging	Sealant application not uniform

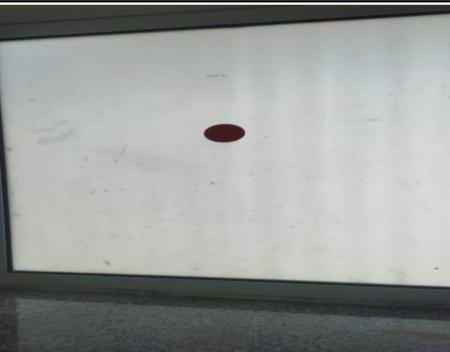
BATHROOM 1	WINDOWS/VENTILATOR			
		1	Windows / Ventilator: Glass cleaned and properly checked for scratches/cracks etc	Glass not cleaned & scratches observed

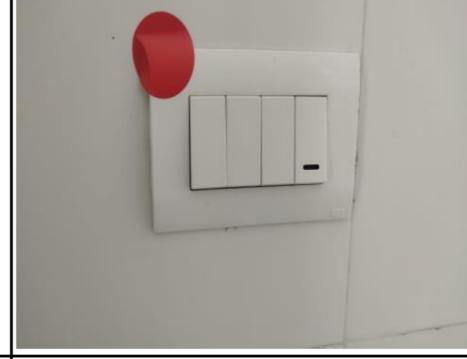
3	Electrical Work: Are switches operating smoothly	switchboard not functioning smoothly

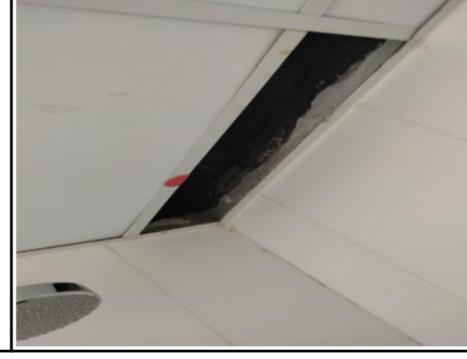
4	Wall Finish: Electrical cut outs in false ceiling properly sealed	Few gaps observed in ceiling cut outs

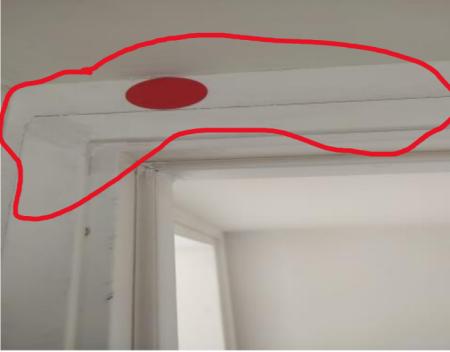
BATHROOM 2	DOORS	1	Doors: Sealant materials applied to fill up the gaps between walls & door frame	Sealant application not satisfactory

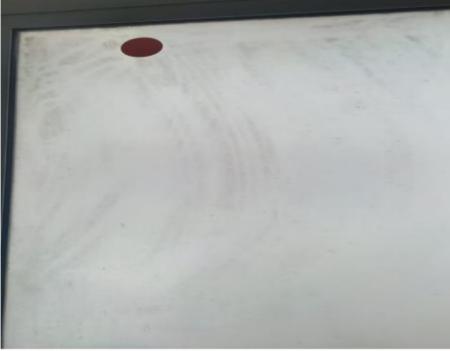
BATHROOM 2	WINDOWS/VENTILATOR	1	Windows / Ventilator: Glass cleaned and properly checked for scratches/cracks etc	Glass not cleaned & scratches observed

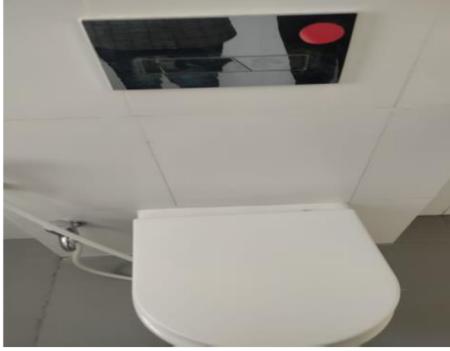
BATHROOM 2	PLUMBING & SANITARYWARE	1	Plumbing: Adequate water temp through hot water tap	No hot water supply to check	
		2	Sanitary ware: Is Fixing of CP and sanitary fittings satisfactory	WC flush not functional

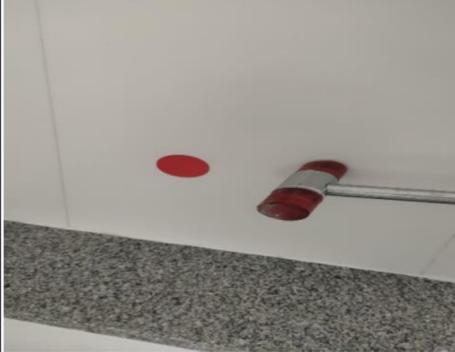
BATHROOM 2	WALL TILES & ELECTRICAL	1	Wall Tiles: Tiles fixed are not sounding hollow or debonding not observed in wall tiles	Few tiles are sounding hollow (less than 5% of tiles)

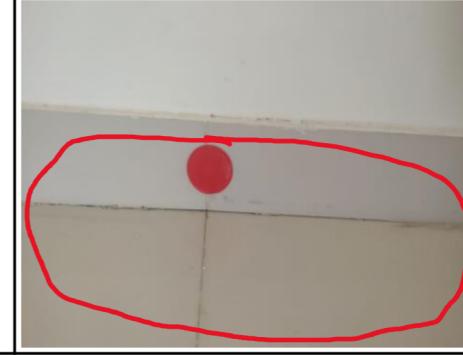
2	Flooring: Are gaps sealing of floor tiles / between skirting & flooring tiles filled properly	Few tiles gaps are not filled properly

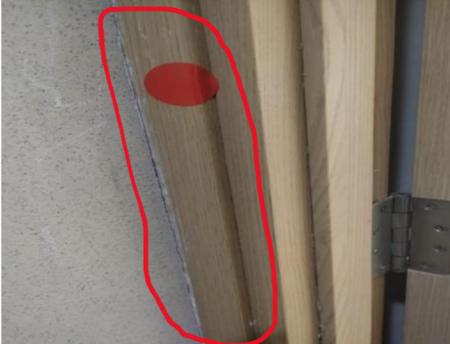
2	Doors: Sealant materials applied to fill up the gaps between walls & door frame	Sealant application not done properly

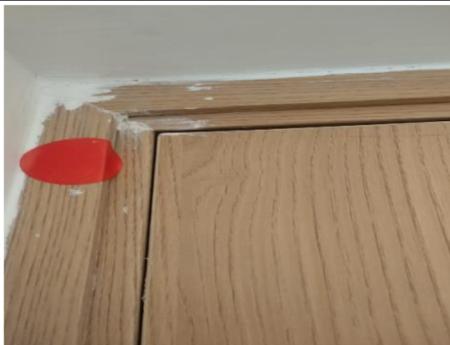
3	Doors: Door fittings are free from paint, dust and rust	Paint stains observed on door frames & fittings

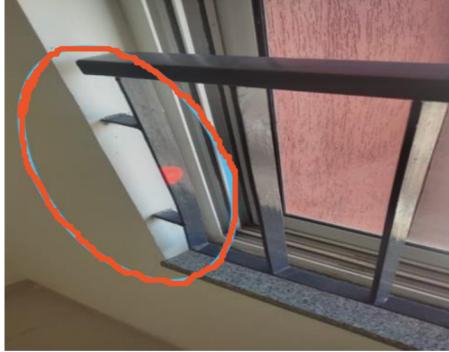
<b>LIVING ROOM</b>	<b>WINDOWS</b>	1	Windows: Any windows frame & shutters bend / damaged?	Bend observed at window inside railing

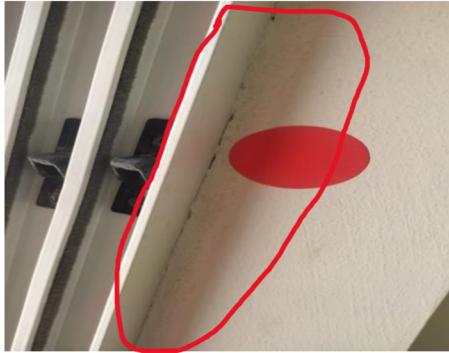
2	Windows: All gaps between frame are sealed with sealant from internal & external side	Sealant application not done properly

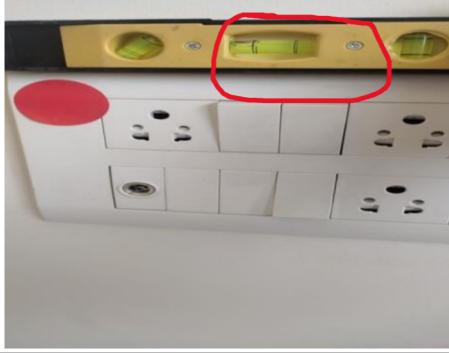
<b>LIVING ROOM</b>	<b>WALL FINISH &amp; ELECTRICAL</b>	1	Electrical Work: All switch boards fixed in line and level	switch boards are not in level

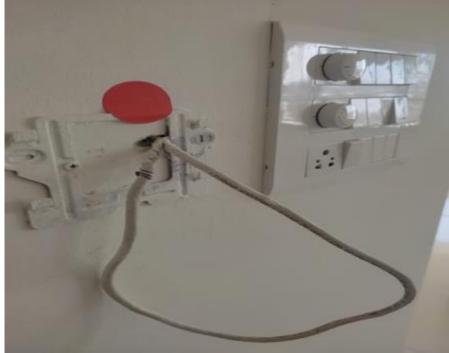
2	Electrical Work: Any Damages/cracks/stains found on switch plates	Cracks observed on walls around switch boards

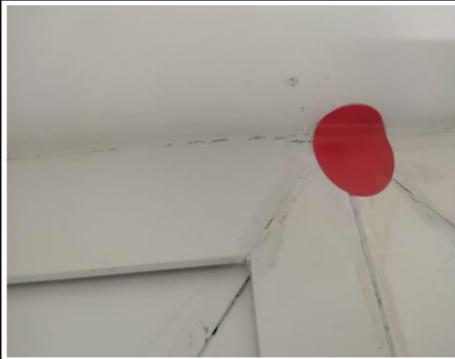
KITCHEN	WINDOWS	1	Windows: All gaps between frame are sealed with sealant from internal & external side	Sealant application not done properly

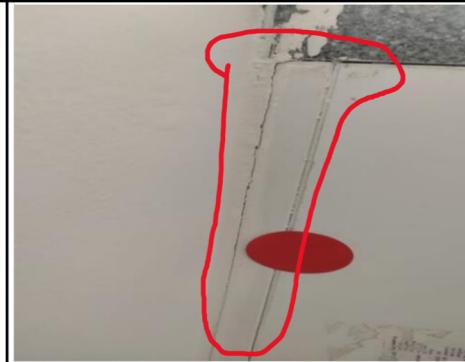
2	Windows: All gaps between frame are sealed with sealant from internal & external side	Sealant not applied properly at many places

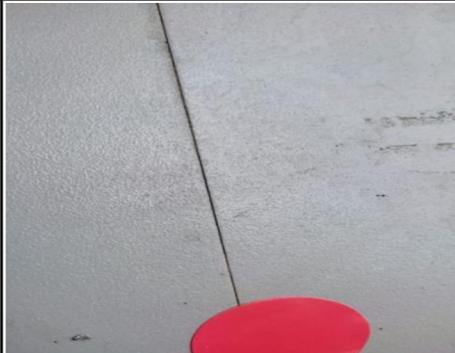
BALCONY	FLOORING	1	Flooring (Tiles): Are the Butt filling and grooves uniform?	Not uniform in many tiles (5% - 20% of tiles)

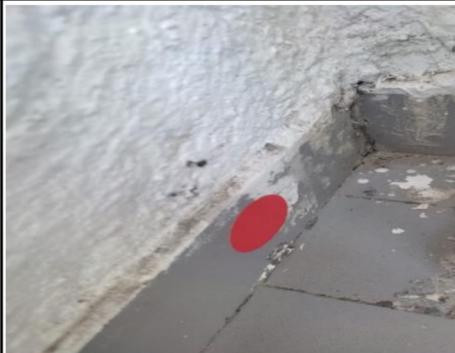
2	Flooring: Any defects found in skirting	Paint stains observed on skirting & tiles

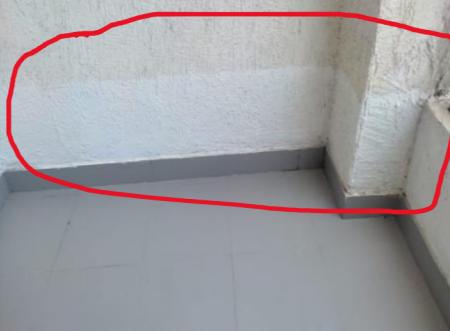
BALCONY	WALL FINISH & HANDRAILS	1	Wall Finish: Shade of paint is uniform at all places	Shade of paint is not uniform

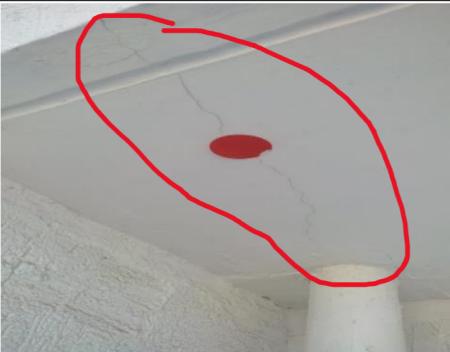
2	Wall Finish: Any cracks / damages /air bubbles/Scratches/peeling off observed in ceiling	Cracks / damages observed at a few places (less than 5% of the ceiling of the room)

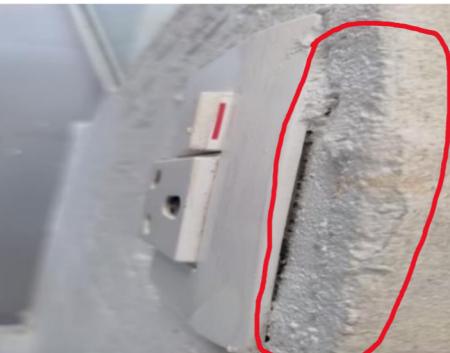
3	Electrical Work: Any gap observed between switch plate & wall/tile surface	Gap observed between switch plate & wall/tile surface

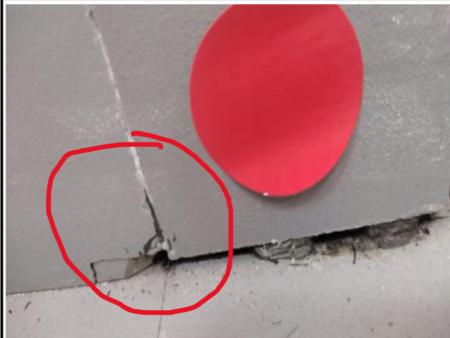
2	Flooring (Tiles): Any cracks / damage / bends observed in floor tiles after fixing	Cracks observed in 1 or 2 tiles

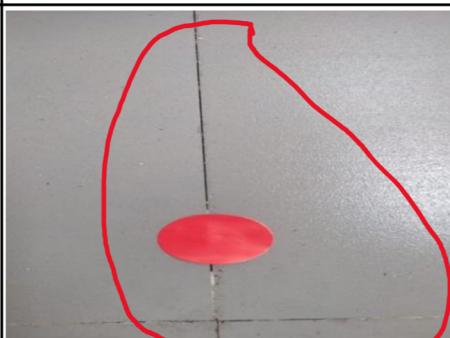
3	Flooring (Tiles): Are the Butt filling and grooves uniform?	Not uniform in many tiles (5% - 20% of tiles)

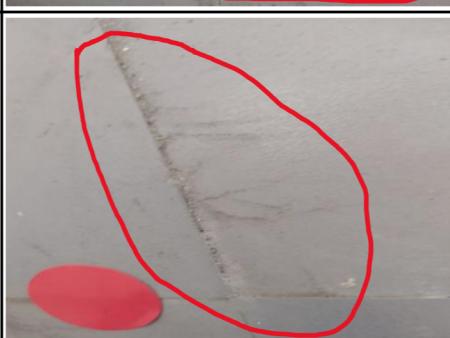
4	Flooring (Tiles): Any offsets observed in the flooring	1 or 2 offsets observed in flooring
