# UCLA Rocket Project

Vehicle: Prometheus (Hybrid) | Cycle: 25-26

## Test Summary Report Cold Flow Campaign #1

**Document No.:** PROM-CFLOW-001-26034  
**Revision:** A  
**Release Date:** 2026-04-12

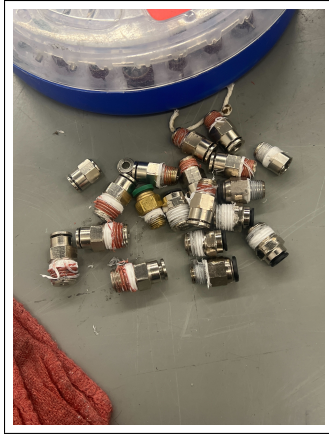
During early high-pressure testing, the push-to-connect fittings failed across multiple attempts. On the first attempt, PTCs sheared at the tank interface, and on the second attempt, a tube connection popped out entirely. The team sourced higher-rated PTCs from McMaster-Carr rated to 800 psi, which were brought in the following day. These failures caused repeated delays to the high-pressure schedule across the Saturday testing window.

(a) PTCs destroyed during high-pressure testing.

When purchasing PTCs and Nylon Lines, verify they are properly rated for high psi to prevent failed tests and to save money. Additionally, ensure the nylon tube IDs are compatible with our

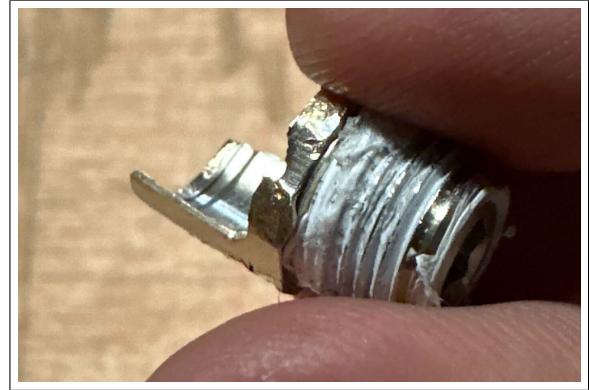
(b) Sheared PTC.

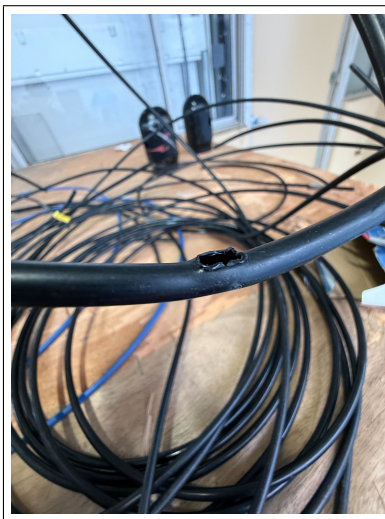
During the first high-pressure attempt with the newly sourced PTCs installed, the nylon tubing in the system burst open. The tubing that failed was older stock found around the lab and in the COTS box, and its pressure rating had not been confirmed prior to use. A slight bend was also observed at the burst location, suggesting the geometry contributed to the failure. The team had 50 ft of 900 psi-rated nylon tubing on hand from McMaster-Carr as a backup, which was then swapped in as a replacement.

Figure 2: Burst nylon tubing.

We tried to high-pressure the entire COTS system (i.e., tank, fill table, engine, etc.) to mimic cold-flow conditions. However, during our attempt, the nylon lines burst, and we terminated the test. We were originally using old nylon lines with an unknown pressure rating, which was likely the cause. Afterward, we were ordered 50ft nylon lines rated for 900 psi.

The first weak link exposed was the nylon tubing. The lines used in the initial high-pressure attempt were old stock with an unconfirmed pressure rating. Had these lines been hydrostatically tested first, the burst would have occurred under water at low stored energy, flagging the lines as unfit. Instead, the failure occurred under high-pressure gas, resulting in a violent burst that immediately terminated the test and required a full line replacement.

Going forward, the standard procedure must be to hydrostatically test all articles in isolation before any high-pressure gas attempt. This means pressurizing to at least 1.5x MEOP and confirming zero leaks and no component deformation. The focus should be entirely on the interface connections, as the COTS tank is already pressure-rated. Skipping hydrostatic testing does not save time; it guarantees time will be lost later, under worse conditions, with more expensive consequences.
