A History of Aerospace Problems, Their Solutions, Their Lessons

*R.S. Ryan
Marshall Space Flight Center • MSFC, Alabama*

National Aeronautics and Space Administration
Marshall Space Flight Center • MSFC, Alabama 35812

September 1996

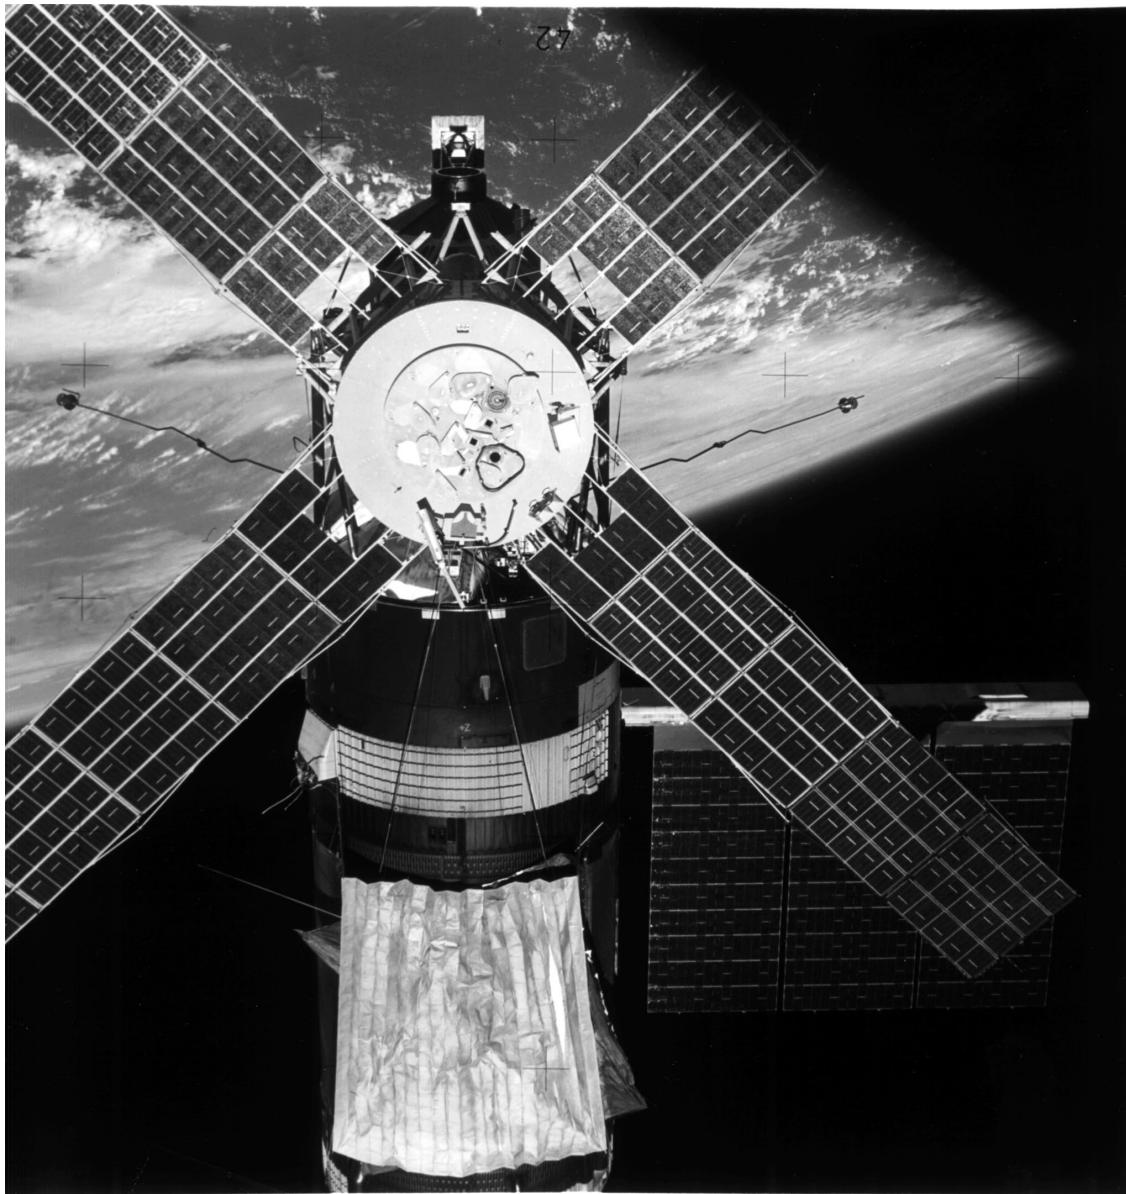
Figure 38. *Skylab twin-pole Sun shade.*

venting design of the box that contained the wing, which caused it to trap the 14.7 lb/in² ground atmospheric pressure that in near vacuum ripped the wing loose and destroyed the debris shield, exposing the gold covering of the workshop.

NASA Centers worked around the clock to understand the problem and to design fixes. The missing solar thermal/debris shield had to be replaced. Many options were looked at, with two being designed, built, and verified. Their installation was practiced extensively in Marshall's Neutral Buoyancy Simulator tank, designed to simulate zero gravity working conditions for astronauts. One lesson is clear: "one must have in place the technologies needed when problems occur." The two solar thermal systems were: (1) a fold-up parasol type shield that could be deployed off the workshop airlock viewing port by the crew (this was accomplished on the first mission and went a long way in stabilizing the temperatures, which dropped to 90° (fig. 38)), and (2) a twin-pole sail, which was deployed by the second crew using EVA by the astronauts (fig. 39). The second shield was more effective and lasted the life of the station.
