SATQUERY AI — EARTH OBSERVATION REPORT

Remote Sensing Inspection & Telemetry

| Visual Query: | Perform bi-temporal change detection and identify any new logistics warehouse construction or altered waterfront infrastructure. | Evidence Type: | change_overlay |

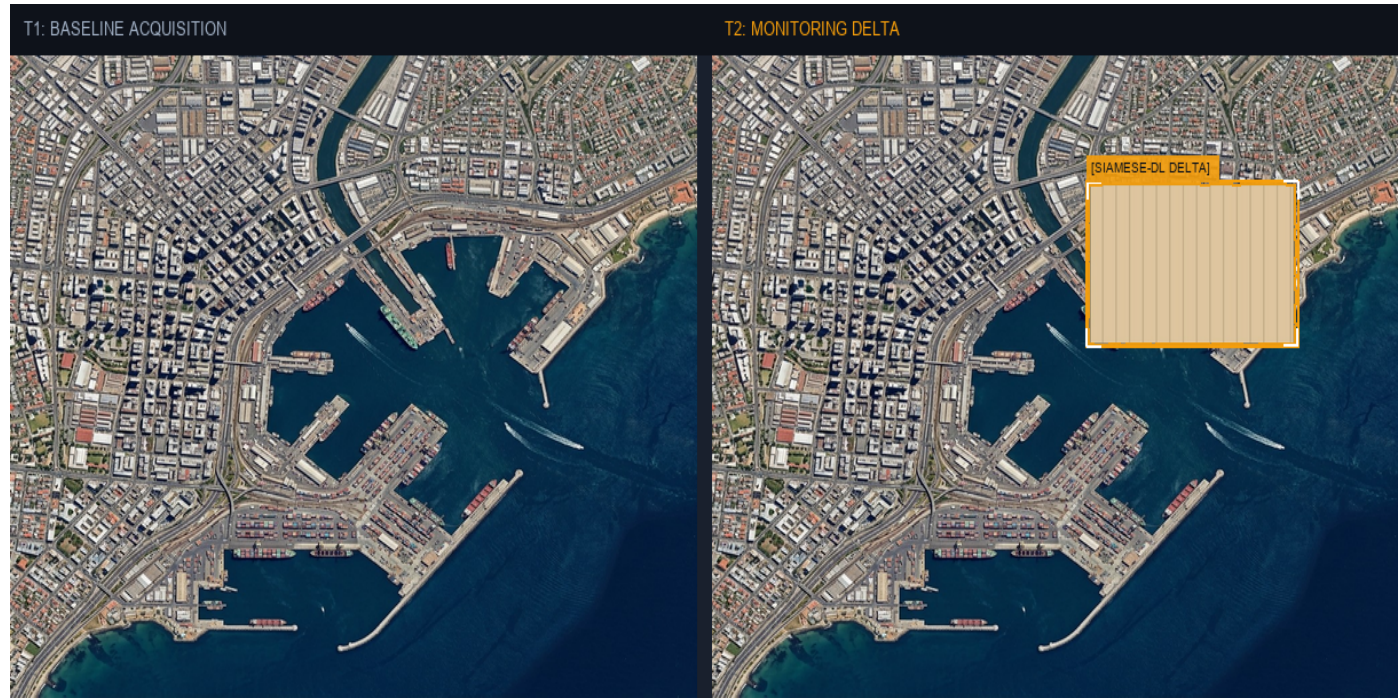
Significant large-scale development has occurred within the port area, specifically in the upper-right quadrant. A substantial portion of existing waterfront infrastructure and adjacent water has been transformed into a new, expansive construction site, indicative of major port expansion or logistics facility development.

| Key Features | <ul style="list-style-type: none"><li>• Large-scale new construction/redevelopment covering existing port infrastructure and water in the upper-right quadrant.</li><li>• Extensive infill and surface alteration within the primary port basin (upper-right quadrant).</li><li>• Potential new logistics hub or expanded terminal facility (upper-right quadrant).</li></ul> |
| Spatial Patterns | The change manifests as a single, contiguous, large-scale infill and redevelopment project within the existing port boundaries, specifically expanding into a previously active water basin and replacing existing structures. This suggests a strategic expansion rather than peripheral growth. |
| Spectral Indicators | A pronounced spectral shift is observed from the varied reflectance of existing port infrastructure (concrete, asphalt, metal, water) to a uniform, bright gray signature characteristic of a large-scale construction site or newly developed surface. This indicates a complete overhaul of the surface material and topography within the affected area. |
| Risk & Exposure | Potential concerns include significant alteration of marine habitats due to infill, increased runoff and potential for water quality degradation during and after construction, and the long-term environmental impact of expanded industrial port operations. |
