TID and SEE Response of the COTS LI-OV9712-USB-M8 Camera

A. Noguera Cundar, D.M. Hiemstra, J. Cardenas Chavez, N. Phonsavath, M. Pajuelo, L. Chen

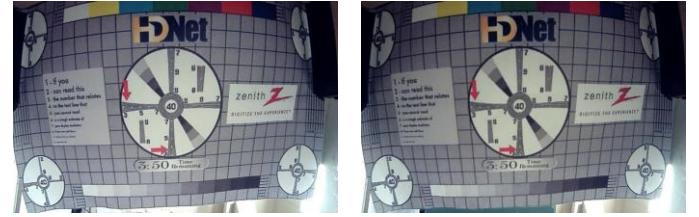
Images presented in Fig. 6 reveal that there is no significant visual degradation of the color or quality of the images captured up to 95 krad dose. Moreover, these pictures help to confirm that as stated before, for accumulated doses below 95 krad there is no presence of dead pixels and all the fixed pattern noise found in the dark pictures can be attributed to increase of the leakage current causing hot pixels.

Fig. 6. Color pictures captured at different total doses using the DUT.
