## SAFETY ALERT

OISD/SA/2022-23/PL/07

Title: Pipeline burst incident in product pipeline.  
Location: Under boundary wall in field location.  
Loss/ Outcome: 21 KI product loss and loss of operation for 27 hours.

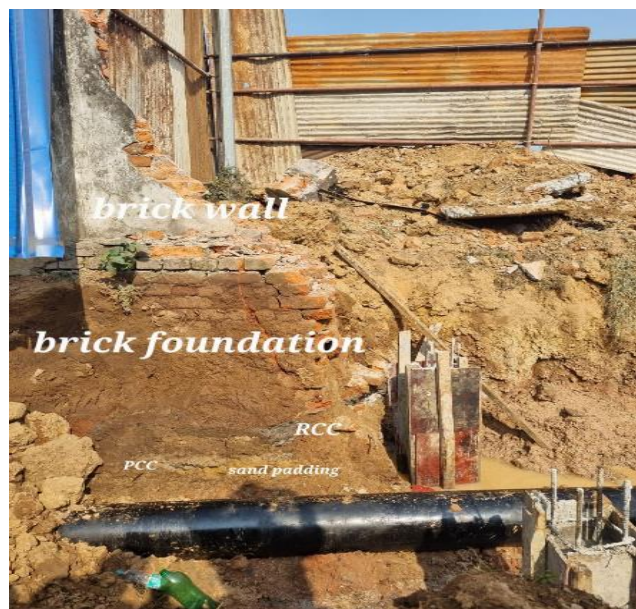
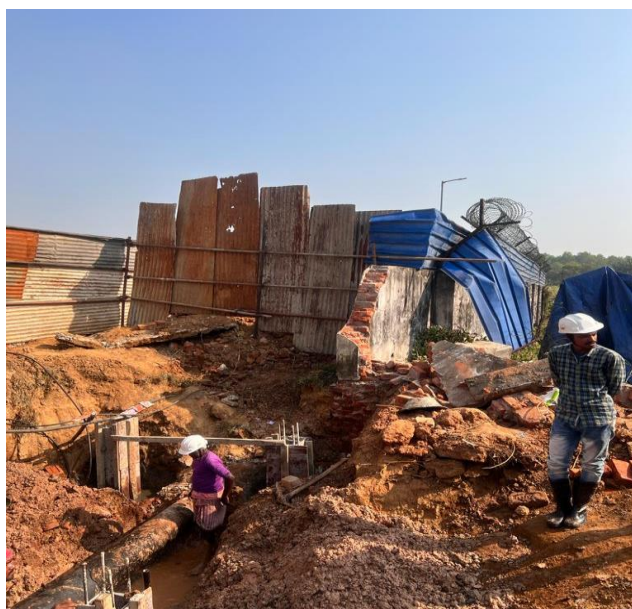
Pipeline under boundary wall

1. The incident took place at the point which was found buried at this incident location under the boundary wall crossing of one of the installations. As gathered and corroborated from Google MAP images, it was observed that Boundary wall construction was done almost 10-12 years back. Similar condition/ crossing of boundary wall was observed at seven other locations within the installation. No permission letter and/or design/drawing approval for boundary wall construction was found. Nevertheless, an agreement between owner & installation was available as part of SOP for attending leak, its detection and repair action.

5. Direct boundary wall shall not be constructed over pipeline, instead protection using casing pipe / construction of culvert over pipeline shall be considered based on structural loading.
