## SAFETY ALERT

OISD/SA/2026-27/P&E/03

**Title:** Fatal Fall from Height during Electrical Cable Laying Activity

**Location:** Hydrogenated Pyrolysis Gasoline Project Area

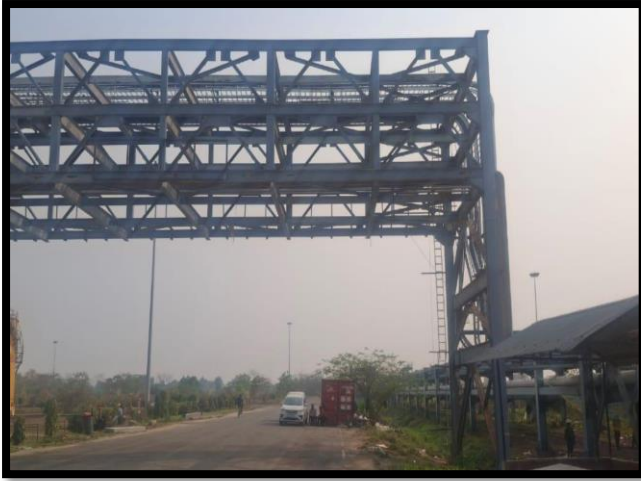
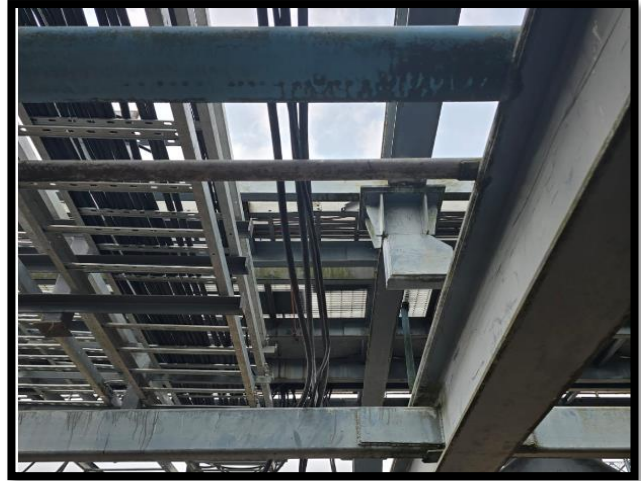
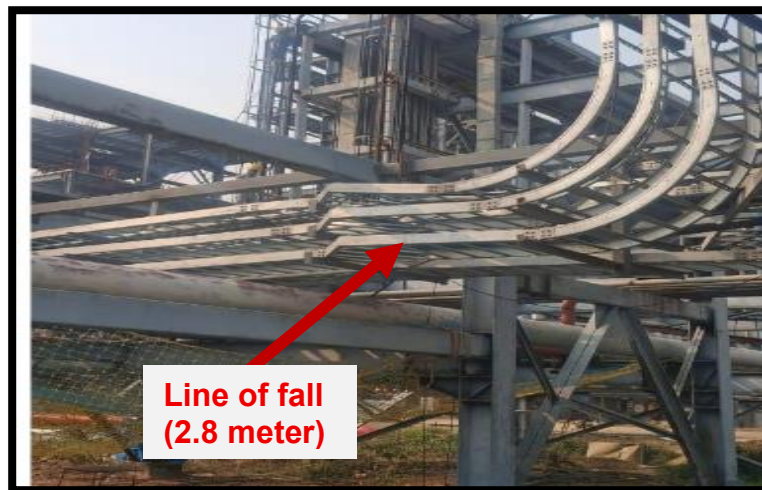
The incident took place in a Project Area. During execution of electrical cable laying activity by the contract workman (hereinafter called Injured Person (IP)), the fall incident occurred at the junction point of East-West to North-South pipe rack. IP was working with proper personal protective equipment including a full body safety harness anchored to a secure point. Subsequently, he moved towards the North-South pipe rack through the horizontal portion of the cable tray to perform cable dressing activity. The cable tray arrangement consisted of three layers, and the workman was moving with his feet on the lowest cable tray while holding the top layer cable tray with his hands for support.

During the movement he had not anchored the full body safety harness. When the workman inadvertently held a loose overhead cable tray, he lost his balance and fell. The loose cable tray got stuck on the beam, while the workman fell approximately 2.8 meters to the ground level.

1. The IP was wearing personal protective equipment; however, the full body safety harness was not anchored during movement at height.
2. Proper walkway/ scaffolding had not been constructed for the job.
3. Illumination at the work site was not adequate.
4. Proper supervision was not done by the job supervisor during execution of the critical activity.

1. Non-anchoring of safety harness during movement at height, indicating unsafe work practice and inadequate supervision.
2. Absence of proper scaffolding/ walkway for work at height.

1. Work at heights shall be carried out on properly erected and inspected scaffolding platforms. Scaffolding with adequate platforms, handrails, and all stipulated appurtenances shall be provided at all such locations in line with OISD-GDN-192.
2. Possibility of using secondary protection devices such as safety net or fall arrestor should be explored for execution of such jobs.
3. Adequate illumination should be available at work site, particularly where work at height is being carried out.
