## सेफ्टी अलर्ट / SAFETY ALERT

OISD/SA/2024-25/MOPOL/04

**Title:** Pipeline Pilferage and Fire incident in 16" MS Jetty Pipeline

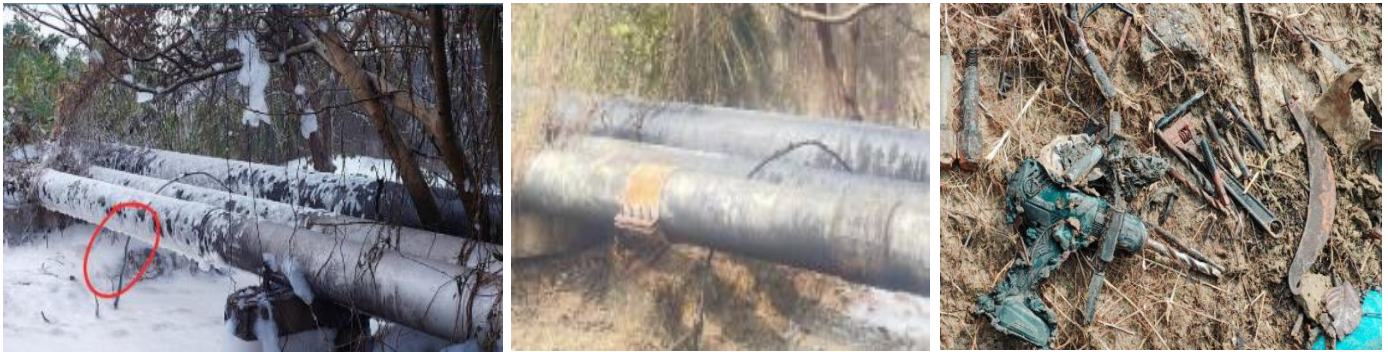
- ❖ As per OMC investigation report, pilferage was being carried out by miscreants evidenced by presence of handheld battery-operated drilling machine and fittings for tapping of the pipeline at the site.
- ❖ There was a pool of products formed which caught fire during ongoing pilferage by miscreants and the vegetation around the pipelines also caught fire.

- ❖ The incident spot is around 40m away from motorable road separated by thick vegetation/muddy soil due to which the location is inaccessible for firefighting from roadside.
- ❖ Security guards were not walking along the pipelines during patrolling, they were walking on the road which is approx. 40 mts from the pipelines. Due to dense vegetation along pipelines, there is no clear visibility from this distance to detect suspicious activities especially during night hours.
- ❖ There are four OMC terminals and one refinery located adjacent to each other, but no common communication system among the OMC installations available.
- ❖ There was no CCTV coverage of the network of pipelines.
- ❖ Approximately 4KL product loss due to pilferage and fire.
- ❖ There were no injuries or fatalities.

- ❖ Security patrolling pathway alongside of the network of pipelines for effective monitoring.
- ❖ The pipeline corridor shall be free from dense vegetation.
- ❖ Explore fixing PTZ CCTV cameras to monitor vulnerable sections of pipelines.
- ❖ OMC industry members should devise a plan to secure the pipeline corridor area.
- ❖ All the nearby installations should explore a common emergency communication system.
