## SAFETY ALERT

OISD/SA/2023-24/P&E/01

Title: Fatal accident due to pipe rollover during unloading of pipes in pipe yard.

Location: Pipe storage yard in Refinery.

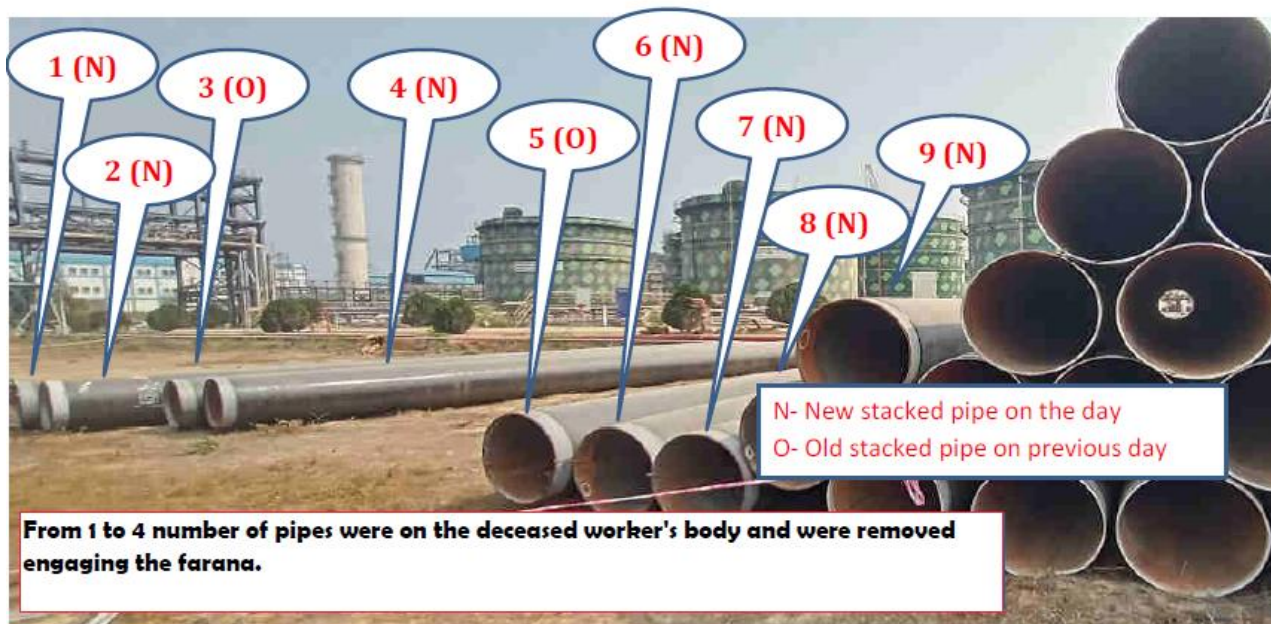
PICTURE: NUMBER PIPE ROLLED DURING ROLL OFF:

The Incident happened when unloading of pipes (NB 24 inch) was being done in pipe yard. Pipes were stacked and lifting of pipe was being done by 17MT Farana crane. During this activity few pipes (9 No.) rolled off from pipe stack and rolled over a contract worker engaged in the unloading work. Four number of pipes rolled over victim while his leg got trapped in one of the rolled pipe. The injured workman was shifted to the hospital, and he had been declared brought dead in the hospital.

- Deceased person was inexperienced for this job, it was his first day for pipe unloading job. He had undergone mandatory safety training for gate pass purpose, but not undergone any toolbox talk for such job.
- The ground where pipe stacking was done was not levelled/ graded and was uneven.
- Some of chocks/ stoppers were observed not adequate to perform its function. The gap between the grade and bottom of the pipe were uneven and in one case the chock/ stopper was below the pipe.
- There was no procedure available for stacking, unloading of pipe.
- There was no supervision during stacking and unloading activity.

- Uneven surface of storage yard.
- Inadequate pipe stoppers/ chocks.
- Engagement of unexperienced worker.
- Lack of supervision and lack of risk perception.
- Toolbox talk was not conducted by which safety measures and risks could be communicated.

- A SOP shall be framed for pipe unloading and stacking mentioning the required manpower skill level, maximum stacking height, maximum numbers of layers of pipes, wedge/ Chock dimension.
- Pipe stack yard surface shall be made even and levelled properly prior to unloading & stacking.
- Stoppers with steel pipe/ RCC pole shall be positioned on both sides of stacked pipe after stacking the bottom layer pipes.

- Adequate chokes shall be placed on outermost bottom layers of pipes. Only after stacking and choking of bottom layer pipe, the subsequent layer shall be stacked.

- Barricading shall be done to indicate the line of fire, and no one shall be allowed to enter the barricade and there should be mandatory deliberation about line of fire during toolbox talk (TBT).
