## SAFETY ALERT

OISD/SA/2024-25/P&E/08

Title: Fatal Incident of Truck Driver.

Location: Vicinity of molten sulphur loading area.

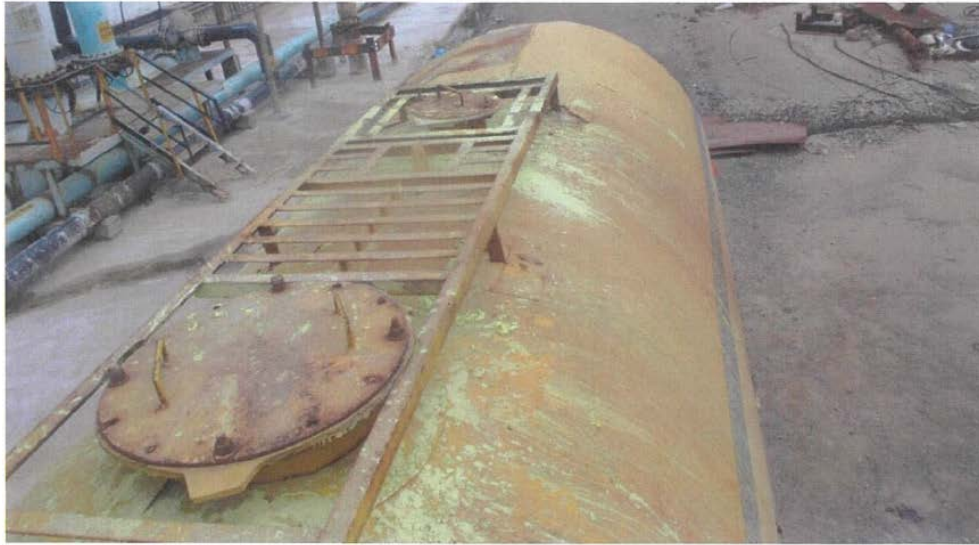
**Fig:1 – Top View of Molten Sulphur Tank Truck**

3. The truck loading lid and dip lid were found in closed condition (Refer Fig:1). This was noticed and reported by the molten sulphur truck loading service assistance worker. Hence, the possibility of driver becoming unconscious due to the presence of H<sub>2</sub>S was less.

The most probable cause could be fall from the top of truck while the driver was trying to either climb up or climb down the ladder attached to the truck. (Post-mortem report was still awaited at the time of publishing the safety alert.)
