Grating Efficiency Analysis

REIXS Spectrometer, CLS

Mark Boots
December 2007

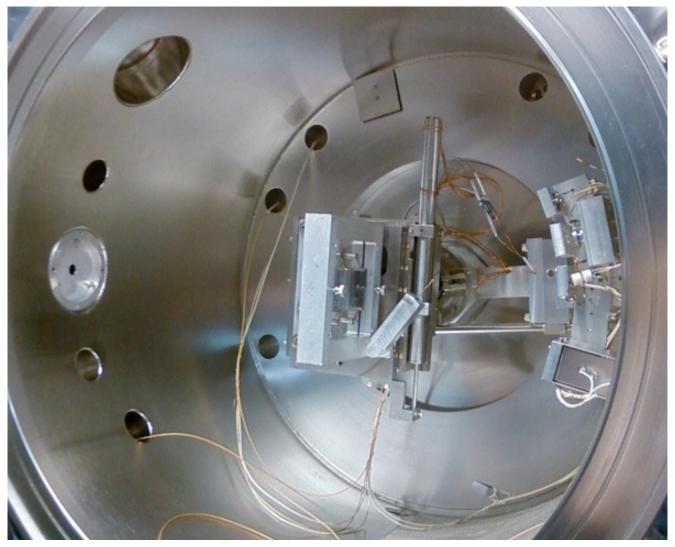
Grating efficiency

Dec: Measured actual efficiency using diffractometer on BL 6 (ALS)

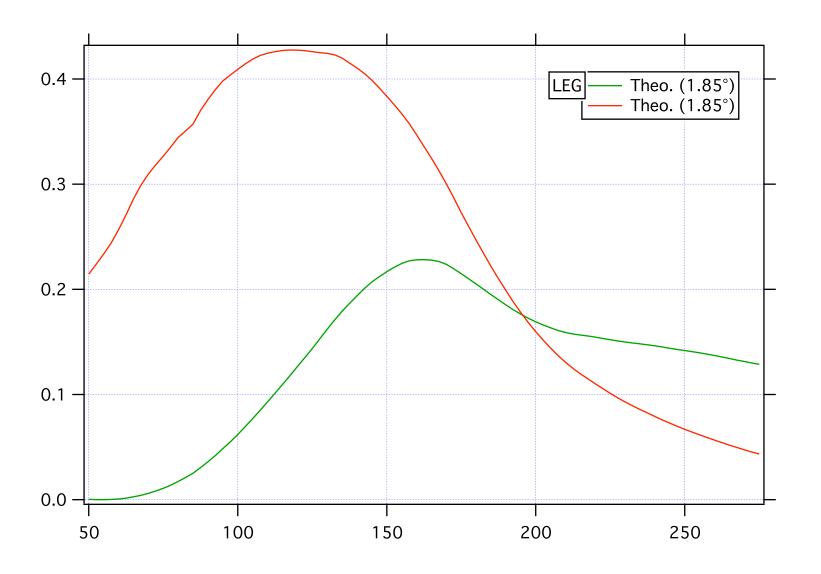
LEG: Predicted

Very efficient: up to 40% @ Si edge

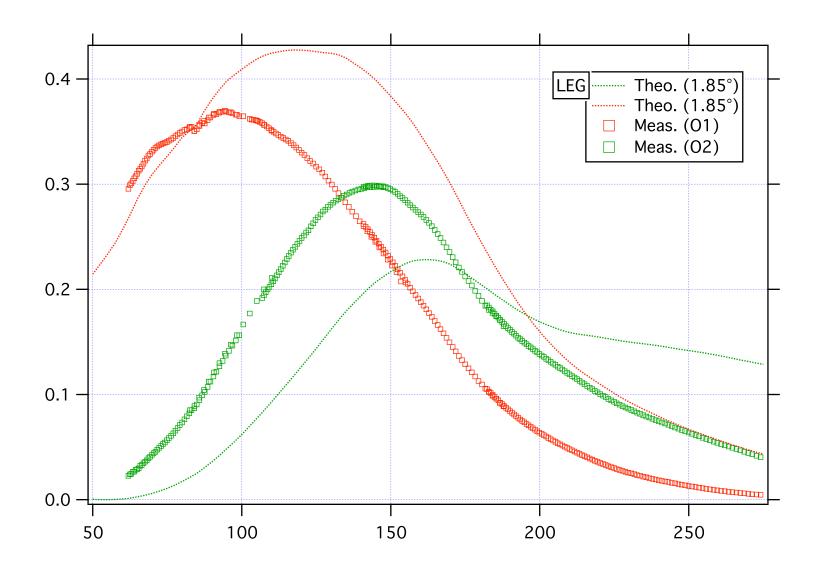
LEG: Measured

What happened? Peaks shifted, 2nd order messed

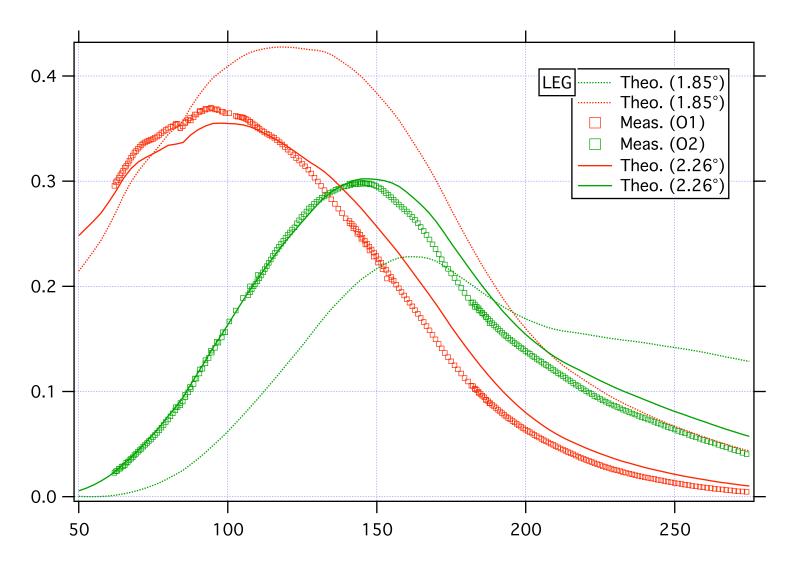
LEG: Hypothesis

Hypothesis: manufacturer missed blaze angle target of 1.85 degrees. Closer to 2.26 (estimated).

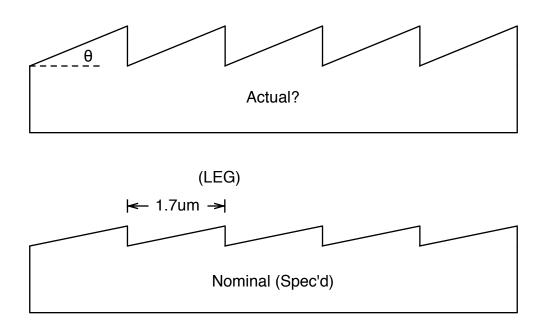
LEG: Hypothesis

Hypothesis: manufacturer missed blaze angle target of 1.85 degrees. Closer to 2.26 (estimated).

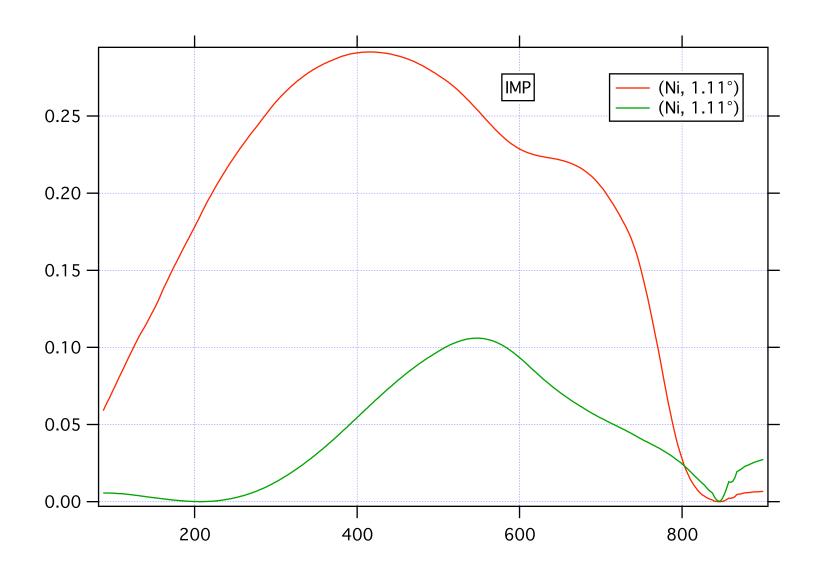
IMP: Predicted

Wide high-efficiency range

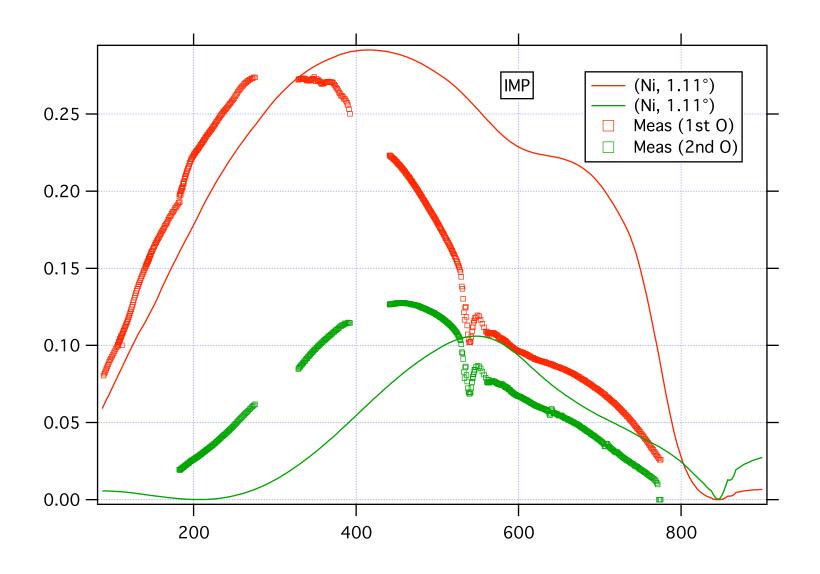
IMP: Measured

What happened? Shifted again, but also...
 Drop-off near 520eV... Hmm... O-edge?

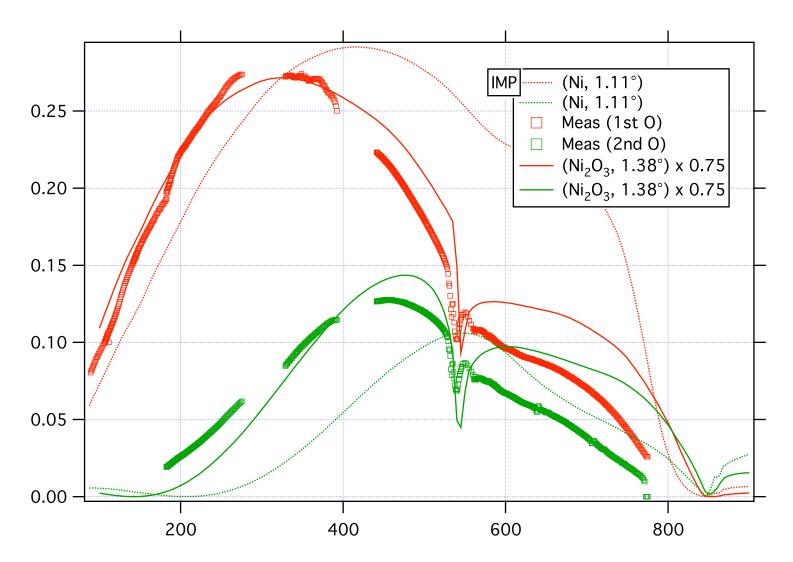
IMP: Hypothesis

- Fitted: modeled as Nickel Oxide, I.38deg blaze angle.
- Conclusion: Missed target blaze; Grating is oxidized.

- Conduct AFM scans of all gratings to actually measure the groove profile / blaze angle
 - Fitting estimates show all blaze angles are 0.3deg to 0.4deg too large.
 - If so, gratings are off-spec (±10%) and should be fixed by Bernie and co.
- Find a chemical that will dissolve nickelous oxides but not nickel...
- Find out what happened with HEG.

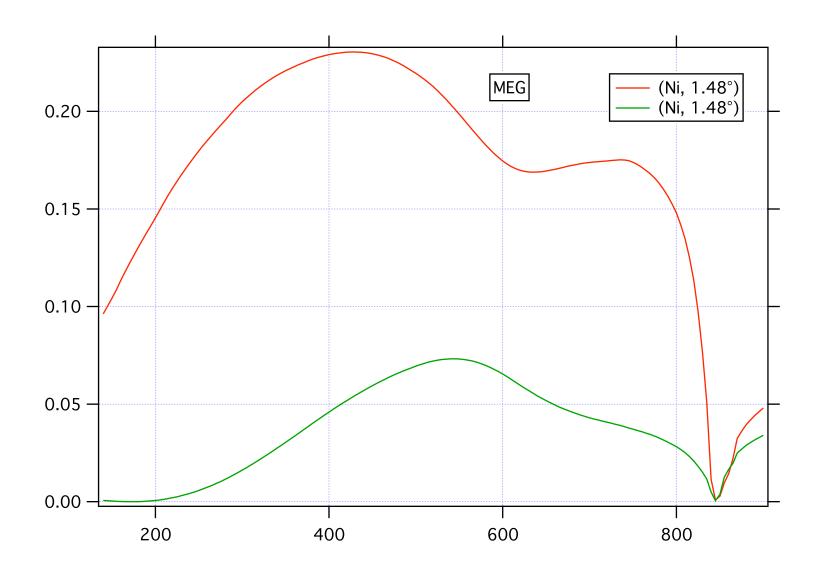
MEG: Predicted

• Same story as IMP...

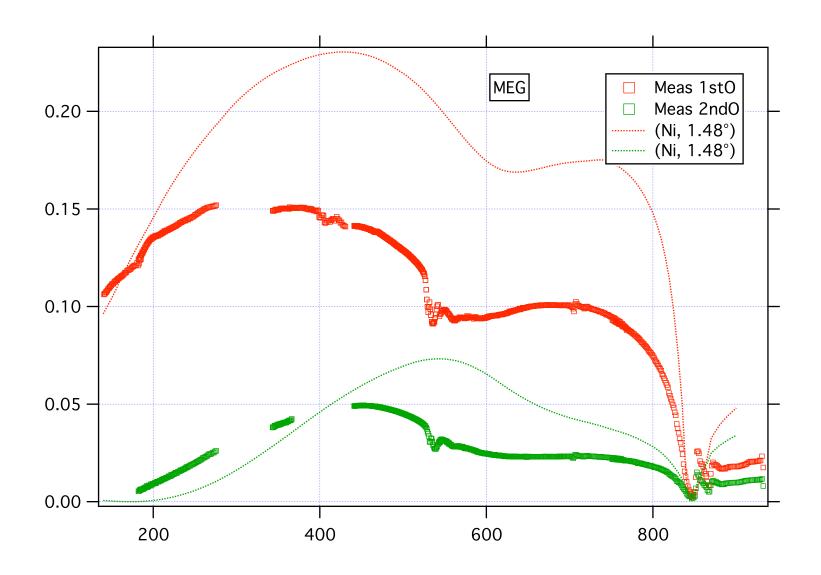
MEG: Measured

What happened? Drop-off near 520eV... Hmm...
 O-edge?

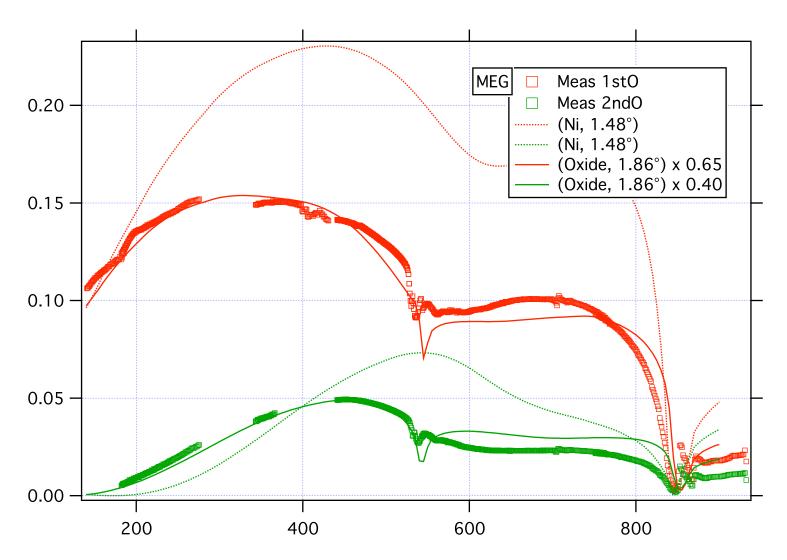
MEG: Hypothesis

- Fitted: modeled as Nickel Oxide, I.86deg blaze angle.
- Conclusion: Missed target blaze; Grating is oxidized.

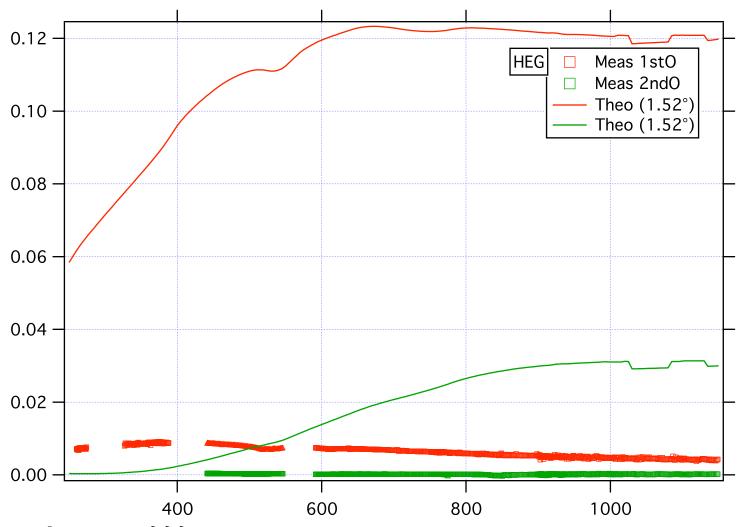
HEG: a total dud...

- Hypothesis: ???(Did they mark the blaze direction backwards?)
- Even high-res gratings in 3rd order get better efficiency

- Very disappointing; HEG is a critical grating.
 - Pt-coated: crucial for measuring above Ni-edge.
 - Covers entire range from 400 I300eV
- Even high-res gratings in 3rd order get better efficiency

- Best scenario: Direction of blaze was marked backwards, so simply rotating the grating 180deg. will fix it.
- If not...???
 - AFM scan will reveal if this is the case.

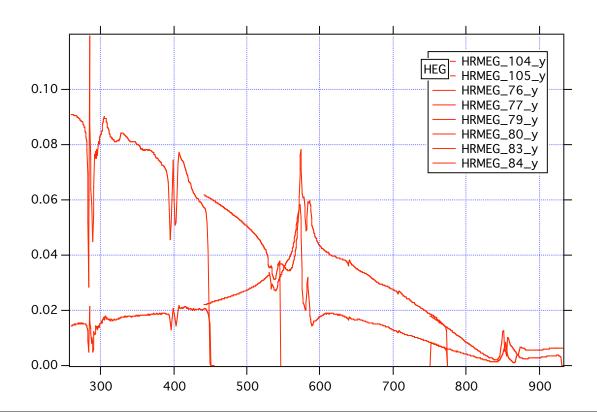
- Still working on analyzing data from HR gratings.
 - Beamline 6 normalizing software had bug with offset points (apparent only near absorption edges)
 - Need to normalize manually, or fix software:
