Subject: Grating Measurement Results

Here are the metrology results for the two grating:

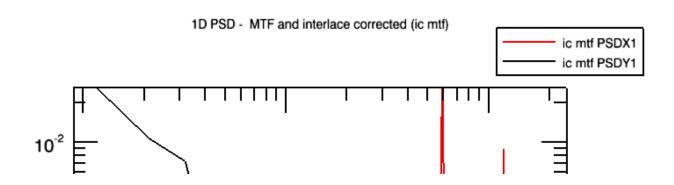
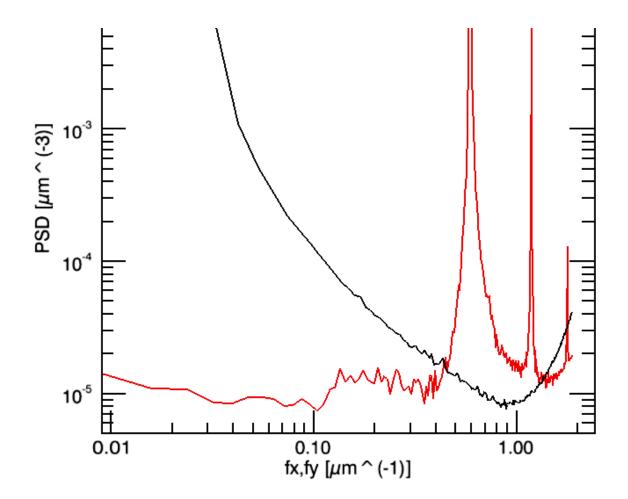
LEG #1 600 lines/mm R5m

Slope Error: 1.735 μ rad RMS Radius: 5.0256 m \pm .0005 m

Line Width: $593.02 \text{ lines/mm} \pm 2.77 \text{ lines/mm} (\pm 0.47\%)$ Line Width error from 600 lines/mm = -1.16% See attachment.

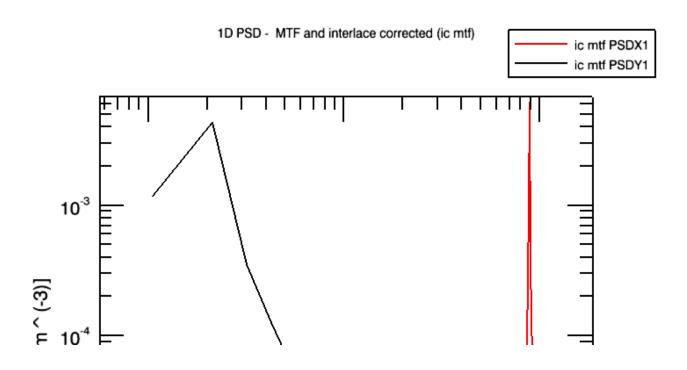
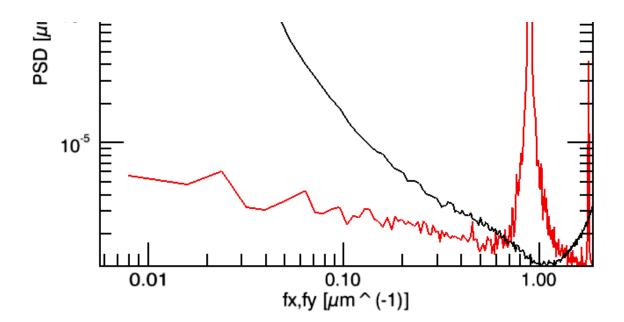
IMPURITY #2 900 lines/mm R6m

Slope Error: 1.535 μ rad RMS Radius: 6.6998 m \pm .0013 m

David: Is this radius supposed to be 6.00 m? If so, it clearly doesn't meet spec and you should discuss this with Bernie Bach?

Line Width: 892.86 lines/mm ± 3.986 lines/mm (±0.45%) Line Width error from 900 lines/mm = -0.793% See attachment.
