# **E/I/I test tables**

Grounding on Boolarong Bank, Weerona Channel, Kanooka Heads

INVESTIGATION WORKFLOW SUITE

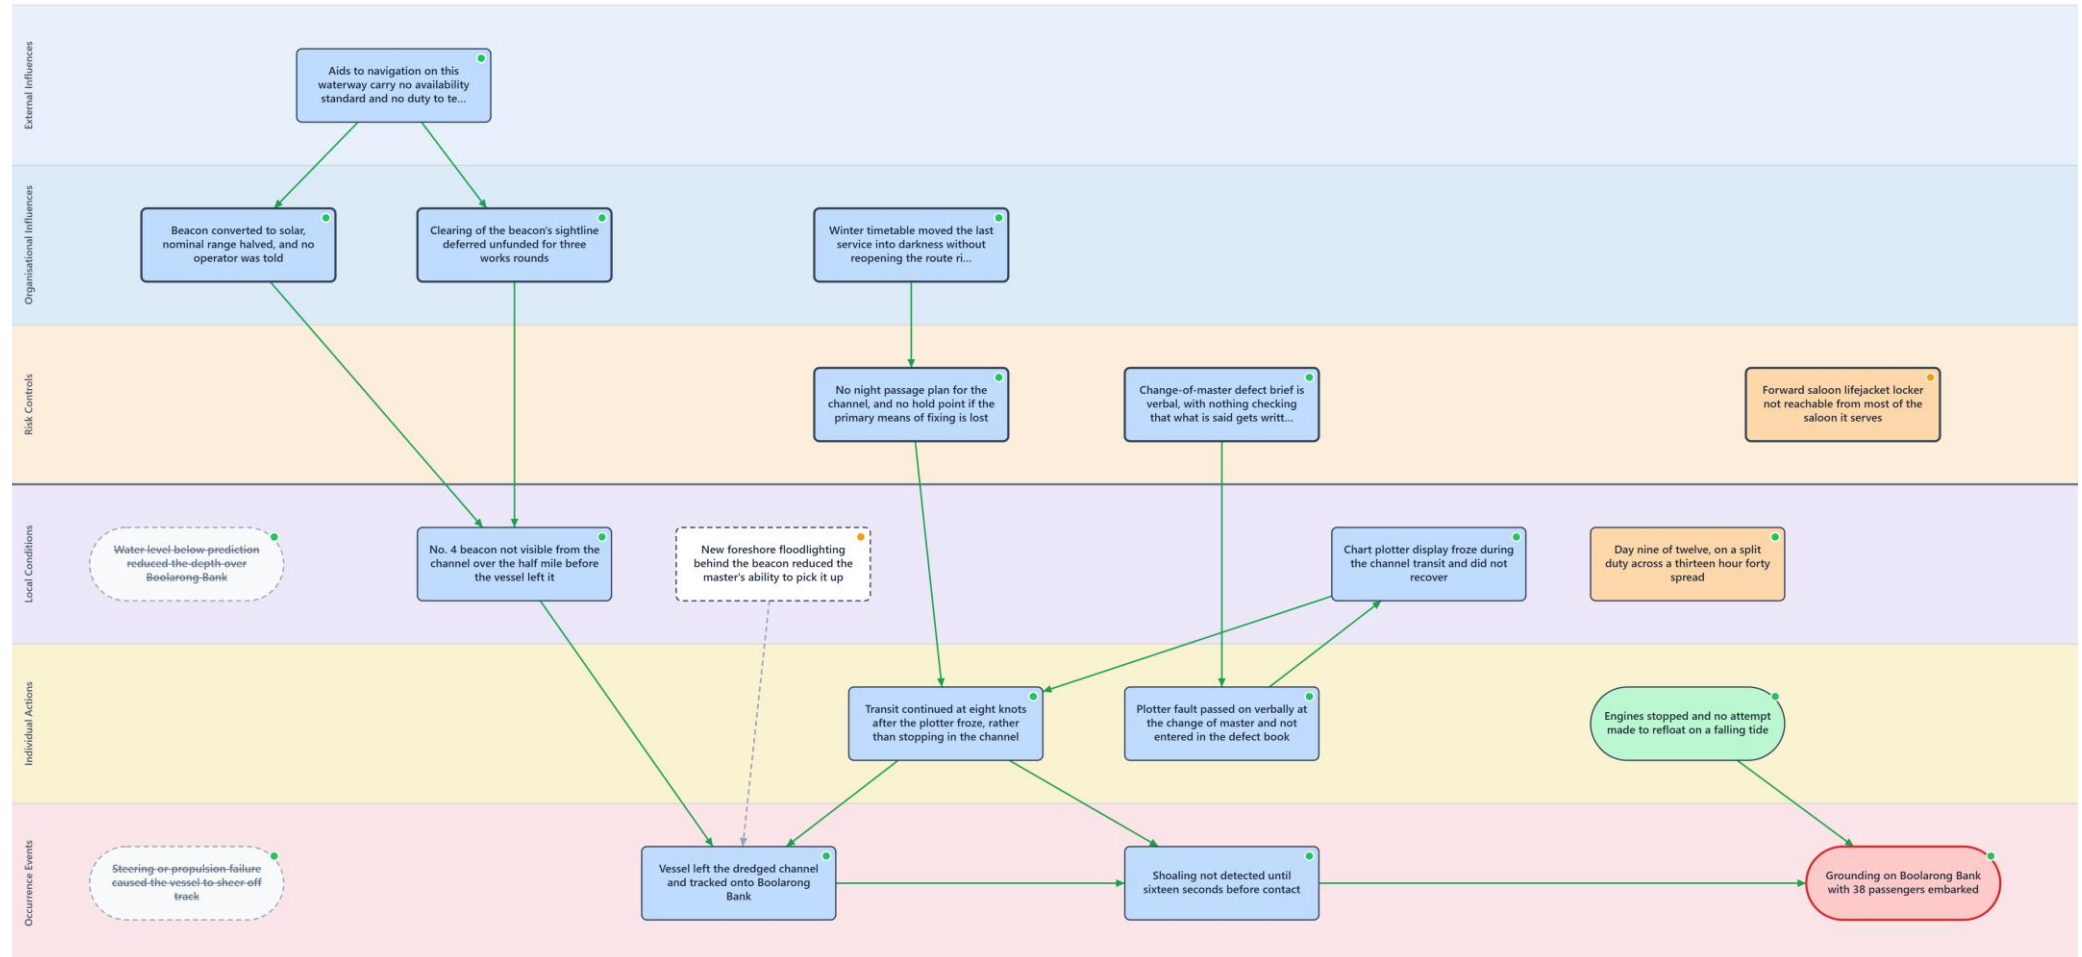
Existence: did it exist or occur? Influence: did it influence this occurrence? Importance: is it worth addressing regardless?
