# Evidence and Argument Tables

Grounding on Boolarong Bank, Merrandi Channel, Kanooka Heads

Exported 8 October 2026

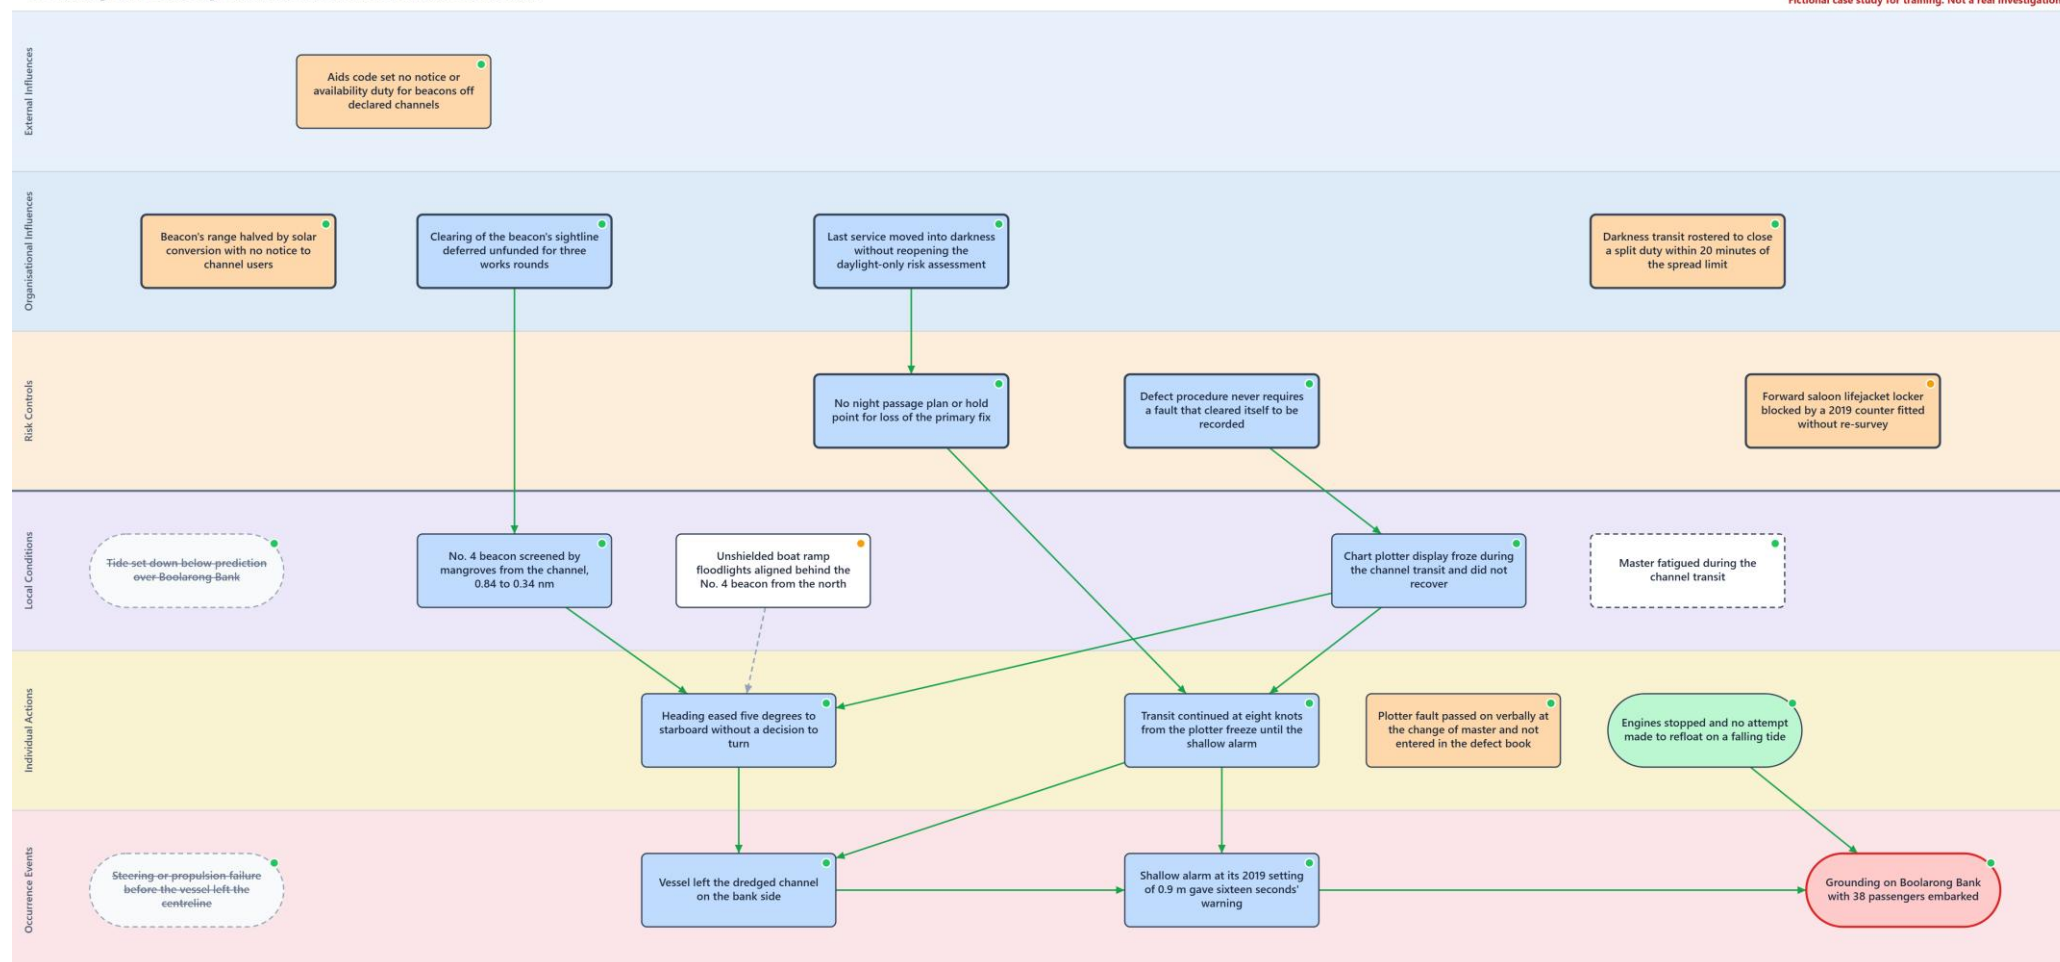
## AcciMap

## Grounding on Boolarong Bank, Merrandi Channel, Kanooka Heads
