# Investigation report

Rejected take-off and runway overrun, Tarlton Springs - NTSB-style  
probable cause report

Drafted 02/10/2026

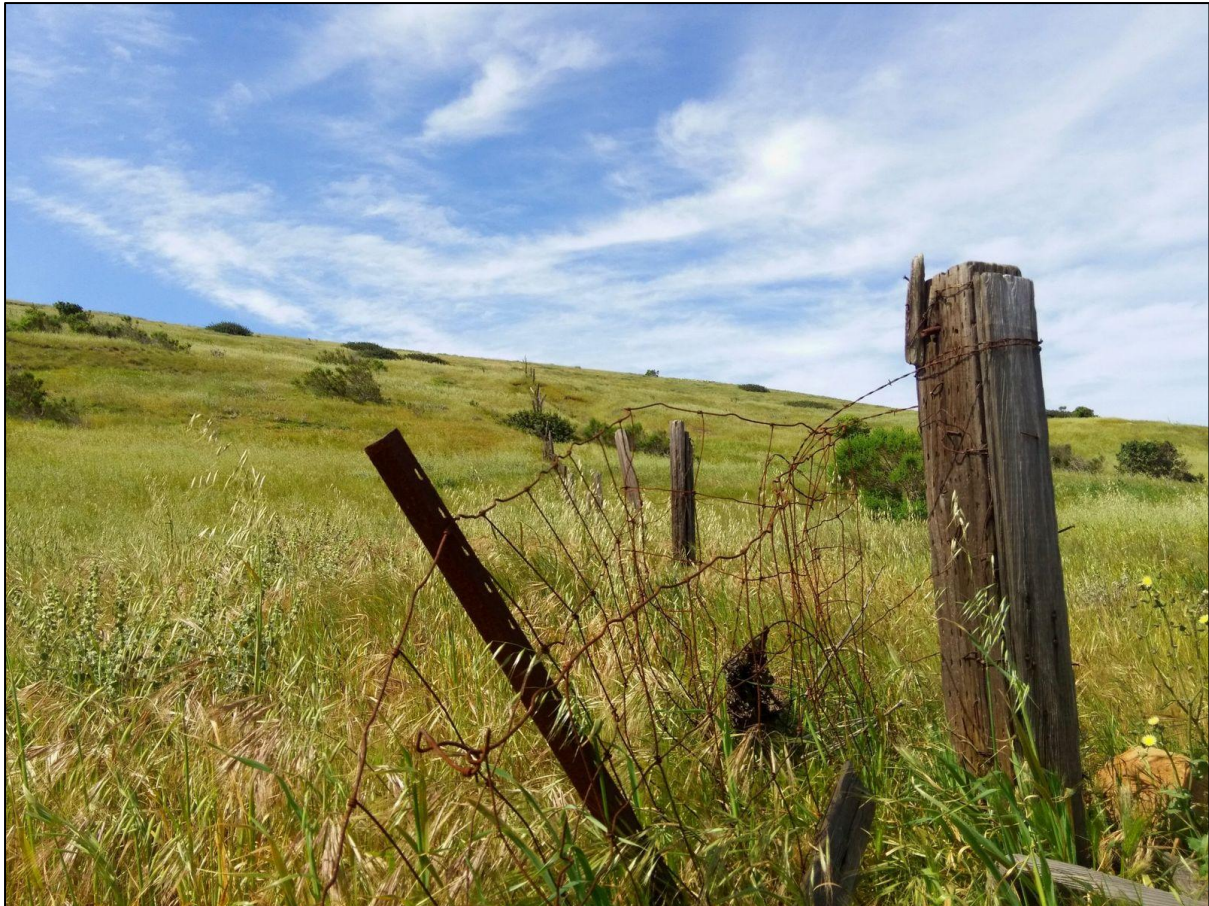
The site inspection on 23/06/2026 found a continuous 140 m section of the northern fence with the bottom two wires separated from the posts. It also found a clear animal pad through the fence at the 1,050 m mark (Figure 1). That inspection took place five days after the occurrence. The register entries made before the occurrence describe the same section as failed and worsening, which is consistent with the condition found.

*Figure 1: The northern perimeter fence at the 1,050 m mark, photographed on the site visit: the fallen section and the animal pad through it. Site inspection photograph SV-2026-0417-07, northern boundary at the 1,050 m runway marker, taken 23/06/2026*

The breach lay on the animals' path. The first officer called the animals on the left of the aircraft. They moved onto runway 09 from the northern side past the 1,100 m point. The carcasses were recovered at 1,188 m and 1,221 m from the runway 09 threshold. Both positions are beyond the pad at 1,050 m and on the same side of the runway. A fence in the condition found does not exclude kangaroos.

The repeated deferral of the northern perimeter fence repair very likely provided the route by which the two kangaroos entered the runway strip and moved onto the sealed surface.

The deferral very likely contributed to the occurrence. A fence in that condition did not exclude kangaroos. The pad lay on the same side of the runway as the carcasses recovered at 1,188 m and 1,221 m, and upstream of them. It was the physical route by which the animals reached the movement area.

On 25/06/2026 the aerodrome operator installed a temporary electric wire. It funded WR-221 from the 2026 contingency and programmed replacement of the 140 m northern boundary section for 09/2026. That action was in progress when it was reported. [NOT ESTABLISHED: whether the replacement was completed as programmed in 09/2026.]
