# Investigation report

Rejected take-off and runway overrun, Tarlton Springs - AAIB-style  
causal and contributory factors report

Drafted 02/10/2026

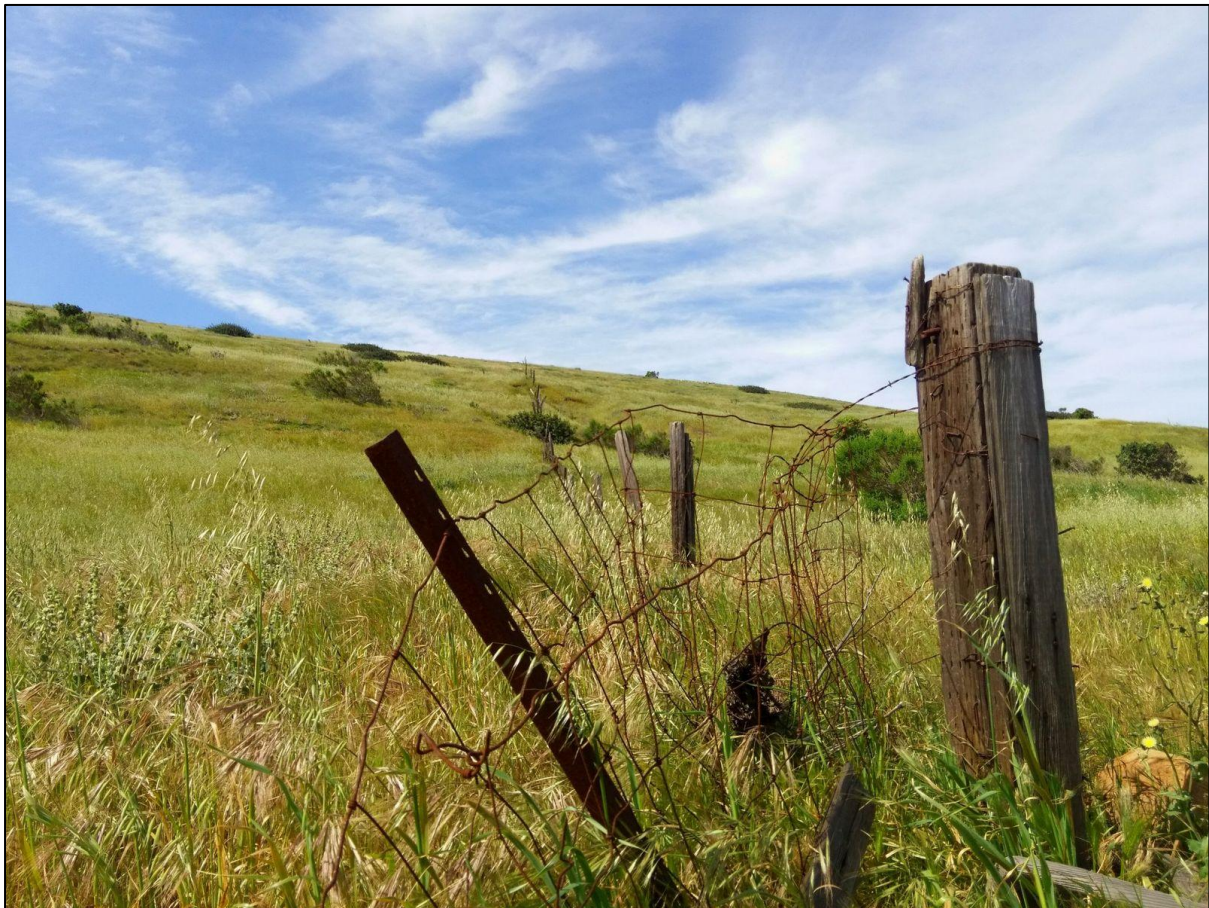
- **The site inspection on 23/06/2026** found a continuous 140 m section of that fence with its bottom two wires separated from the posts and a clear animal pad through it at the 1,050 m mark.

The site inspection on 23/06/2026 found what the register predicted. A continuous 140 m section of the northern fence had its bottom two wires separated from the posts, and a clear animal pad ran through it at the 1,050 m mark (Figure 1). It is virtually certain that the fence was in this condition at the time of the occurrence.

*Figure 1: The northern perimeter fence at the 1,050 m mark, photographed on the site visit: the fallen section and the animal pad through it. Site inspection photograph SV-2026-0417-07, northern boundary at the 1,050 m runway marker, taken 23/06/2026*

On this evidence, it is very likely that the deferred repair allowed the animals onto the runway strip. The finding is not put higher than very likely, because the link between the breach and these two animals is inferred from position and from the animal pad rather than observed. The deferral was also not by itself sufficient to produce the overrun. The outcome additionally depended on the timing of the departure, the absence of a runway inspection, the decision to reject above V1, and the reduced deceleration after the strike. Each of those is argued in its own subsection. The deferral is therefore placed as contributory rather than causal.

- Perimeter fence repair was deferred for three budget cycles after works register item WR-221 recorded the northern fence as failed in 04/2023 with animals observed passing through, leaving a continuous 140 m section with an animal pad at the 1,050 m mark on the same side of the runway as both carcasses, and it is very likely that this provided the route by which the kangaroos reached the movement area. (Safety issue)

The deferred repair very likely contributed to the occurrence. A fence in that condition did not exclude kangaroos, and it gave the two animals their route onto the runway strip and the sealed surface. The defect, and the fact that animals were using it, had been known to the aerodrome operator for more than three years without being remedied.

The aerodrome operator funded item WR-221 from its 2026 contingency and programmed replacement of the 140 m northern boundary section for 09/2026. A temporary electric wire was installed on 25 June 2026 as an interim measure, and the replacement work was in progress.
